Collision with terrain following an engine power loss involving Cessna 172M, VH-WTQ

12 NM (22 km) north-west of Agnes Water, Queensland on 10 January 2017

ATSB Transport Safety Report
Aviation Occurrence Investigation
AO-2017-005
Final – 17 October 2019

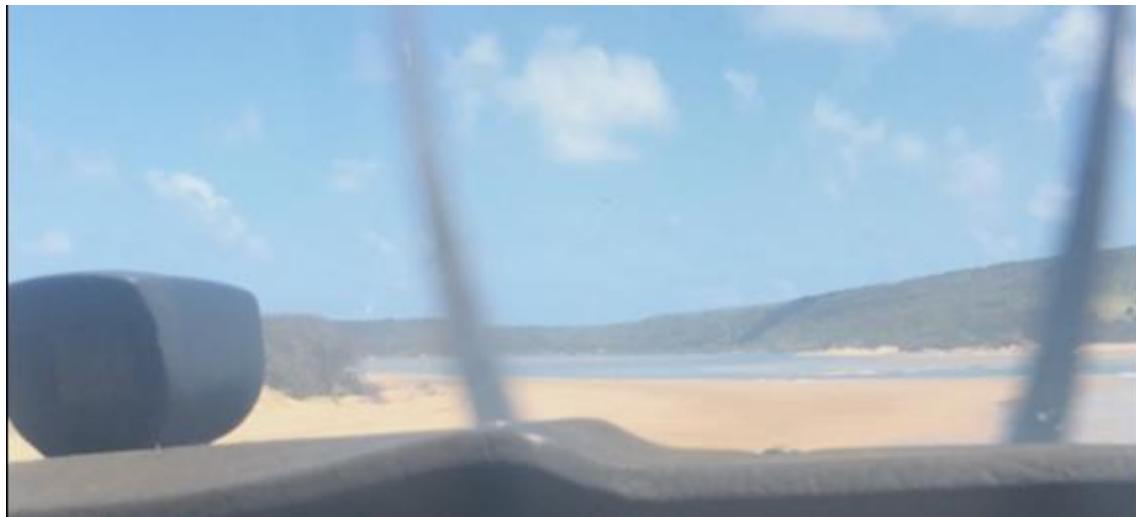
Figure 4: A still image taken from the video footage 2 seconds after engine power loss (1037:36)

Figure 4 shows the view of the remaining landing area at 1037:36, 2 seconds after the engine power loss. This shows an area of beach visible ahead, but does not show a further area of beach that was available for an emergency landing around a bend to the left (see Figure 2 and *Beach available for an emergency landing north of the landing area*).

At the time this image was taken the phone camera was oriented to the left of the aircraft's heading. The image shows an area of sand on Middle Island beach, just prior to a bend to the left with further beach beyond. Source: Queensland Police Service.

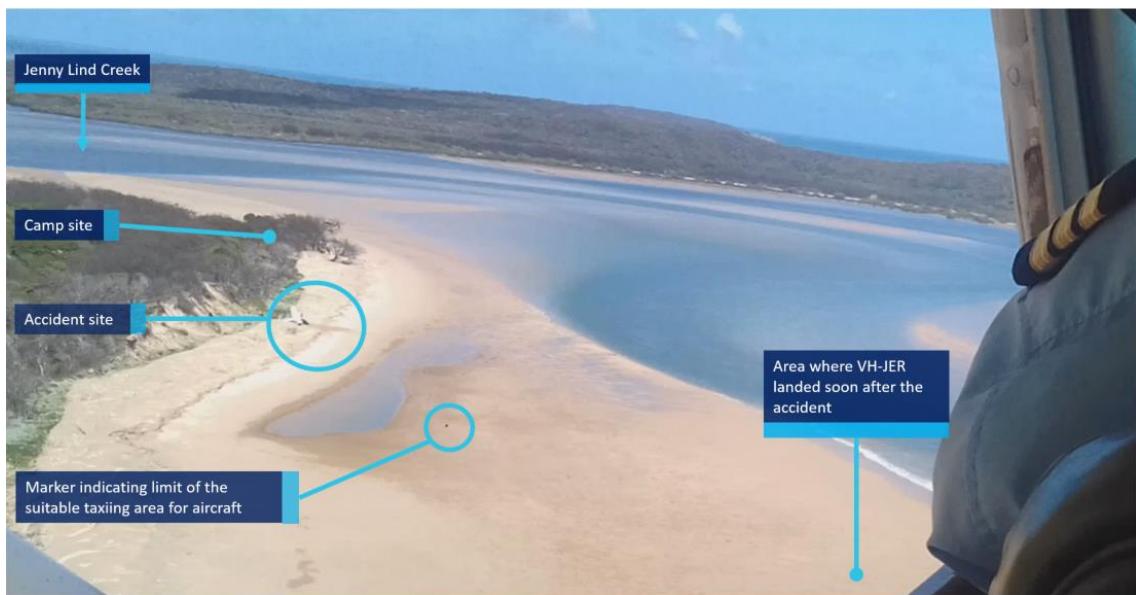
Figure 6: Accident site, as viewed from VH-JER

Following the impact, the aircraft cabin was inverted and the occupants were all held in place by their restraints. A significant amount of fuel was observed to be leaking from the aircraft's fuel tanks. The camp site employee, the chief pilot and other first responders extracted the occupants and moved them away from the wreckage to provide first aid. One of the rear-seat passengers was unresponsive, so the first responders provided cardiopulmonary resuscitation (CPR) but she could not be revived. A subsequent post-mortem examination determined that her injuries were not survivable (see also *Occupant injuries*).

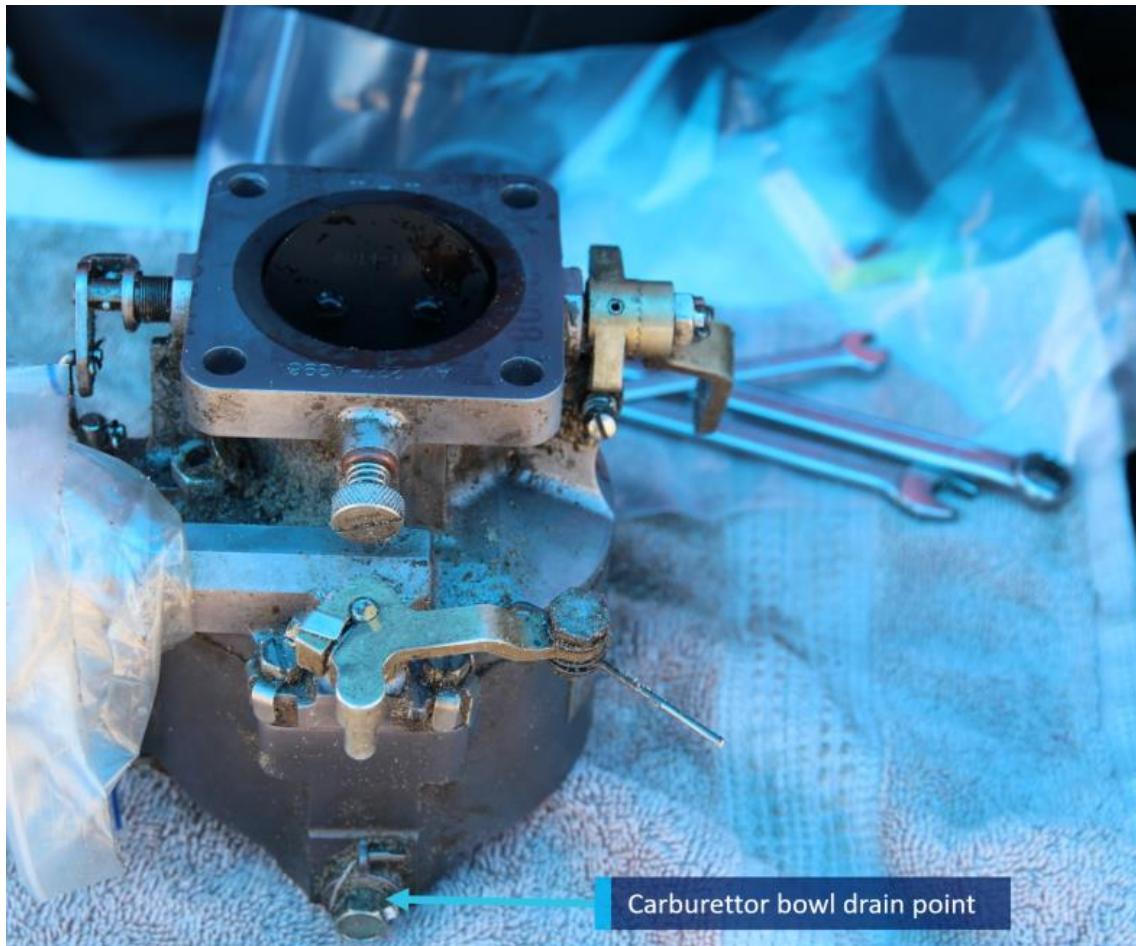
Figure 12: Carburettor showing drain point located at its base

As part of the removal process, care was taken not to invert the carburettor so as to prevent fuel draining out of the unit. With the carburettor in an upright position, the carburettor bowl drain was removed in order to ascertain if any fuel remained in the unit (Figure 12). No fluid of any kind was drained from the unit. It is possible that some fuel had leaked out of the unit while it was on its side; however the orientation of the unit meant that some fuel should have remained in the carburettor bowl.

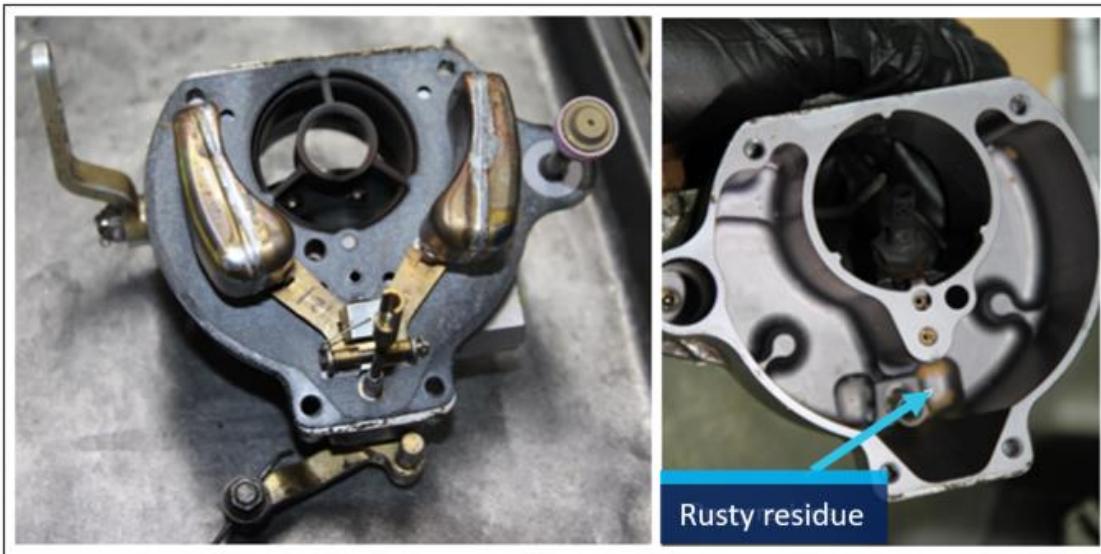
Figure 13: Disassembled carburettor showing internal components

- No pre-accident defects were identified with the mechanical components of the engine.
- The carburettor was disassembled and inspected, with no faults identified. There were no foreign particles and debris, apart from a small amount of rust-like residue at the drain point reservoir (Figure 13). The fuel metering orifice was also clean and free of foreign particles and debris. Given that no actual particles or debris were found in the carburettor, the presence of this rust-like residue was very unlikely to have contributed to the engine power loss.
- The magnetos were checked for correct timing and then removed for functional testing. Both magnetos functioned as designed with no faults identified.
- All the spark plugs were removed from the engine, inspected and tested. No faults were identified.

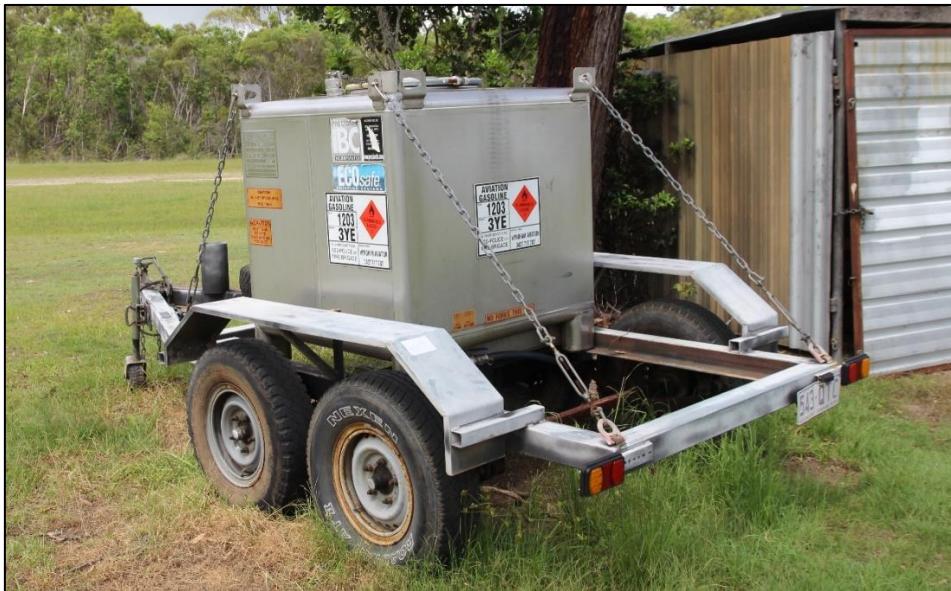
Figure 15: Fuel storage tank containing aviation grade gasoline

The fuel storage tank at Agnes Water ALA (Figure 15) was utilised by both of the operator's Cessna 172 aircraft, with the same batch of fuel being used in the period leading up to the day of the accident without any problems being noted.

The chief pilot stated that the fuel in the storage tank was checked visually for quality and the presence of water prior to each aircraft refuel. When the fuel storage tank was empty it was taken to Bundaberg Aerodrome and refuelled with 100LL aviation grade gasoline.

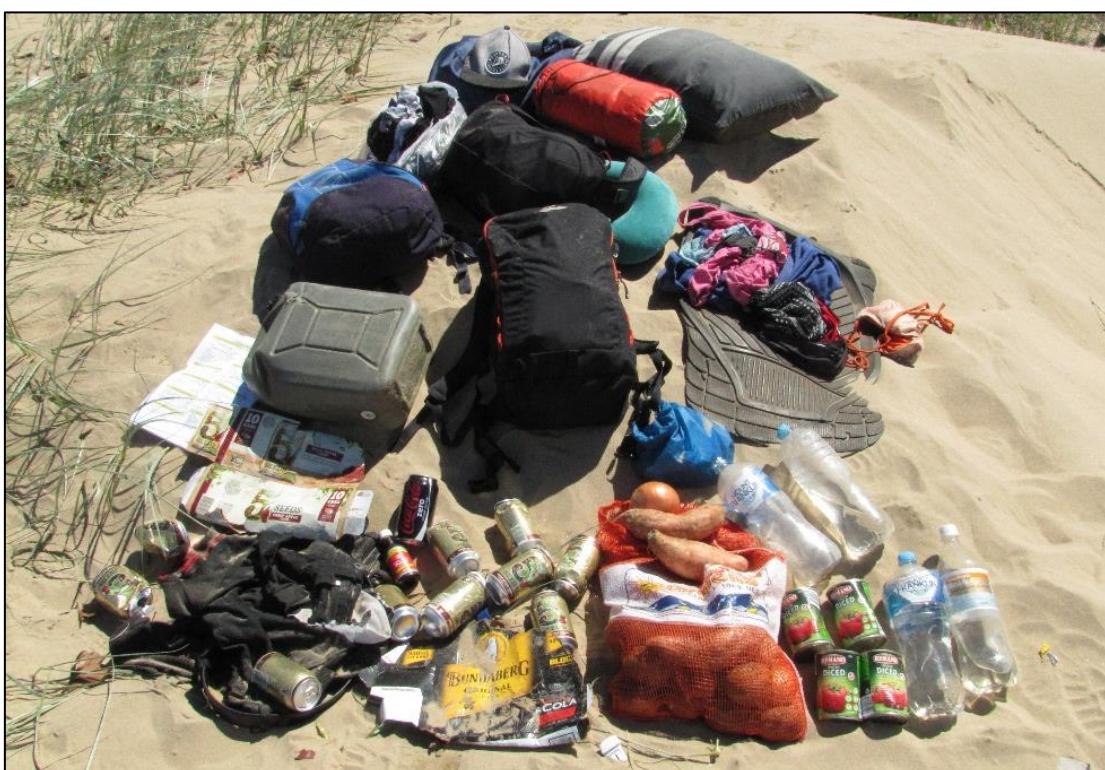
Figure 16: Some of the contents from VH-WTQ's baggage compartment at the accident site

During the on-site investigation, the ATSB recovered personal baggage and camping equipment from the baggage compartment of VH-WTQ. The ATSB also recovered camp food and drink supplies from the baggage compartment, as well as some of these supplies from the aircraft cabin and a small number of similar items from the surrounding area that were potentially on board the aircraft (Figure 16).

Some other items recovered by the ATSB from the wreckage are not included in this photograph. Those included cans of alcohol. It was reported that a full carton of rum and cola drink was on board but only 18 cans were recovered and included in the baggage weight. A large (3 kg) pumpkin was found close to the wreckage but not included in the final calculation. Only one of the 1.5 L water bottles shown in the photograph was included in the ATSB weight calculation (although others were found nearby and were potentially on board). The rubber mat was also not included in the ATSB calculations.

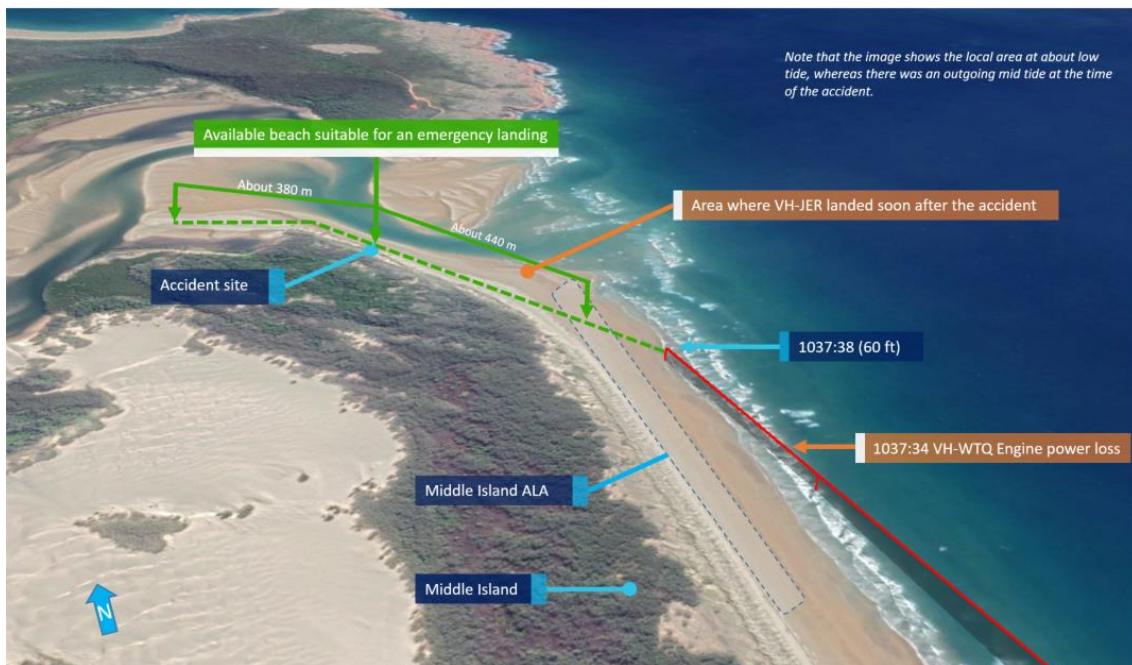
Figure 18: Image of Middle Island aeroplane landing area and the beach area to the north

Figure 18 shows a Google Earth image of the landing area and beach north of the landing area. This image was taken in May 2016, and it was the Google Earth image that most closely represented the conditions at the time of the accident flight. Based on reviewing video footage taken from the accident flight, and the following flight in VH-JER, there was significantly less beach area around Jenny Lind Creek inlet at the time of the accident compared to this Google Earth image. The width of the beach near the landing area was also slightly narrower. However, there was still a substantial amount of beach surface north of the landing area at the time of the accident.

In summary, most of the beach area north of the ALA indicated in Figure 18 was present at the time of the accident flight. More specifically, as indicated in the video footage from VH-WTQ, the aircraft was almost over the beach at the time of the engine power loss (1037:34). Figure 18 compares this location with the estimated touchdown point of VH-JER (heading south) a few minutes after the accident (see also Figure 6). Based on a review of video footage from VH-JER, from 1037:38 (just after the pilot commenced a right turn), there was about 440 m (1,440 ft) along the beach until abeam where the aircraft wreckage was located. In addition, there was about

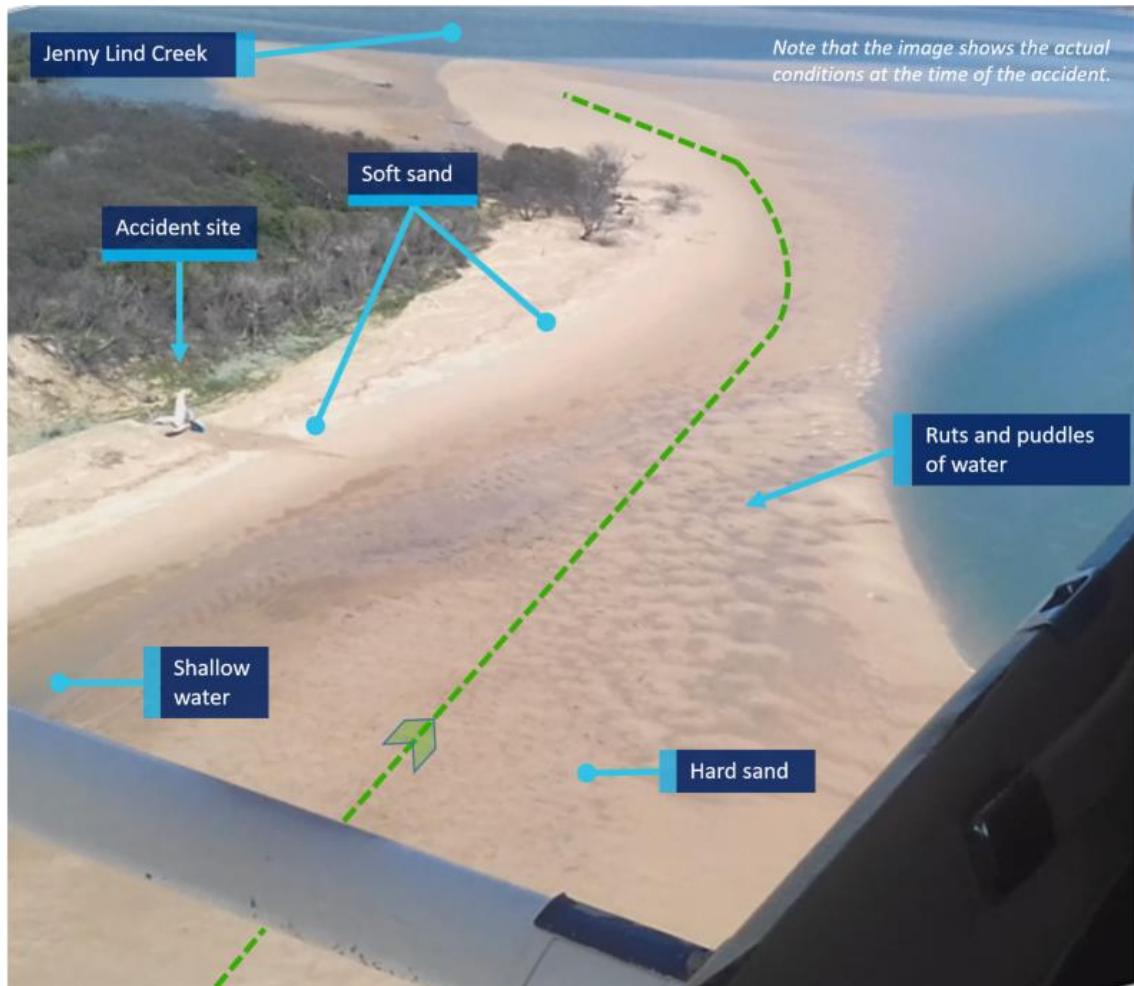
Figure 19: Image taken from VH-JER soon after the accident showing area of beach to the north of the landing area

Figure 19 shows the beach area to the north of the accident site as seen just after the accident. As indicated in this image, most of the sand area shown in Figure 18 was present at this time. The beach included an area of shallow water just south of the accident site, areas of hard sand, areas of hard sand with ruts and very shallow puddles and areas of soft sand. Figure 20, also taken from VH-JER just prior to it landing, shows the beach from the accident site up to the camp site.

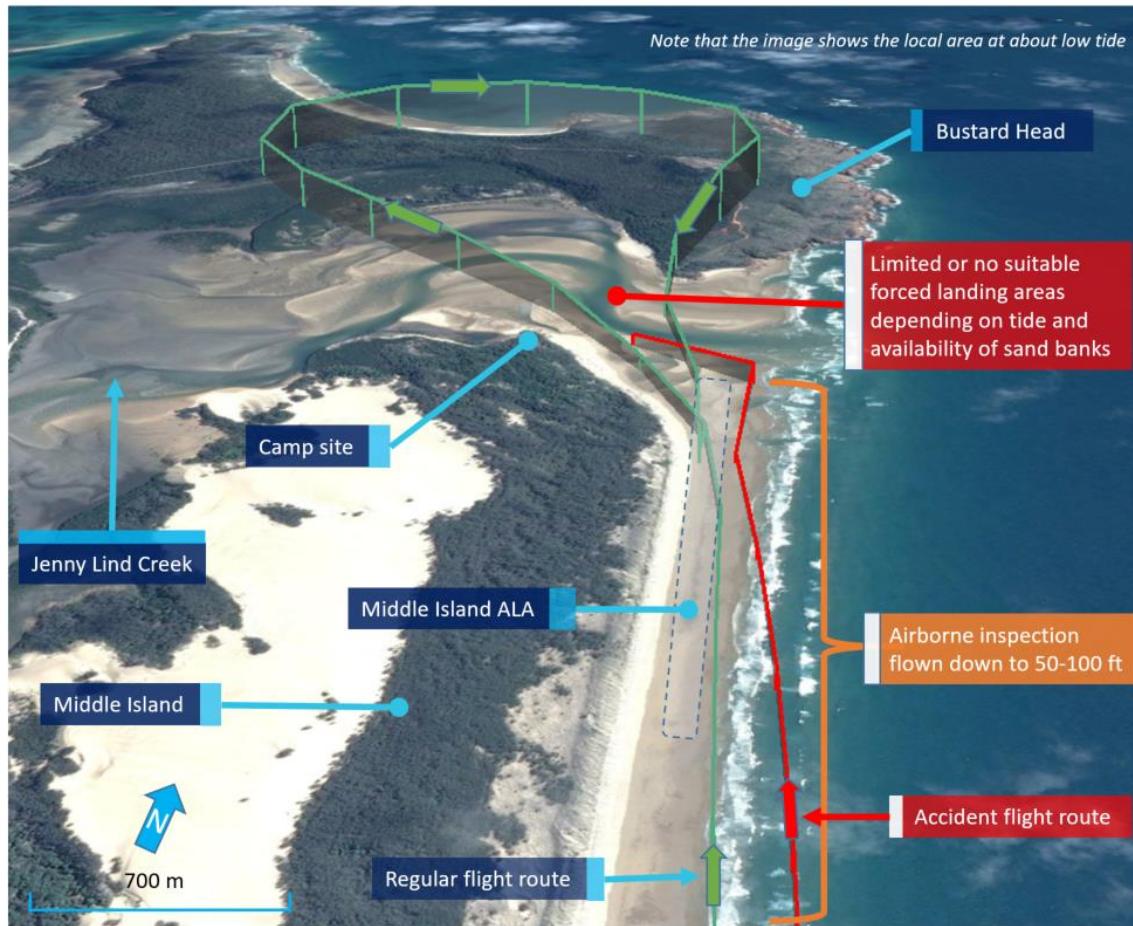
Figure 21: VH-WTQ GPS-derived regular flight path for an airborne inspection on the southerly beach landing area (green line)

In general, the aircraft passed within 300 m to the east of the lighthouse (which had a focal height of 336 ft) on Bustard Head during the approach to landing, often at an altitude of about 450–500 ft AMSL, passing directly over terrain which was up to 280 ft AMSL. In a small number of cases, the right turn over Jenny Lind Creek was completed to the west of Bustard Head, with the aircraft reaching an altitude of 350–600 ft prior to the approach.

In all cases, there was a significant segment of the airborne inspection and climb out that had no suitable forced landing areas in the event of an aircraft emergency such as an engine power loss (Figure 21 and Figure 22). In none of the cases was a standard (four-leg) circuit pattern flown after the inspection.

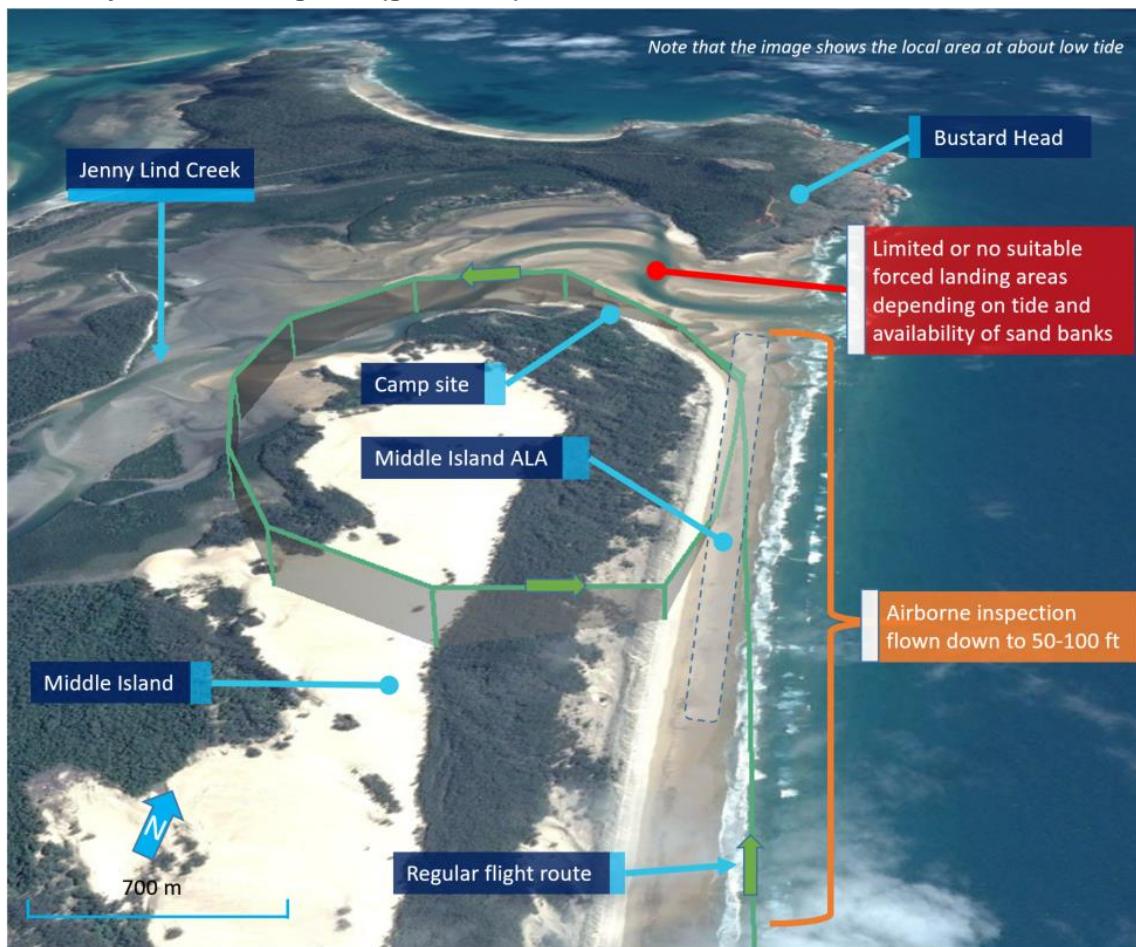
Figure 22: VH-WTQ GPS-derived regular flight path for an airborne inspection on the northerly beach landing area (green line)

- the aircraft remained at about 50–100 ft AMSL and flew past the operator's camp site
- passing the camp site the aircraft commenced a climbing left turn over the Jenny Lind Creek inlet
- the aircraft reached a maximum altitude of about 300–400 ft AMSL while the pilot conducted a left circuit
- the pilot established the aircraft on the beach ALA centreline and conducted an approach and landing to the north.

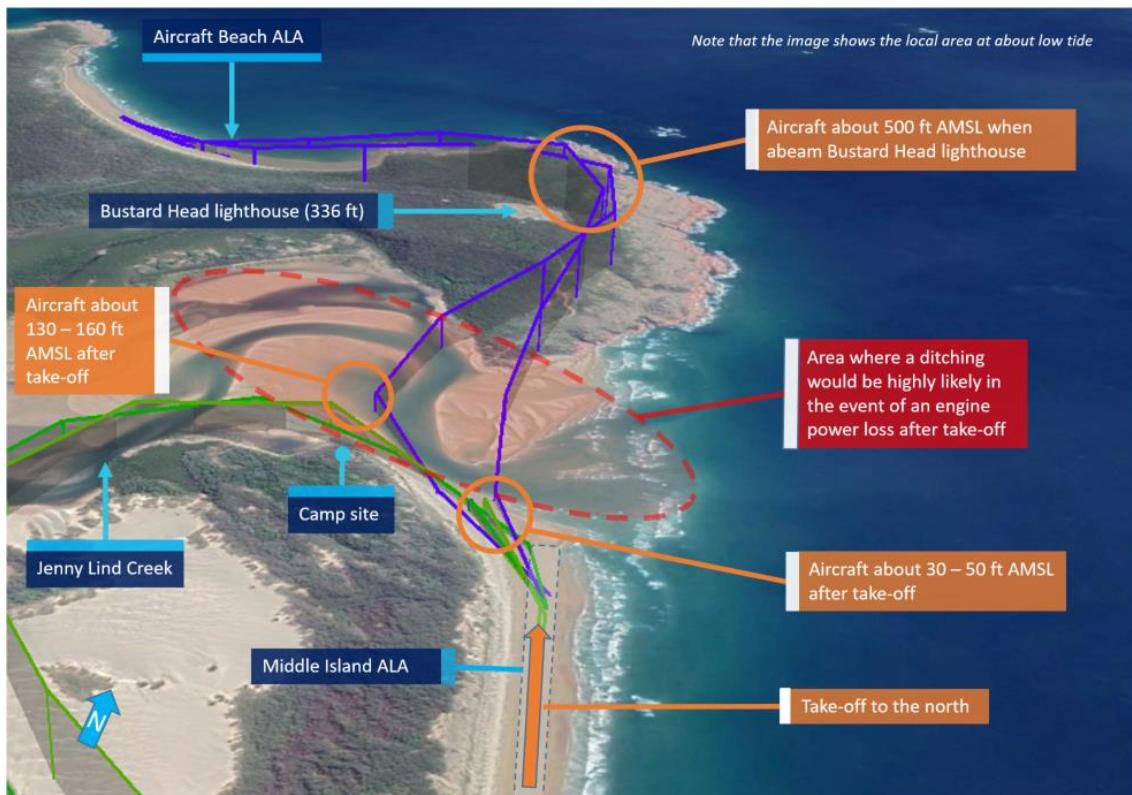
Figure 25: GPS flight paths of take-offs to the north flown in VH-WTQ

- Two flights from Middle Island to Aircraft Beach that commenced with a take-off to the north, with both flights passing over the Jenny Lind Creek inlet at a low height soon after take-off before flying over Bustard Head, just to the right of the lighthouse and at a height of about 200 ft AGL (Figure 25).

- Two flights from Middle Island to Agnes Water that commenced with a take-off to the north, before turning to the left at a low height (below 200 ft AMSL) and then proceeding to Agnes Water (Figure 25).

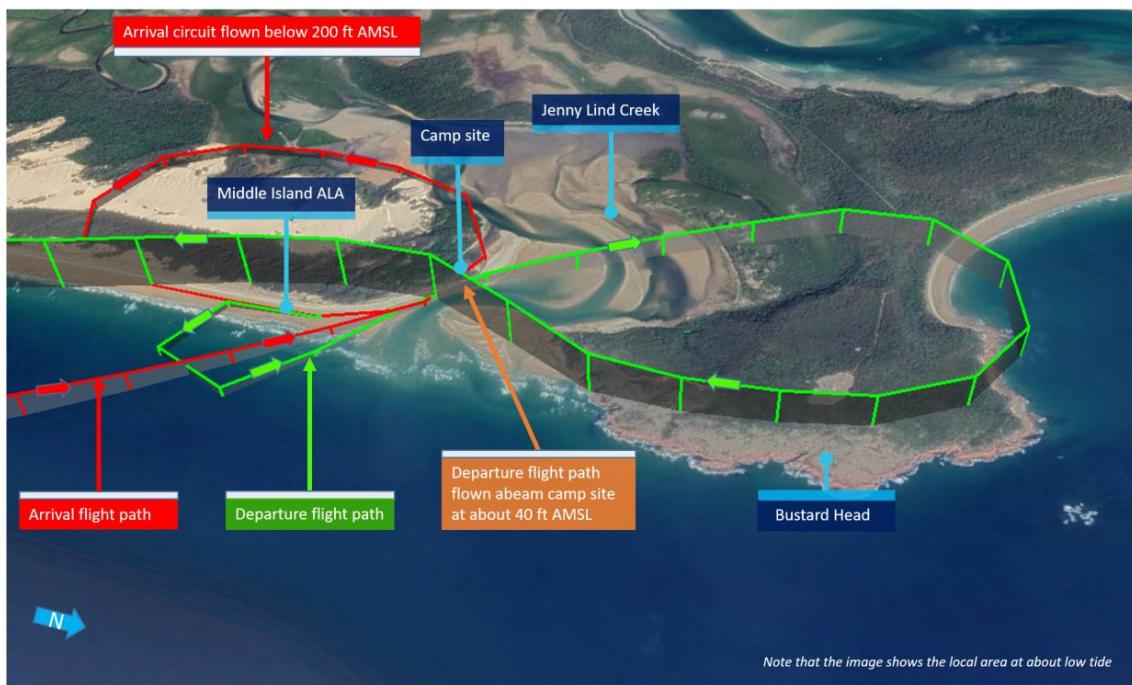
Figure 26: Additional observed GPS flight paths flown in VH-WTQ on 1 January 2017

- One flight from Middle Island to Agnes Water that commenced with a take-off to the south before turning sharply to the left over water, coming back over the northern end of the Middle Island ALA and descending to a lowest height of about 40 ft abeam the camp site, conducting a right turn around the Bustard Head lighthouse at an altitude of about 500 ft AMSL and then proceeding back to Agnes Water (see Figure 26).

In terms of approaches to Middle Island ALA, many of the approaches that did not involve an airborne inspection involved conducting a turn onto final approach below 500 ft AGL.³⁵ The most notable flight was an approach to the Middle Island ALA from over the water down to about 80 ft abeam the camp site before a left circuit and return to a landing on Middle Island. During the left circuit the aircraft only reached a maximum altitude of about 200 ft AMSL (when over terrain of about 100 ft) (see Figure 26). This flight was conducted on the same day (1 January 2017) as the last take-off listed above.

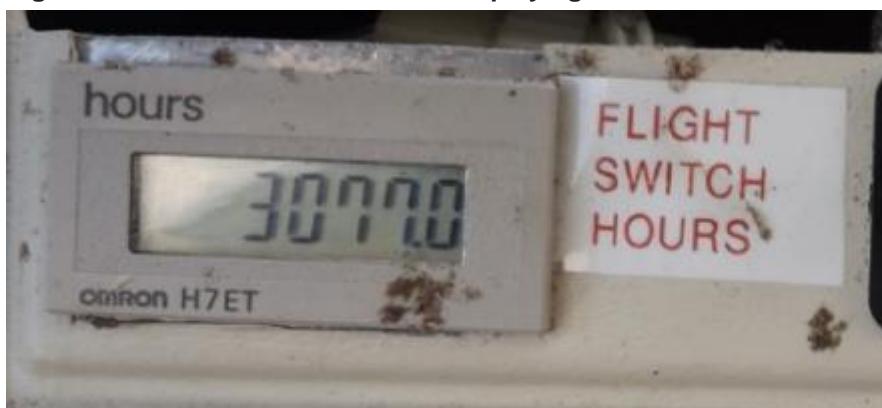
Figure A1: Hour meter on VH-WTQ displaying the value at the time of impact

- The hour meter reading after the accident was 3,077.0 hours (Figure A1), and this figure was also visible in the video footage of the accident flight at 1037:39 (20 seconds prior to impact). The reading prior to take-off would therefore have been about 3,076.9 hours. This figure indicated there had been 167.8 hours flight time since the 12 November 2015 inspection. It also indicated that the flight time documented on the maintenance releases underestimated the actual flight time by 34.3 hours (or 20 per cent) during the period from 12 November 2015 to 10 January 2017.
- There was no evidence in the maintenance records that the hour meter was considered faulty during the period that Wyndham Aviation used the aircraft from 2013 to 2017. The chief pilot and pilot of the accident flight reported that they were not aware of any problems with the aircraft's hour meter.

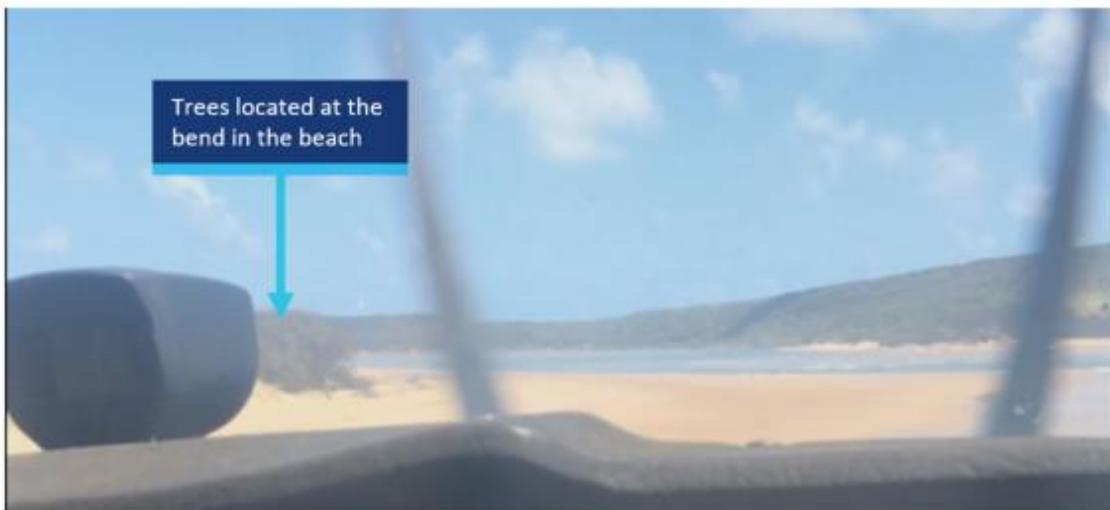
Figure B1: A still image taken from the video footage 2 seconds after engine power loss (1037:36)

- At 1037:36, 2 seconds after the engine power loss, the video footage showed that the aircraft was still a significant distance south of the bend in the beach on Middle Island (see Figure B1 and the location of the bend in Figure 2). Given the aircraft's groundspeed was about 124 kt (or 64 m/s) at that time, the image shown in Figure B1 was taken about 130 m north of the engine power loss. If the engine power loss had occurred at the position reported by the pilot, then the area of beach north of the bend should have been visible in Figure B1. Instead, this image is consistent with what would be expected if the engine power loss occurred at the position indicated in Figure 2 (based on the recorded GPS data).

At the time this image was taken the phone camera was oriented to the left of the aircraft's heading. The image shows an area of sand on Middle Island beach, just prior to a bend to the left with further beach beyond.

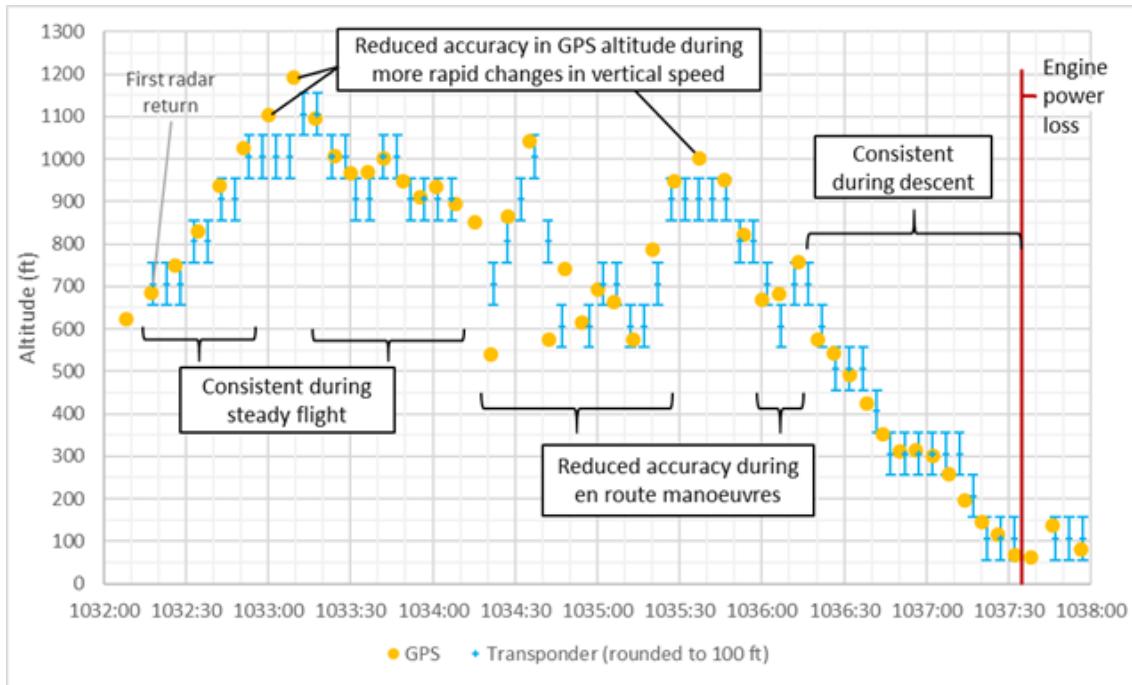
Figure B2: Comparison of recorded GPS and transponder altitudes

⁷⁰ 'QNH' refers to the altimeter barometric pressure subscale setting used to indicate the height above mean seal level. Transponder altitude data is based on a standard QNH of 1,013.2 hPa, which was very slightly below the QNH measured at a nearby town (Seventeen Seventy) at 0900 (1,013.4 hPa). This would result in the transponder altitude reading about 6 ft too low. The ATSB corrected the transponder altitude for this analysis.
