Final Report

On the accident on **1st June 2009**
to the **Airbus A330-203**
registered **F-GZCP**
operated by **Air France**
flight AF 447 Rio de Janeiro - Paris

Bureau d'Enquêtes et d'Analyses
pour la sécurité de l'aviation civile

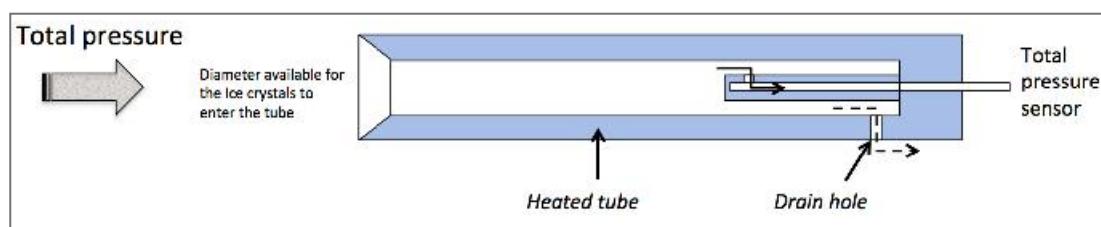
Figure 8: Pitot probe diagram

When highly specific climatic conditions are met, in particular with the presence of ice crystals in excessive quantities, the conditions for use of the probes can exceed the conditions for qualification and robustness. In this type of situation, a partial obstruction of the total pressure probes in icing conditions and at high altitude (above 30,000 feet) can occur. This results in a temporary and reversible deterioration of total pressure measurement.

In the presence of ice crystals, there is no visible accretion of ice or frost on the outside, nor on the nose of the probe, since the crystals bounce off of these surfaces. However, the ice crystals can be ingested by the probe air intake. According to the flight conditions (altitude, temperature, Mach) if the concentration of crystals is greater than the capacity for de-icing of the heating element and evacuation by the purge holes, the crystals accumulate in large numbers in the probe tube.

As soon as the concentration of ice crystals is lower than the de-icing capacity of the probe, the physical barrier created by the accumulation of crystals disappears and measurement of the total pressure becomes correct again.

Experience and follow-up of these phenomena in very severe conditions show that this loss of function is of limited duration, in general around 1 or 2 minutes.

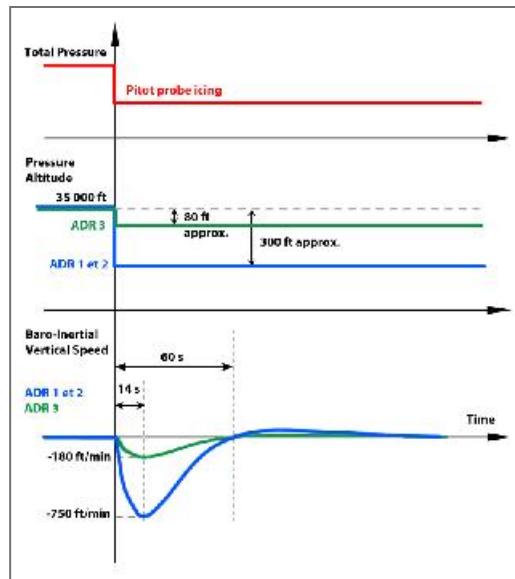
Figure 10: Effect of a drop in total measured pressure on pressure altitude and vertical speed

The first consequence of a drop in measured total pressure is a drop in the Mach and the CAS. The drop in Mach leads to a drop in standard altitude due to the correction of the measured static pressure. This drop is different according to the ADR under consideration: in the flight conditions of the event, it is of the order of 300 to 350 ft for the ADR 1 and 2 and of 80 ft for ADR 3.

The drop in indicated standard altitude also causes a transient variation in Vzbi. Just as the drop in standard altitude is lower for ADR 3 than for ADR 1 and 2, the variation in Vzbi is lower for ADR 3 than for the two others, as illustrated by the graph below:

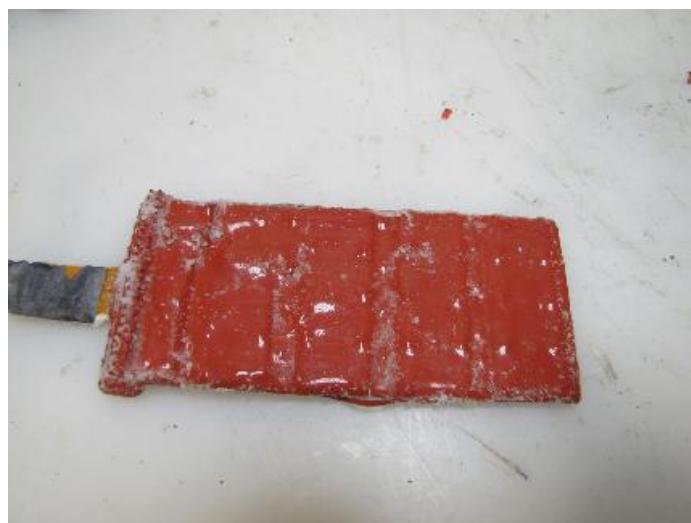
Figure 19: FDR memory board

The memory board was cleaned. Visual inspection did not reveal any damage to the board. The board was placed in an oven for 36 hours in order to remove the moisture in the components and the printed circuit board. The impedance measurements that were then made on the input connector were in accordance with the measurements made on reference units.

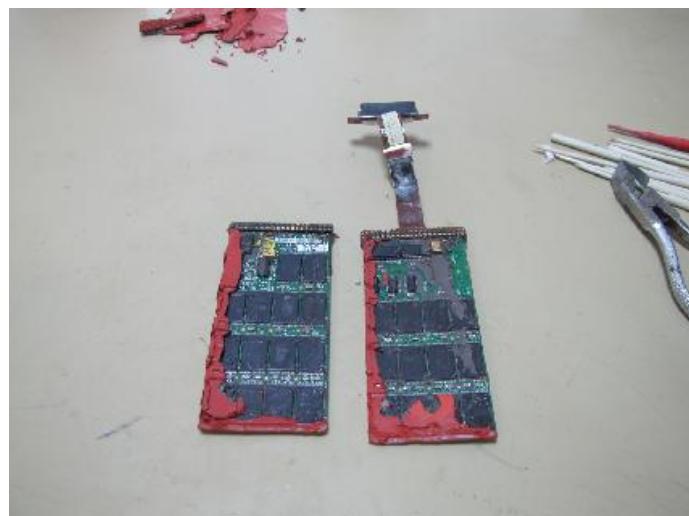
Figure 23: CVR memory boards before cleaning

Visual inspection of the boards revealed damage: a capacitor and a resistor were cracked on one of the boards; two decoder-type components were damaged on the other board.

The boards were placed in an oven for 42 hours. The damaged components were unsoldered and replaced. The impedance value measured at the input connector complied with the measurements made on reference boards. The memory boards were then connected separately to the BEA's memory reader. A few memory components selected previously were addressed and read entirely. The consistency of the binary contents of each memory could then be checked using the manufacturer's hardware and software. The boards were then connected to the BEA's chassis and the data was extracted and decompressed using the manufacturer's official hardware.

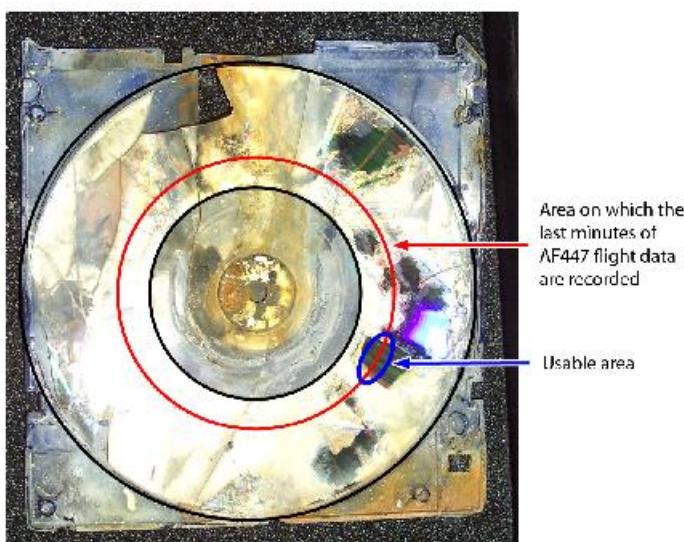
Figure 29: Optical disk showing the location of the readable zones

This computer is an unprotected parameter recorder used for flight analysis purposes by the operator. The data was recorded on a magneto-optical disk which was removed from the computer. The disk was so badly damaged that it was impossible to use traditional reading methods. It was therefore examined in collaboration with the solid-state physics laboratory at Paris-Sud University, and in conjunction with the manufacturer, Thales.

Readable zones were identified. The only zone likely to contain flight data was analysed. It relates to one second of information recorded every 100 seconds. Very little information could thus be recovered, and this data did not supplement the elements recovered by other means. The examination was therefore terminated after this feasibility study.

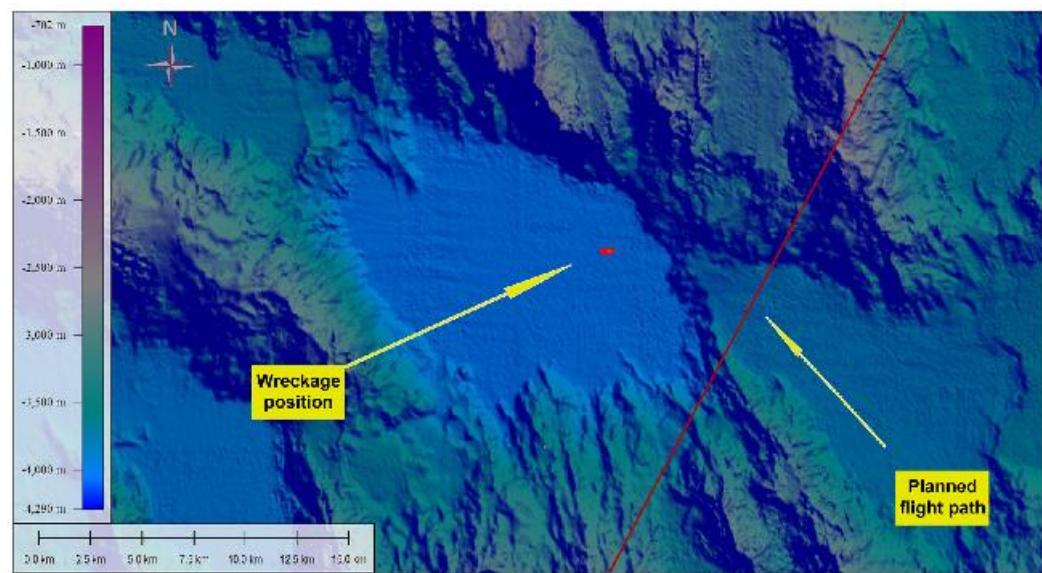
Figure 32: Wreckage localisation

The aeroplane wreckage was found about 6.5 NM on the radial 019 from the last known position, slightly to the left of the planned route. The wreckage rested on an abyssal plain at a depth of 3,900 metres. This plain, surrounded by terrain, made of clay type sediment, was around 15 km wide and was located west of the scheduled aeroplane flight path.

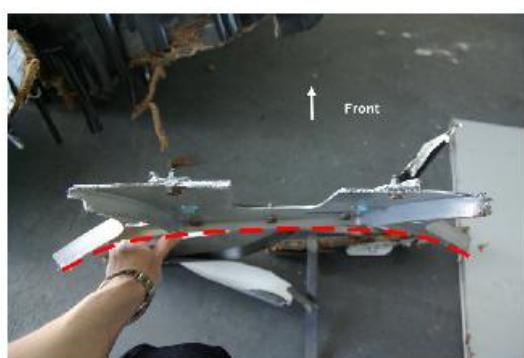
Figure 36: Luggage rack fitting deformed towards the front Toilet door (L54)

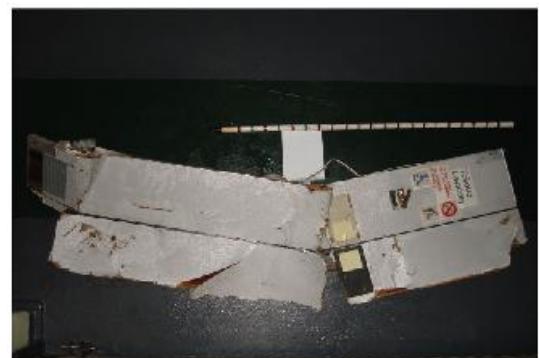
Figure 37: Metallic stiffeners deformed by buckling

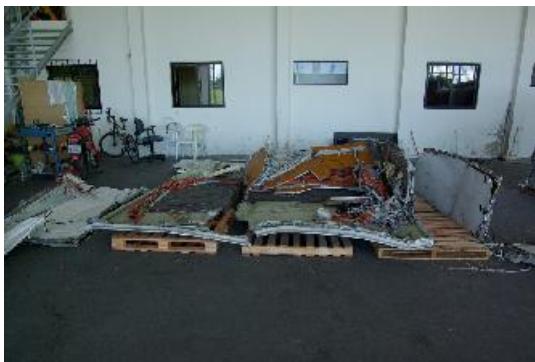
The wall fragments were crumpled. The reconstitution of the ceiling showed it was bent downwards and the floor bent upwards.

These deformations were symmetrical on the left and right sides with respect to the aircraft centreline.

Figure 38: Floor of the LDMCR:
with bottom-upwards deformation

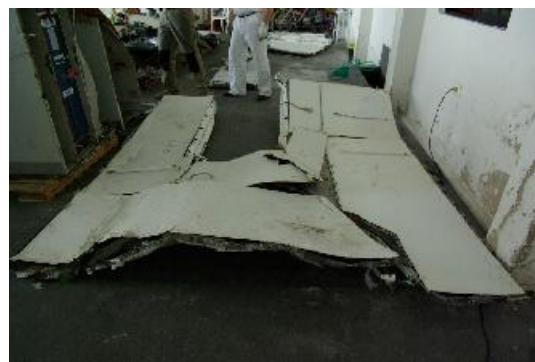
Figure 39: Ceiling of the LDMCR:
with top-downwards deformation

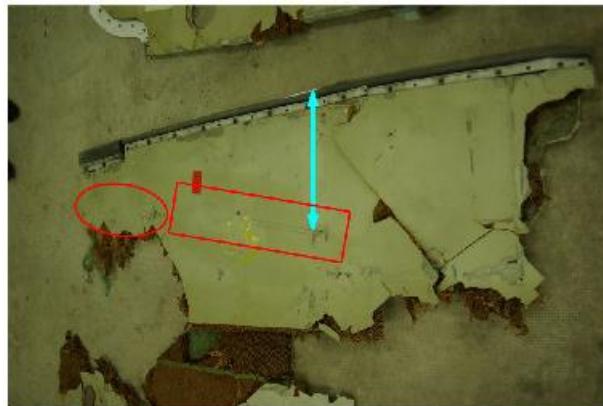
Several parts of the flap extension mechanism fairing were found. There were marks on two of them (positioned at the level of flap track N°3), made by the flap extension track on impact. Analysis of these marks (morphological and dimensional examinations) and comparison with an identical aeroplane made it possible to determine that the flaps were in the "retracted" position (see photo below) at the time of impact with the water (measurement of the distance between the track and the lower surface of the flap, position of the carriage on the track).

Figure 43: Part of the No. 3 flap track fairing on the left wing

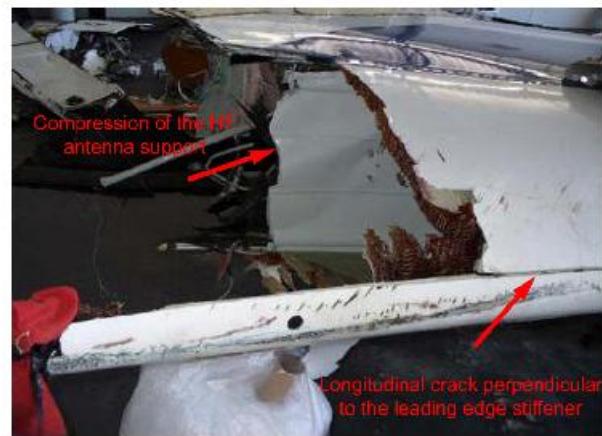
- Failure of the leading edge right- and left-hand panels
- Longitudinal cracking of the leading edge stiffener
- HF antenna support (attached to the forward spar): failure of the lower part, crumpling indicating bottom-upwards compression loads.

Figure 46: HF antenna support

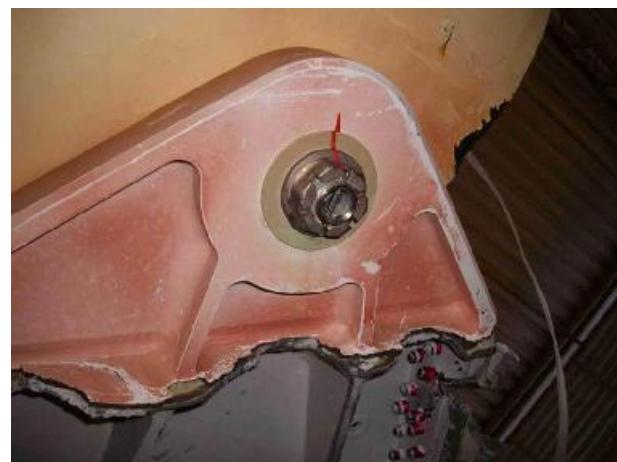
Figure 49: Right-hand aft lug: shearing of the fuselage along main frames 86-87

The part of frame 87 that can be seen had undergone S-shaped deformation: the left-hand side forwards, and the right-hand side backwards. The horizontal stabiliser actuator supports were deformed and broke in a backwards movement from the front. These observations indicate a backwards movement of the trimmable horizontal stabiliser.

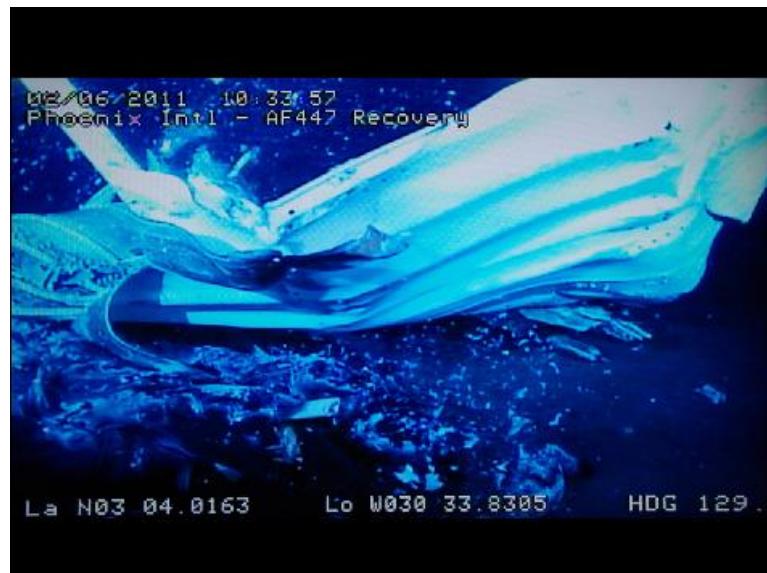
The lower elements of the fuselage were badly broken up and deformed. In these areas, crushing of the sheet-metal between the ribbing was noted, which indicates a vertical component at the time of impact.

Figure 56: Parts of the fuselage

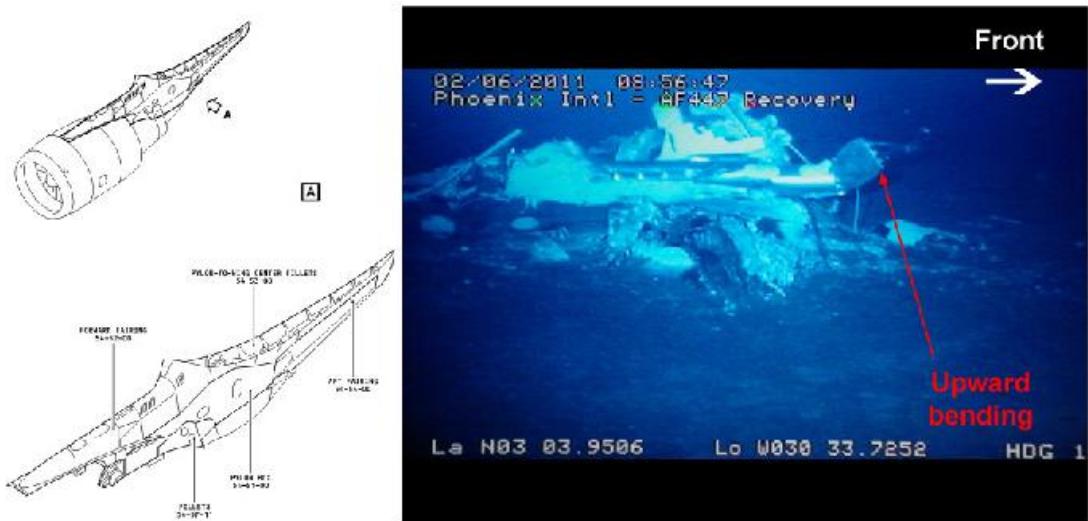
The engine pylons were found separated from the wings. They had deformations compatible with loads on the engines from below to above.

Figure 58: Engine pylon

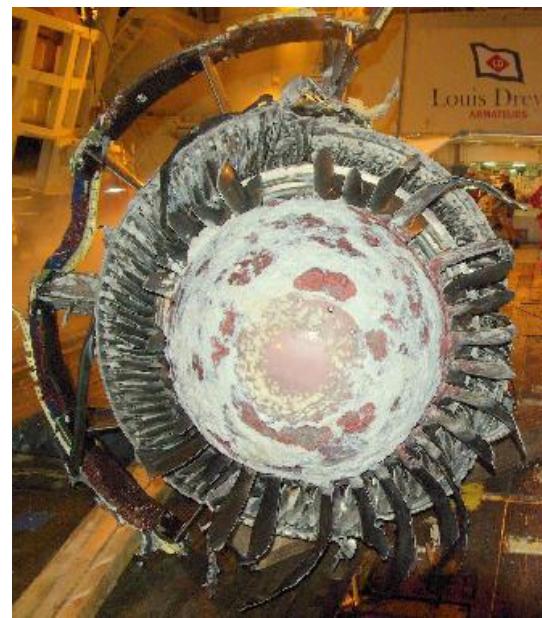
The visual examination of the two engines showed that they were at high RPM at the moment of impact with the sea.

Figure 60: Front view of engine

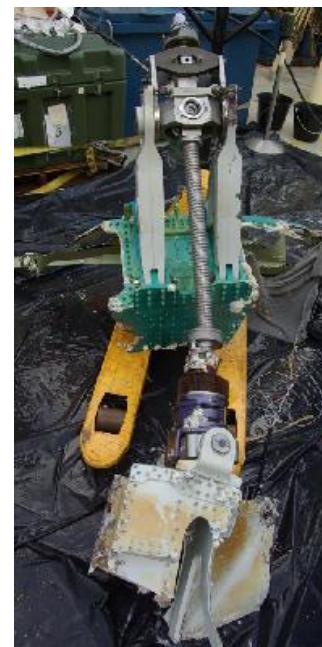
According to the manufacturer's technical documentation, the relative position of the actuator and the THS screwjack corresponded to a THS position of between 13° and 13.5° nose-up.

Figure 61: Trimmable horizontal stabiliser screwjack after being raised on board

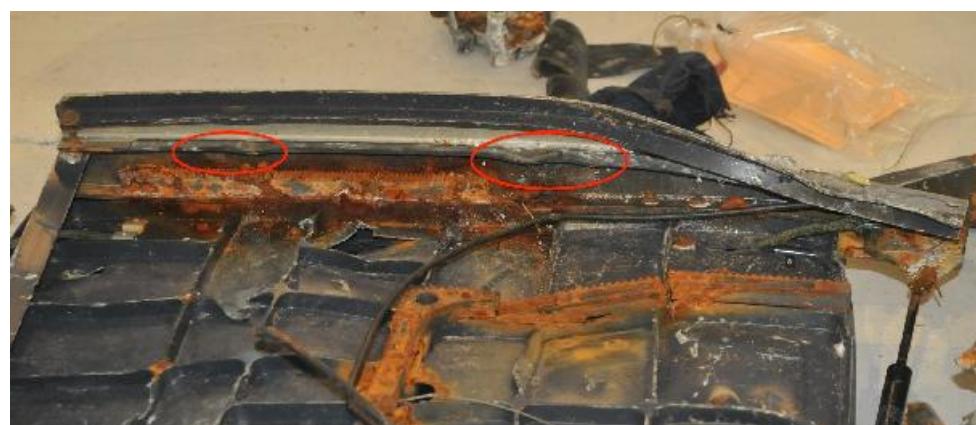
The marks left by the adjustment mechanism under the seat cushion enabled the horizontal position of the seat on impact to be determined: the seat was pushed back and moved to the left (in the "storage" position).

Figure 80: Roller marks on the guidance rail

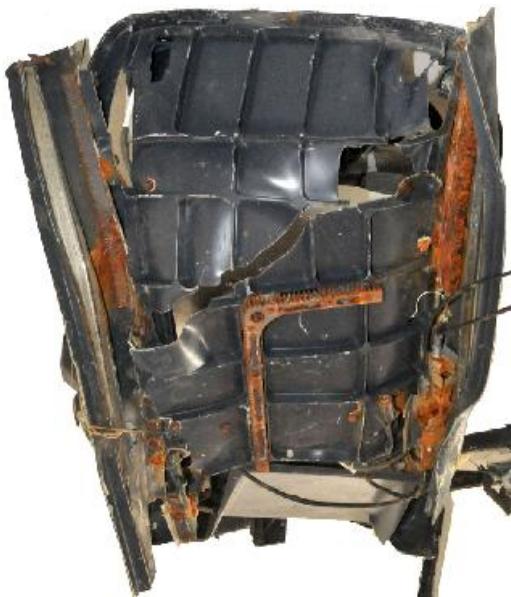
Figure 81: Right side seat cushion

The marks left by the adjustment mechanism under the seat cushion enabled the horizontal position of the seat on impact to be determined. The seat was positioned 5.5 cm from the most forward position.

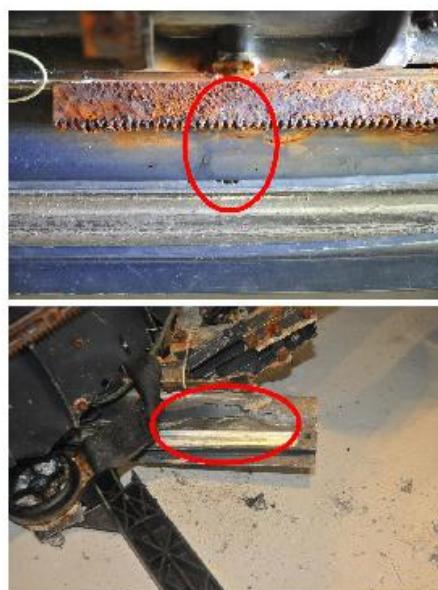
Figure 82: Marks on the adjustment mechanism

The threaded rods of the two tilt adjustment bolts were recovered almost completely drawn in, asymmetrically. For the same reasons as those explained for the left side seat, the positions deduced from observation of these bolts were not validated.

The seat's height adjustment mechanism was frozen at a height of 7.5 cm. The seat height may have been modified during impact. The height before impact may have been slightly higher (clutch slip).

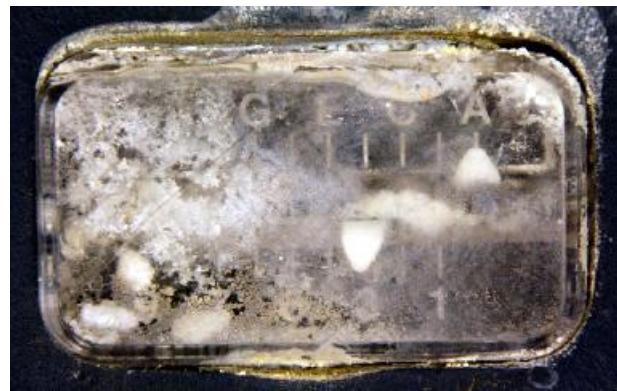
Figure 83: Dial indicating armrest position

The armrest was recovered in the up position, a probable consequence of the impact. The armrest position was indicated on the dial dedicated to this function. The needles were positioned on A values (adjustment from A to K for height) and 3 (adjustment from 1 to 9 for tilt angle). The armrest cladding was dismantled in order to check mechanism integrity and validate the needle positions. The mechanisms were demonstrated to be irreversible during certification tests, that is to say that leaning on the armrest did not modify the adjustments made with the knobs.

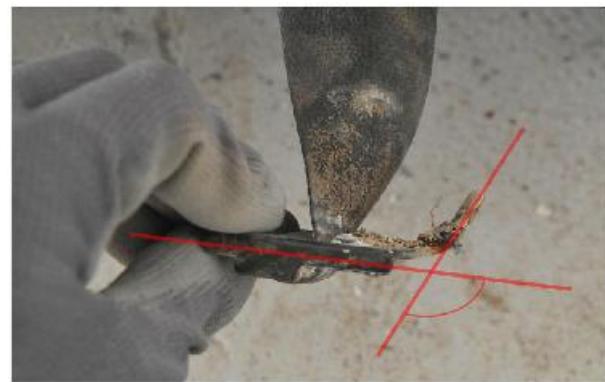
The shoulder straps, the left lap belt and crotch belt were recovered detached. Examinations showed that on impact the left lap belt and crotch belt were locked and that the shoulder straps were not.

Figure 84: Malformation of the crotch belt fastening

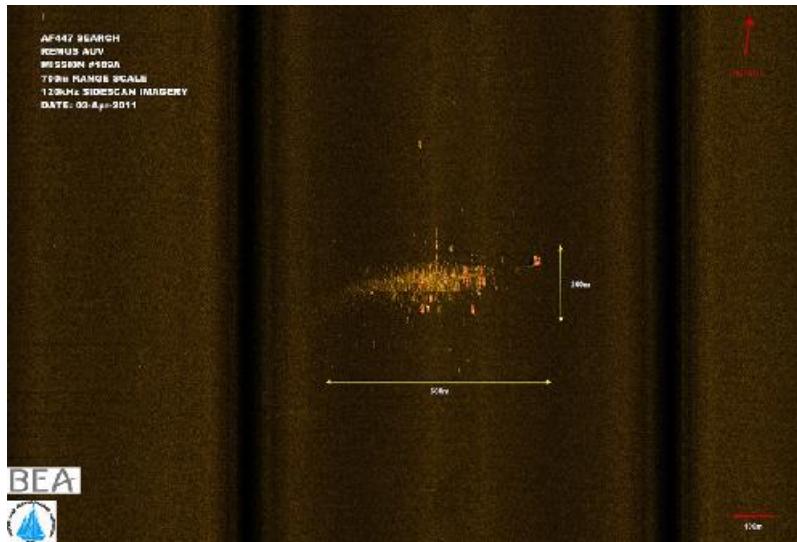
Figure 92: General view using sonar imaging: 120 kHz, range of 700 m

The wreckage was discovered on 2 April 2011 with the aid of the REMUS AUV's side scan sonar adjusted to a frequency of 120 kHz and a 700-metre range.

The first passage brought to light a concentration of backscattered data over an area of around 600 metres by 200 metres.

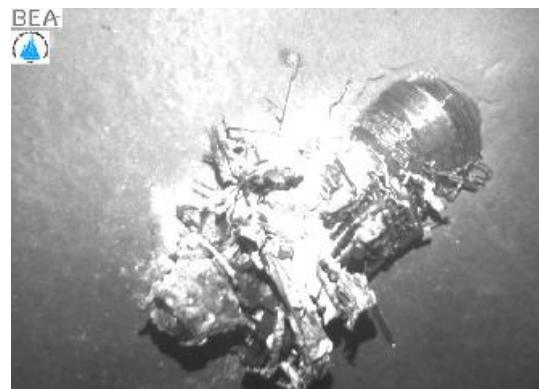
Figure 93: Engine

During the course of the following mission, the REMUS was programmed to take photos in bursts at a height of around ten metres to formally identify the wreckage of flight AF 447.

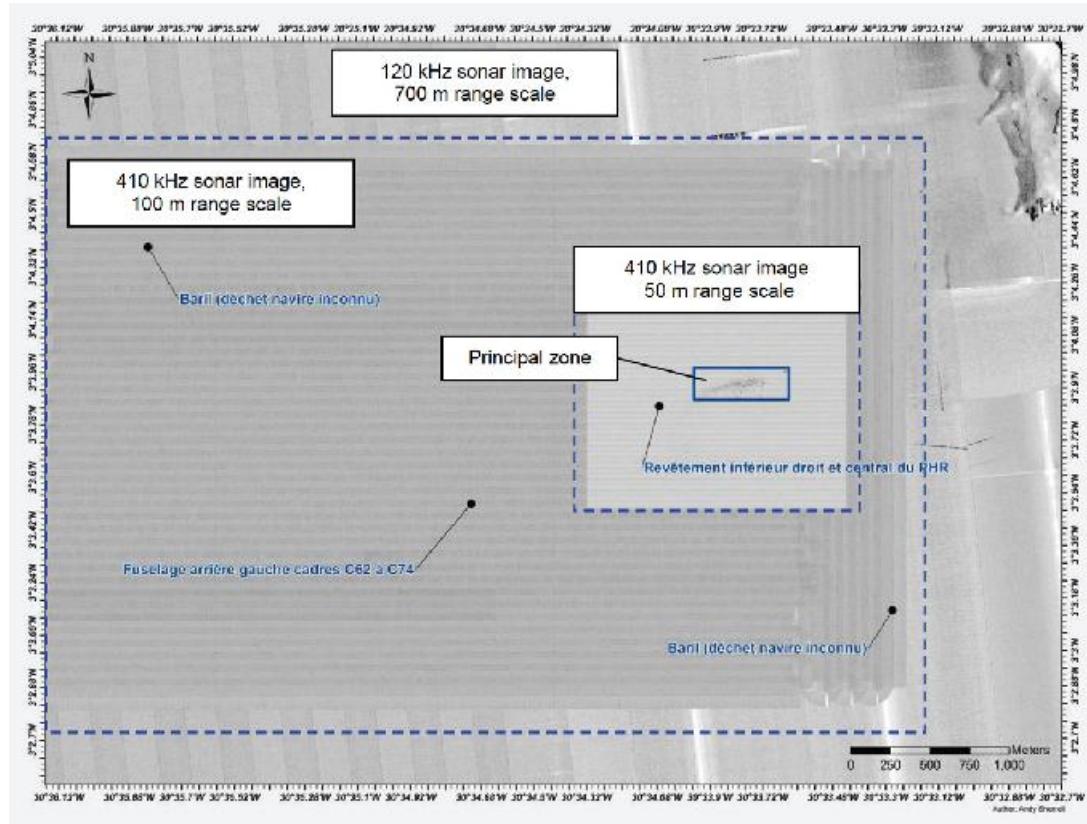
During phase 4, the area was scoured several times by the REMUS AUVs with different sonar settings to make sure that no possible debris, located beyond the main zone, was forgotten. This exploration made it possible to localize a part of the fuselage about two kilometres from this zone as well as objects such as oil drums that did not come from the aircraft (see the following figure). The initial imagery was subsequently enhanced by high resolution 410 kHz sonar images at various range scales.

Figure 97: Overlay of sonar images taken with various settings:
120 kHz, 700 m range scale - 410 kHz, 100 m range scale - 410 kHz, 50 m range scale

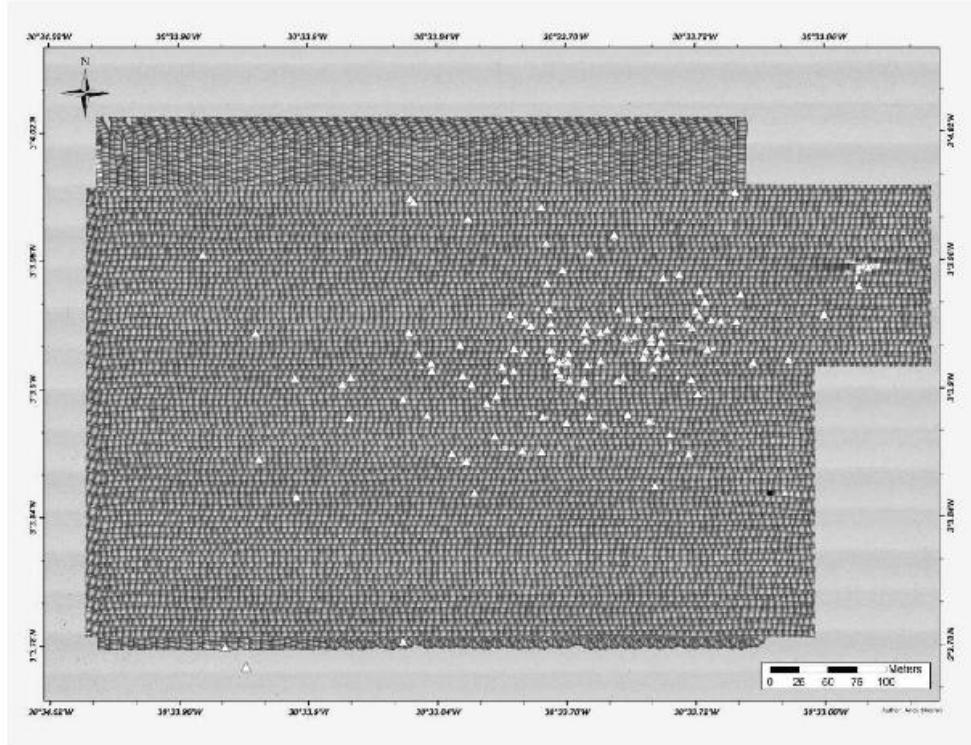
These photographs enabled the first chart of the wreckage site to be produced in mosaic form (see diagram below).

Figure 98: Visualisation of the photo mosaic obtained with REMUS AUV images and the aeroplane debris identified by using the REMORA ROV
