FINAL REPORT

AAIU Synoptic Report No: 2008-004

Aircraft Type and Registration:	(i) B737-8AS, EI-DCZ (ii) MD-83, OE-IKB
No. and Type of Engines:	(i) 2 x CFM 56-7B (ii) 2 x PW JT8D- 219
Aircraft Serial Number:	(i) 33815 (ii) 49448
Year of Manufacture:	(i) 2005 (ii) 1986
Date and Time (UTC):	23 September 2007 @ 19.51 hrs
Location:	Reporting Point 'BANBA', off the SE coast of Ireland.
Type of Flight:	Both Public Transport.
Persons on Board:	(i) Crew - 6 Passengers - 179 (ii) Crew - 6 Passengers - 164
Injuries:	None
Nature of Event:	AIRPROX, loss of required vertical and lateral separation of aircraft.
Commander's Licence:	Both JAA ATPL's
Commander's Details:	(i) Male, aged 52 years (ii) Male, aged 43 years
Commander's Flying Experience:	(i) 13,800 hours of which 3,000 were on type (ii) 7,500 hours of which 1,100 were on type
Notification Source:	General Manager, ATC, Shannon Airport.
Information Source:	AAIU Field Investigation

SYNOPSIS

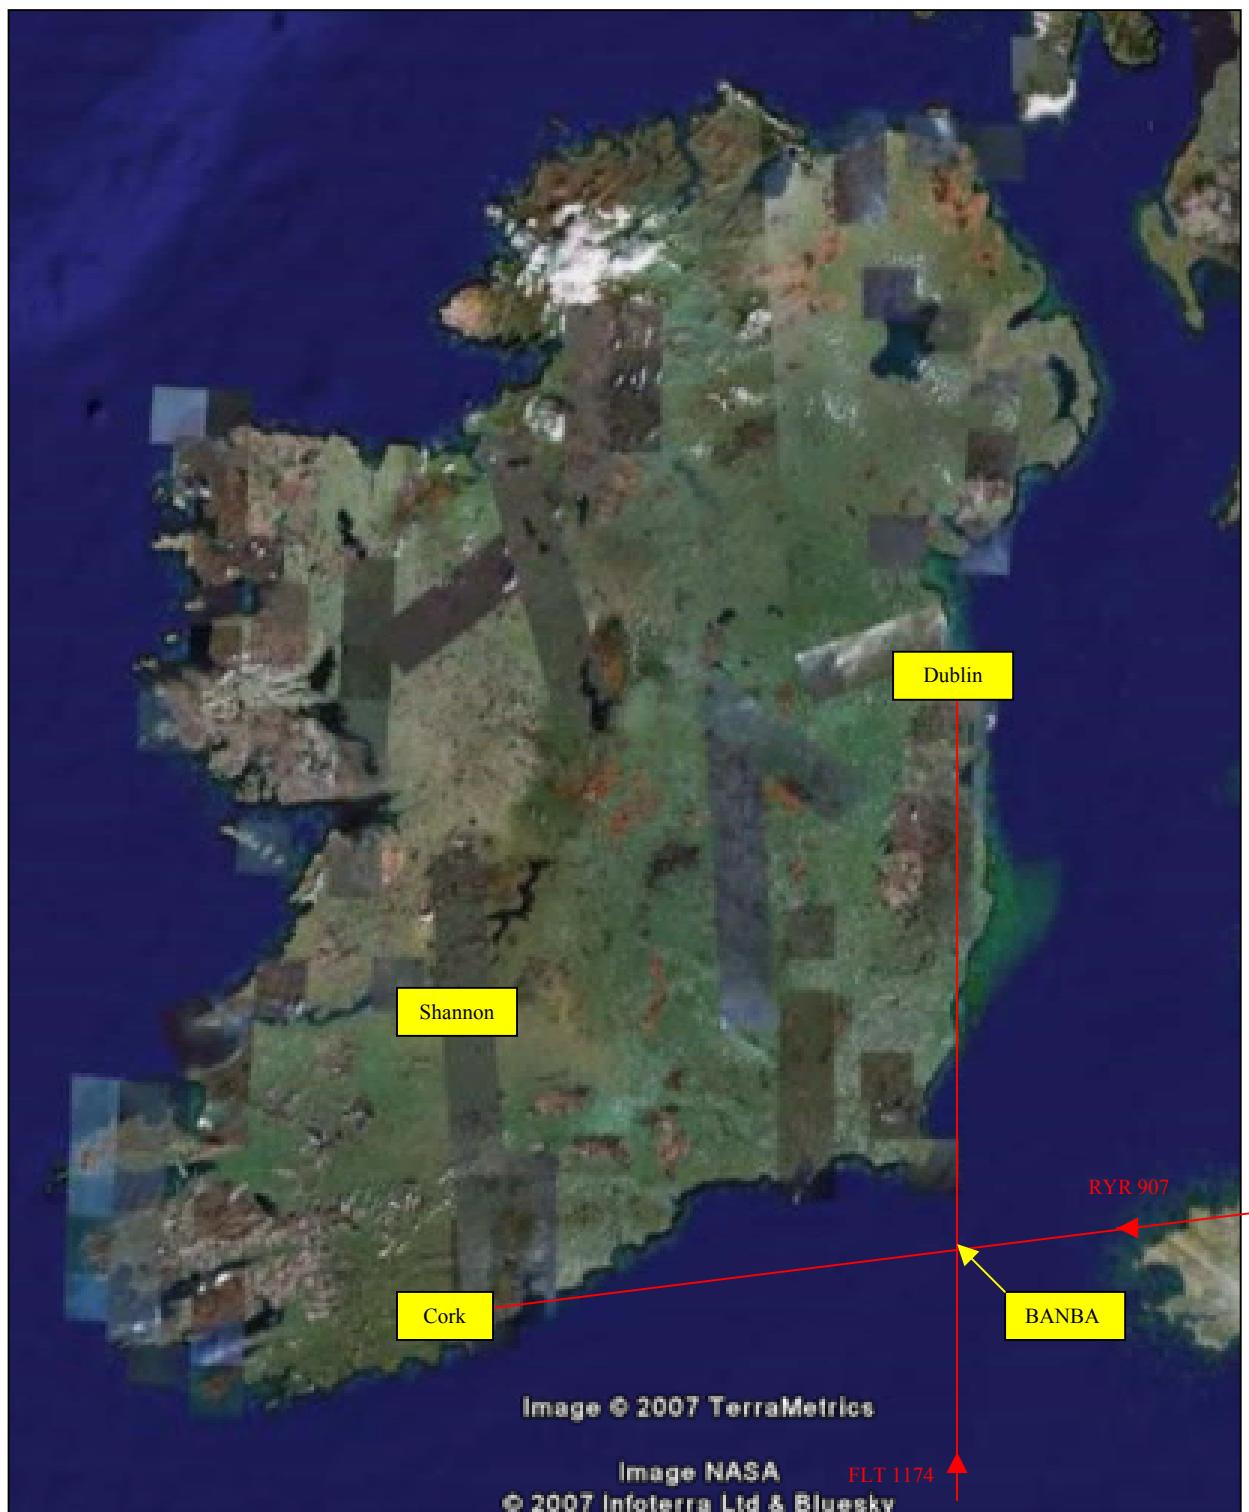
Appendix B

Highlighted in yellow are Intersection BANBA and Dublin, Cork and Shannon airports.
Approximate flight paths of both aircraft are also shown in red
