FINAL REPORT

AAIU Synoptic Report No: 2009-018

Aircraft Type and Registration:	Agusta Westland A109E, EI-SBM
No. and Type of Engines:	2 x Pratt and Whitney PW 206 C
Aircraft Serial Number:	11174
Year of Manufacture:	2004
Date and Time (UTC):	20 March 2008 @ approximately 15.40 hrs
Location:	Lagore, Dunshaughlin, Co. Meath
Type of Flight:	Private Category
Persons on Board:	Pilot - 1
Injuries:	Pilot - Serious
Nature of Damage:	Substantially damaged
Commander's Licence:	Commercial Pilot Licence (H)
Commander's Details:	Male, aged 41 years
Commander's Flying Experience:	2,421 hours, of which 1,500 were on type
Notification:	ATC Station Manager, Dublin Airport
Information Source:	AAIU Field Investigation AAIU Accident Report Form submitted by Pilot

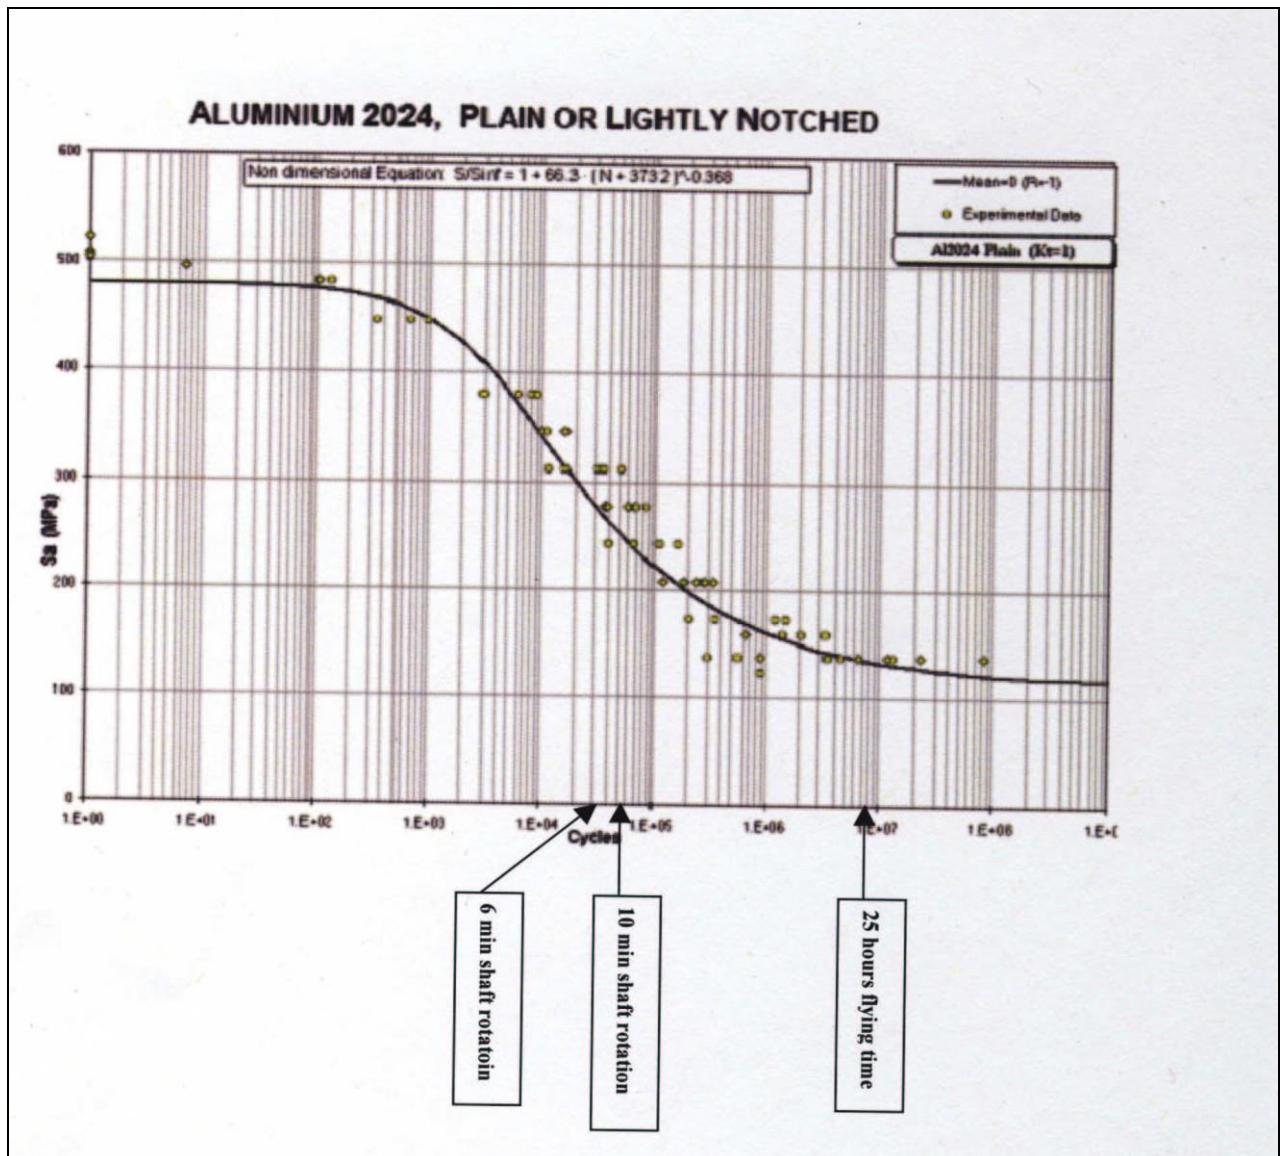
Figure E1

The stress versus cycles-to-failure data (S-N curve) for Aluminium Alloy 2024, based on data provided by Agusta Westland.
