Air Accident Investigation Unit Ireland

FACTUAL REPORT

ACCIDENT
Cessna 172S, EI-DDX
Cork Airport

6 January 2020

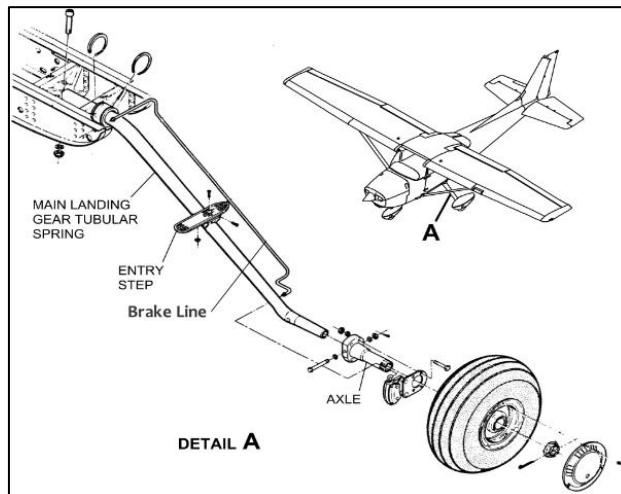
**Figure No. 1:** General undercarriage arrangement

The Cessna 172S is a high wing aircraft constructed from aluminium and powered by a single 180 horsepower (134 kW) Lycoming IO-360-L2A engine. It has a fixed tricycle landing gear configuration and was factory-built in 1999. At the time of the accident it had completed a total flying time of 14,674 hours. The total number of landings for the aircraft was not recorded in the aircraft's maintenance records, nor are they required to be as per the Manufacturer's requirements. The aircraft's main wheels are attached to the aircraft fuselage via an undercarriage leg assembly, which comprises a main landing gear tubular spring, axle, wheel, and associated sub-assemblies (**Figure No. 1**). For clarity, **Figure No. 1** illustrates the arrangement with the aerodynamic fairing removed from the undercarriage.
