FINAL REPORT

AAIU Synoptic Report No: 2005-013
AAIU File No: 2004/0066
Published: 20/06/05

Aircraft Type and Registration:	ATR 72 – 202, EI-RED
No. and Type of Engines:	2 x Pratt and Whitney PW 124B
Aircraft Serial Number:	373
Year of Manufacture:	1994
Date and Time (UTC):	15 December 2004 @ 10.47 hrs
Location:	Eastern end of Runway (RWY) 26 Galway Airport (EICM)
Type of Flight:	Scheduled Public Transport
Persons on Board:	Crew - 4 Passengers - 31 + 1 Child
Injuries:	Crew - Nil Passengers - Nil
Nature of Damage:	Nil
Commander's Licence:	Irish ATPL issued by the IAA
Commander's Details:	Male, aged 64 years
Commander's Flying Experience:	Approximately 21,000 hours, of which 3,000 were on type
Information Source:	The Operator, AAIU Incident Report Form submitted by Captain, Field Investigation.

SYNOPSIS

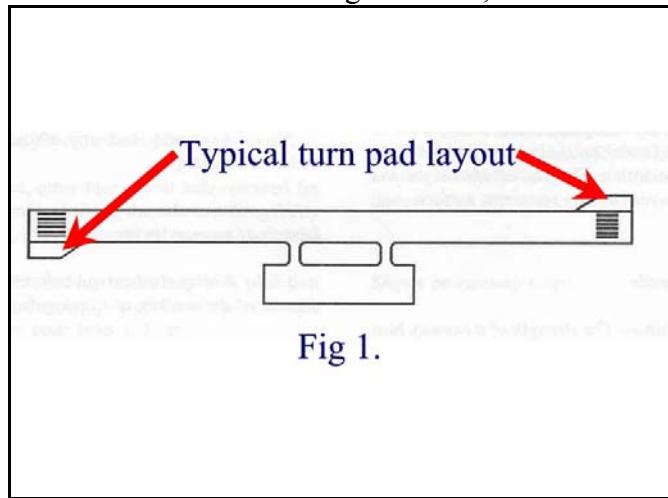
Section 3.3.2 of Annex 14 specifies as a Recommendation⁶ that, “*Where the end of the runway is not served by a taxiway or a taxiway turnaround and where the code letter is A, B, or C (Galway Airport is coded C), a turn pad should be provided to facilitate a 180-degree turn of aeroplanes.*”

A graphic illustration of a runway turn pad is presented below as Fig 1. The initiation of the turn would be facilitated by locating the turn pad on the left side of the runway, since the left seat is the normal position of the pilot-in-command. Guidance on the design of runway turn pads is available in the ICAO Aerodrome Design Manual, Part 1

ICAO Recommends that, where the end of the Code C runway is not served by a taxiway or a taxiway turnaround, a turn pad should be provided to facilitate a 180-degree turn of aircraft. A Recommendation is recognized as desirable in the interest of safety, regularity, and to which Contracting States will endeavour to conform in accordance with the Convention. The Investigation accepts that an aircraft the size of the ATR 72 can carry out an 180° turn on the runway at Galway, without a compromise in safety, once the manoeuvre is performed properly.

In the spirit of the ICAO Recommendation for Turn Pads, the Investigation concludes that for any further runway development in Galway, the Airport Management should consider the inclusion of Turn Pads at either end of the runway. A Safety Recommendation has been made to that effect.
