# Air Accident Investigation Unit Ireland

## SYNOPTIC REPORT

ACCIDENT  
Tandem Parachute Jump  
Near Clonbullogue Airfield (EI CL),  
Co Offaly, Ireland  
18 August 2012

**AAIU Report No: 2013-007**  
**State File No: IRL00912090**  
**Report Format: Synoptic Report**  
**Published: 8 May 2013**

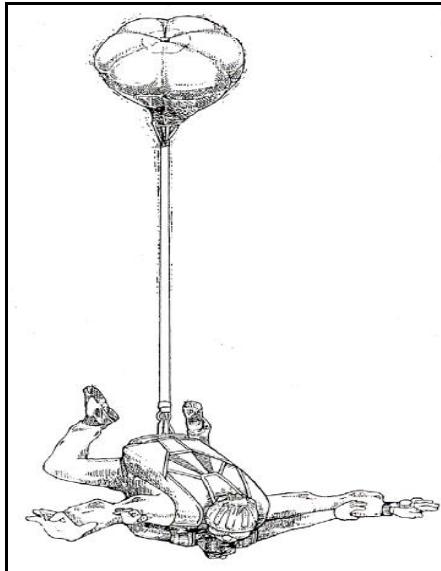
Graphic No. 1: Drogue-fall

On leaving the aircraft, a drogue-chute is deployed by the TM into the slipstream in order to reduce the tandem free-fall velocity. When fully inflated, the drogue provides enough drag to give a tandem pair a descent velocity of approximately 120 mph. Without a drogue, a tandem pair would accelerate to 170 mph in 18 seconds, risking hard opening shocks and possible canopy damage. Descent with a drogue deployed is referred to as 'drogue-fall'. The drogue may be released at any time during the drogue-fall but normally for a tandem jump it would be no lower than 5,500 ft. The drogue is released (thus deploying the main canopy) by pulling the orange drogue release handle normally located at the bottom left-hand corner of the container. The drogue can also be released through a second blue handle located on the right hand side of the container.

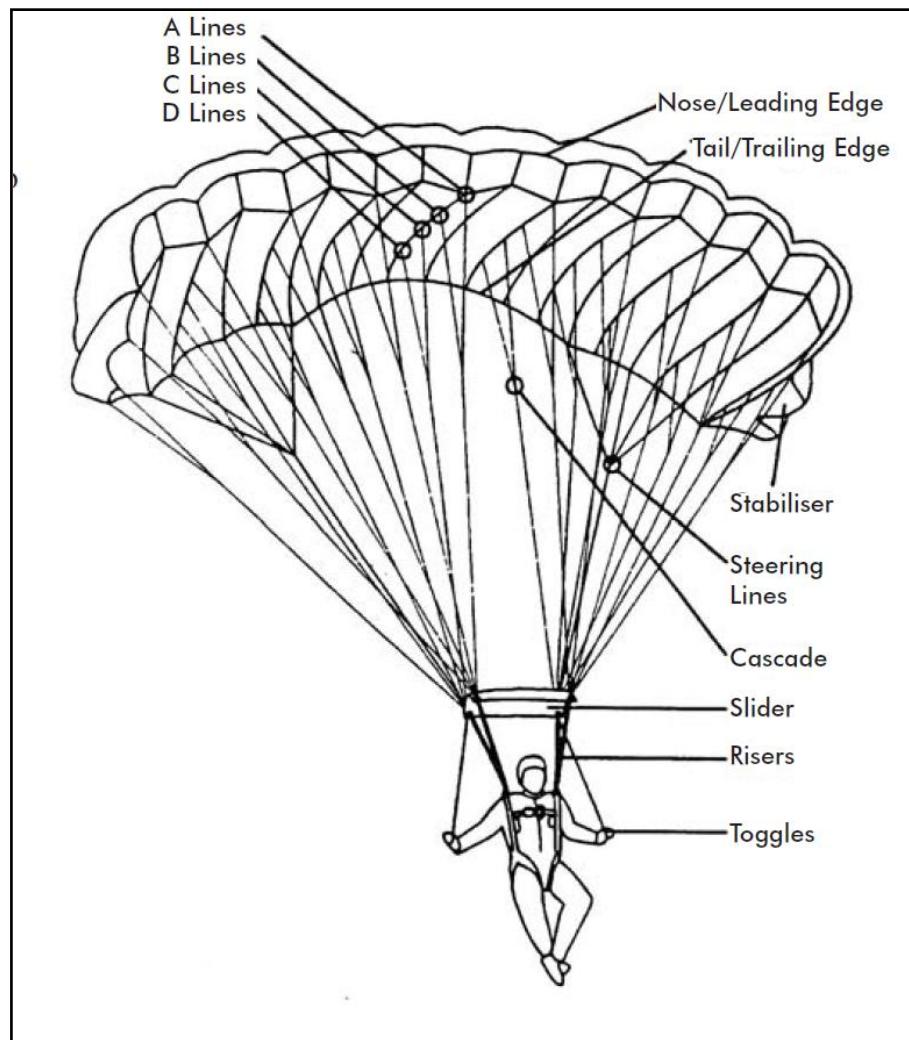
**Graphic No 3: Canopy and Lines**

In order to control the parachute, two sets of lines, referred to as 'control/steering lines' are connected to the rear edge of the canopy on the left and right sides. These lines are controlled by two handles known as 'toggles' which are located at the end of each line. When you pull on the left toggle, you lower the back part of the left side of the canopy. This causes the left side of the canopy to slow down, and you turn to the left. If you pull down the right toggle, you turn to the right. If both toggles are pulled down together it slows the whole canopy down and acts like a brake. This allows you to flare for landing.
