Air Accident Investigation Unit Ireland

ACCIDENT
Fairchild Aircraft Corporation
SA 227-BC Metro III, EC-ITP
Cork Airport, Ireland
10 February 2011

AAIU Report No: 2014-001
State File No: IRL00911013
Report Format: Formal Report
Published: 28 January 2014

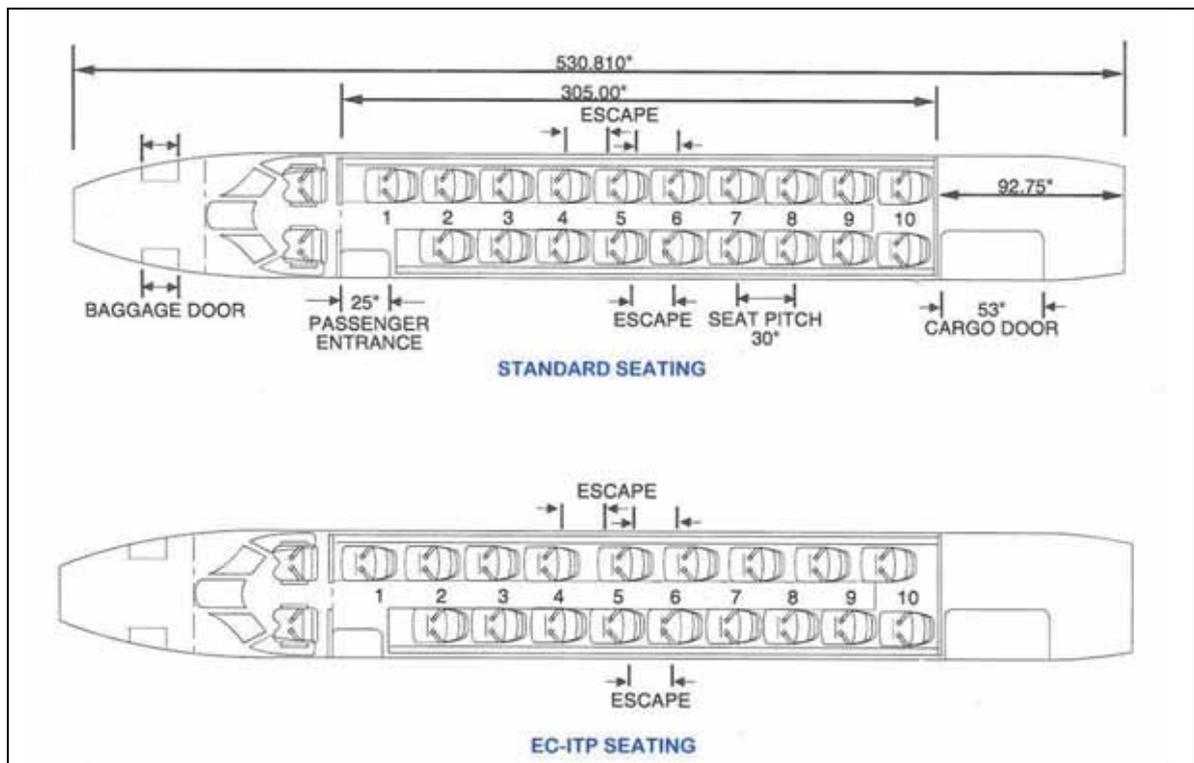
Figure No. 4: Standard 19-seat passenger layout and non-standard 18-seat layout as found on EC-ITP (*adapted from SA 227 AFM*)

The seat pitch on the right-hand side commenced at 20 inches with a pitch of 38 inches provided adjacent to the aft emergency (escape) exit at the position of seat 5R. Seats behind 5R to the aft bulkhead were arranged with a pitch of 33 inches (**Figure No. 4**).

AFS personnel removed all but two of the passenger seats to gain access to the casualties. In most cases the aisle-side seat legs were cut; some of the seats were forcibly wrenched free resulting in twists and fractures to the seat legs. Following recovery of the wreckage to the AAIU facility, the seats were examined. The Investigation compared the cut and fractured seat legs on the removed seats and established the location of each passenger seat in the cabin prior to the accident. The examination revealed a non-standard layout and seat pitch on the right hand side of the aircraft (**Figure No. 4**).

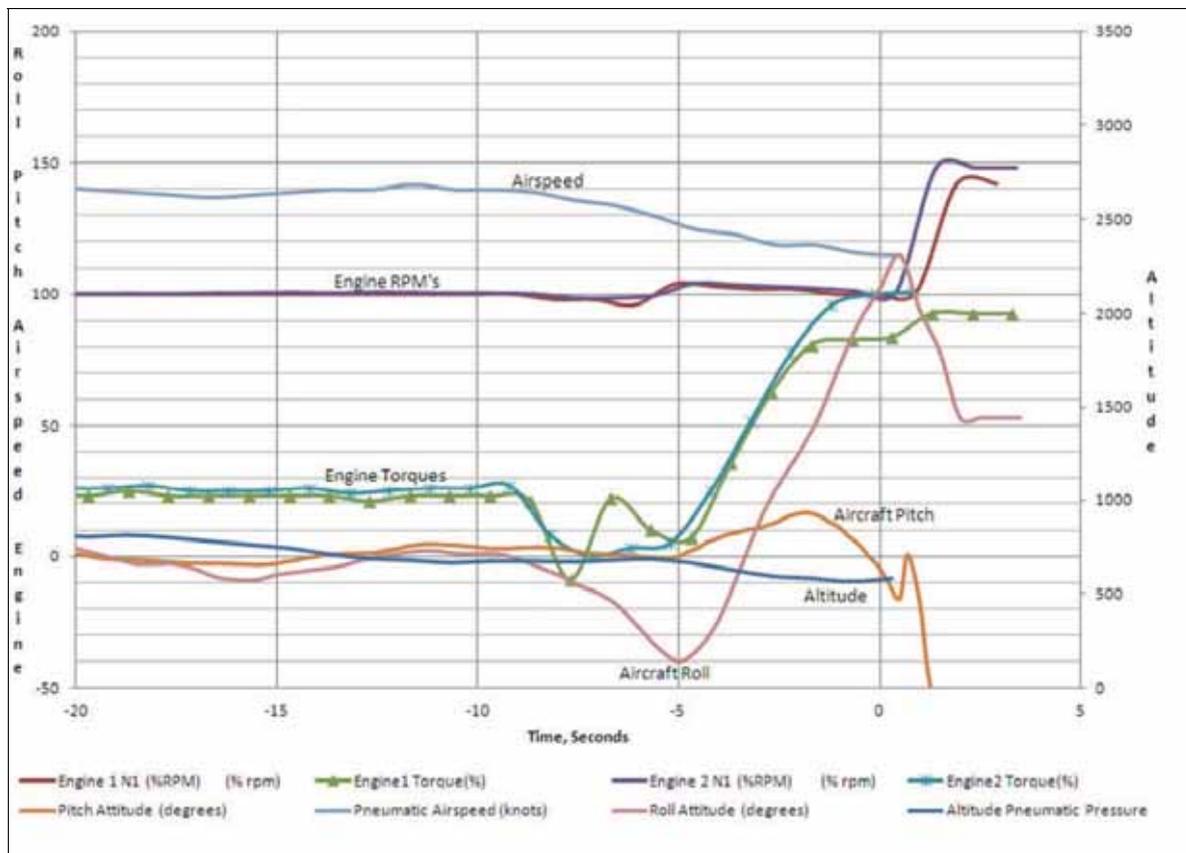
Figure No. 5: FDR data for final 20 seconds of recording

The graph in **Figure No. 5** shows the final 20 seconds of relevant parameters recovered from FDR data. Aircraft heading, not shown for clarity, was consistent with the roll readings. Until approximately 9 seconds before impact, the indicated airspeed recorded by the FDR was consistent with engine power settings and expected aircraft performance. The first significant event was a reduction of delivered engine torque from both engines, commencing approximately 9 seconds before impact, accompanied by a decrease in airspeed.

Effect (3) is evident at several times in the recorded data. During the period from -20 to -10 seconds (**Figure 5, 5a**), engine No. 2 torque was generally approximately 4% higher than that for No. 1 engine. During the time when the data indicates the power levers were brought below the Flight Idle stop (Beta range), the FDR recorded a minimum torque value of -9 % for No. 1 engine, while the minimum recorded torque value for No. 2 engine was 0%.

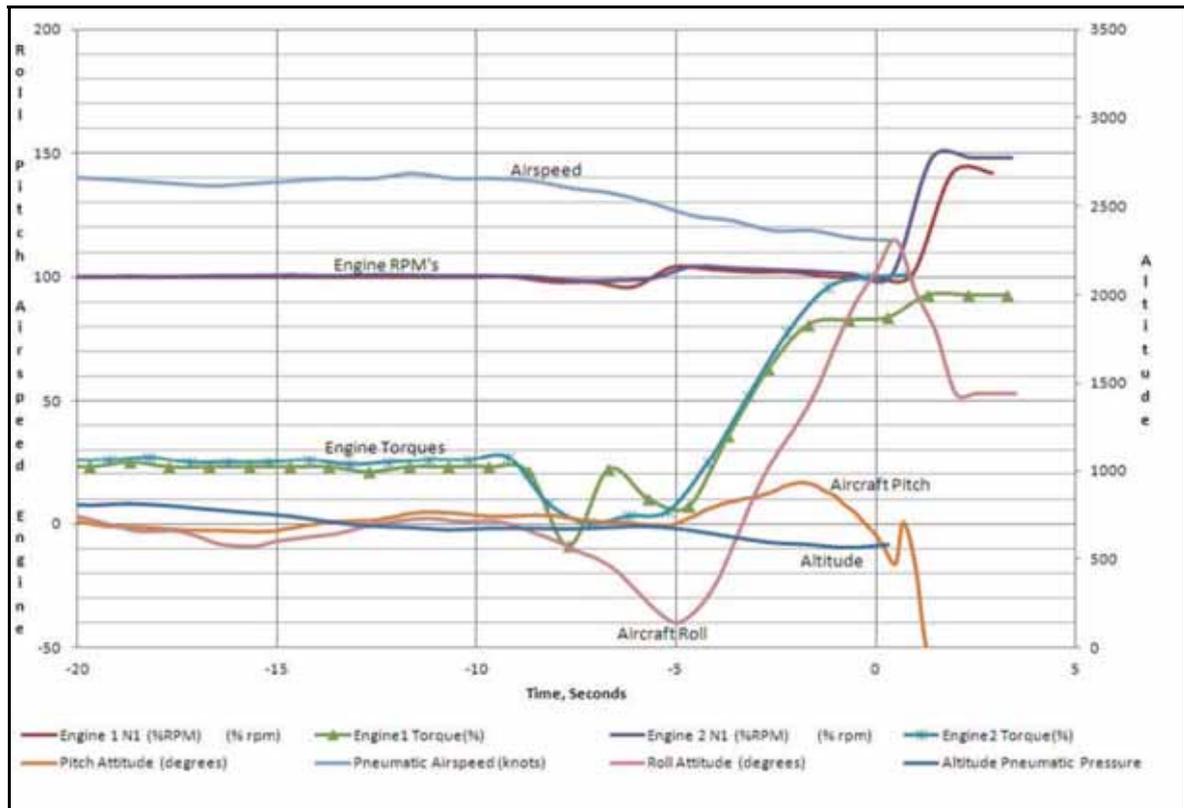
Figure No. 5a: FDR Data for final 20 seconds of recording

Relevant FDR parameters for the final 20 seconds of the flight are illustrated in **Figure No. 5a** (this is a reproduction of **Figure No. 5** to assist the reader).

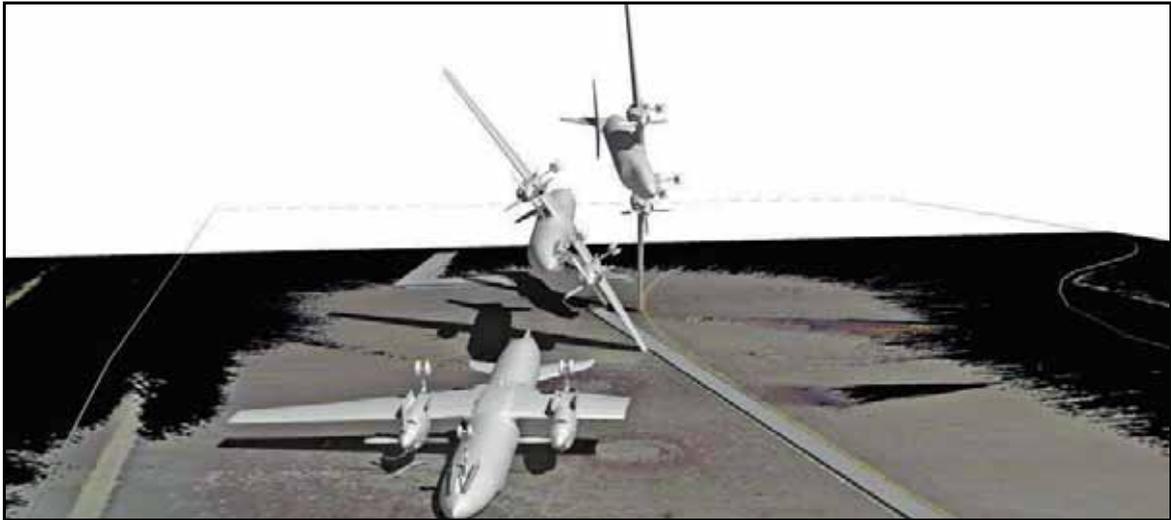
Graphic No. 5: Reconstruction of initial impact sequence

Impact evidence showed that the aircraft first contacted the runway surface with the right wingtip. At that moment the aircraft was at a roll angle of 97 degrees to the right, following which it continued to roll right, impacting the runway surface in an inverted position (**Graphic No. 5**).

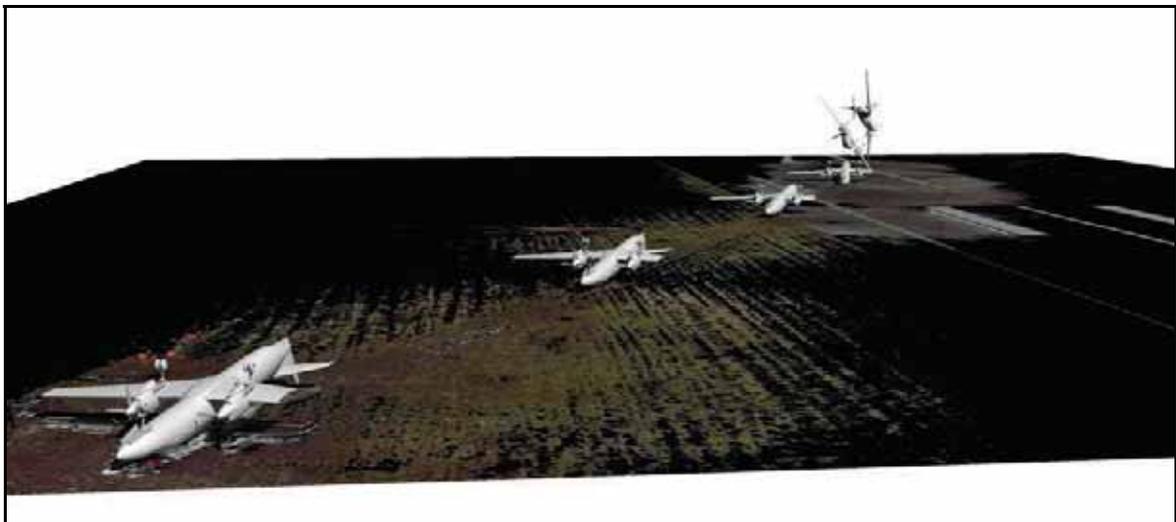
Graphic No. 6: Reconstruction of ground path to final resting place

Three of the right propeller blades detached as contact was made with the runway surface and were found at various distances from the main wreckage. The aircraft left the paved area and decelerated rapidly in the soft ground (**Graphic No. 6**). At this point the roof of the forward fuselage ruptured allowing a substantial quantity of soil to enter the cabin.

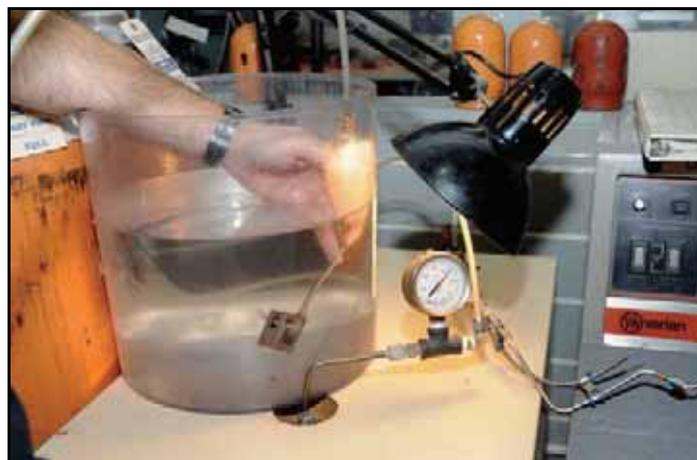
Photo No. 3: P_{T2}/T_{T2} leak check test

The P_{T2}/T_{T2} sensor was cut midway in the capillary tube to isolate the bellows from the probe to determine which end may be breached. Each half was pressured using helium, then dunked into a tank of Stoddard Fluid (MIL-F-7024 type II) (**Photo No. 3**).

No leak (bubbles) was noted coming from the bellows but a streak of bubbles was noted coming from the sensing tube (**Photo No. 4 & Photo No. 5**). The sensing tube was marked where the bubbles appeared to have been coming from (**Photo No. 6**). Additional examination will be needed to determine the exact location and cause of the breach.

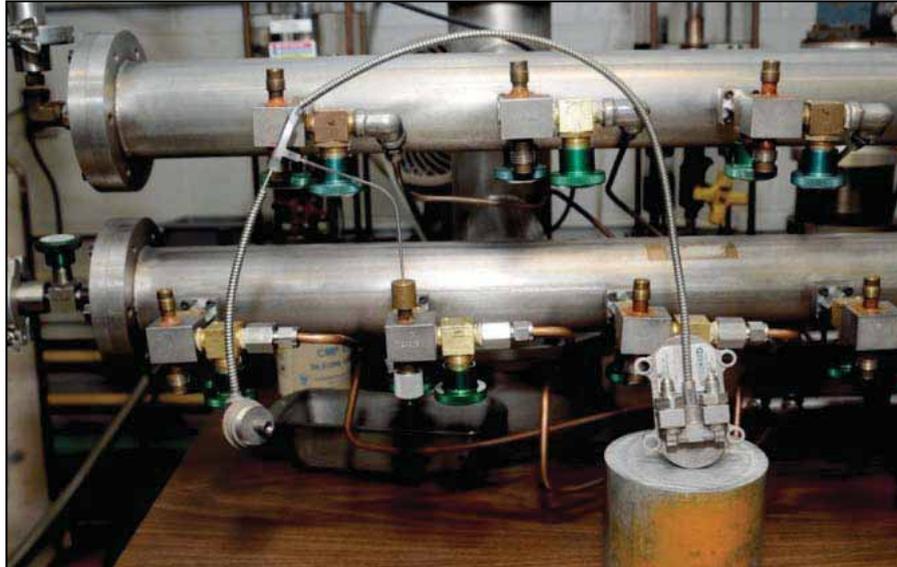
Photo No. 7: pressurizing the P_{T_2}/T_{T_2} sensor to determine leak rate

The modified P_{T_2}/T_{T_2} sensor was then put under vacuum to draw any air trapped out the system and then it was filled with N-butyl alcohol (**Photo No. 7**).

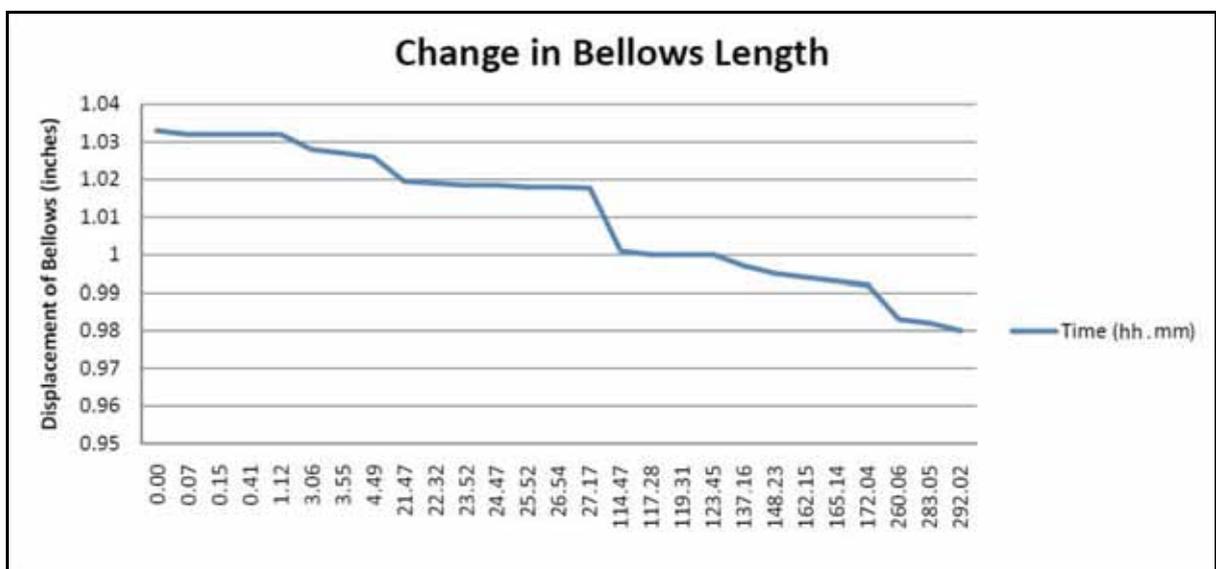
Plot 1: Bellows Length Change vs Time

A 15-pound load was then applied to the bellows that simulates the load it would experience when attached to the engine. Under this load, the bellows displacement was measured to be 1.33-inches. The loss of internal pressure (bellows displacement) was monitored and recorded as a function of time (**Plot 1** and **Table 1**). The following displacements and times were recorded:

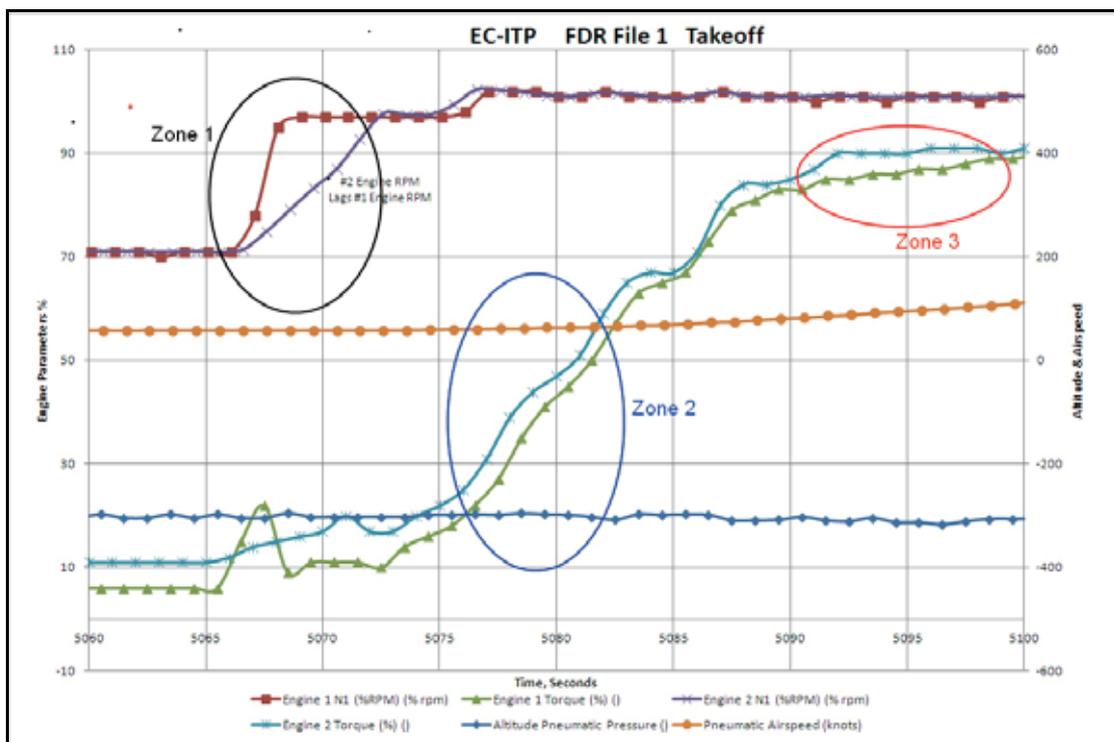
Figure No. 1: Previous Take-off FDR Parameters

Figure No. 1 shows FDR recorded parameters from EC-ITP on a take-off several weeks before the accident flight indicating that the P_{T2}/T_{T2} anomaly existed at that time.

In Zone 1, the two curves show the engine speeds measured in RPM for the No. 1 engine (red) and the No. 2 engine (purple). The curves show that when the speed levers were advanced from Low RPM to High RPM in preparation for take-off and the engine speeds increased from 70% to approximately 97%, the speed response of the No. 2 engine lagged behind that of the No. 1 engine by approximately 5 seconds.

This effect can be seen in Zone 3 of **Figure No. 1** where the engine torques are settling close to take-off values, the torque achieved by engine No. 2 is several percentage points greater than that for engine No. 1.

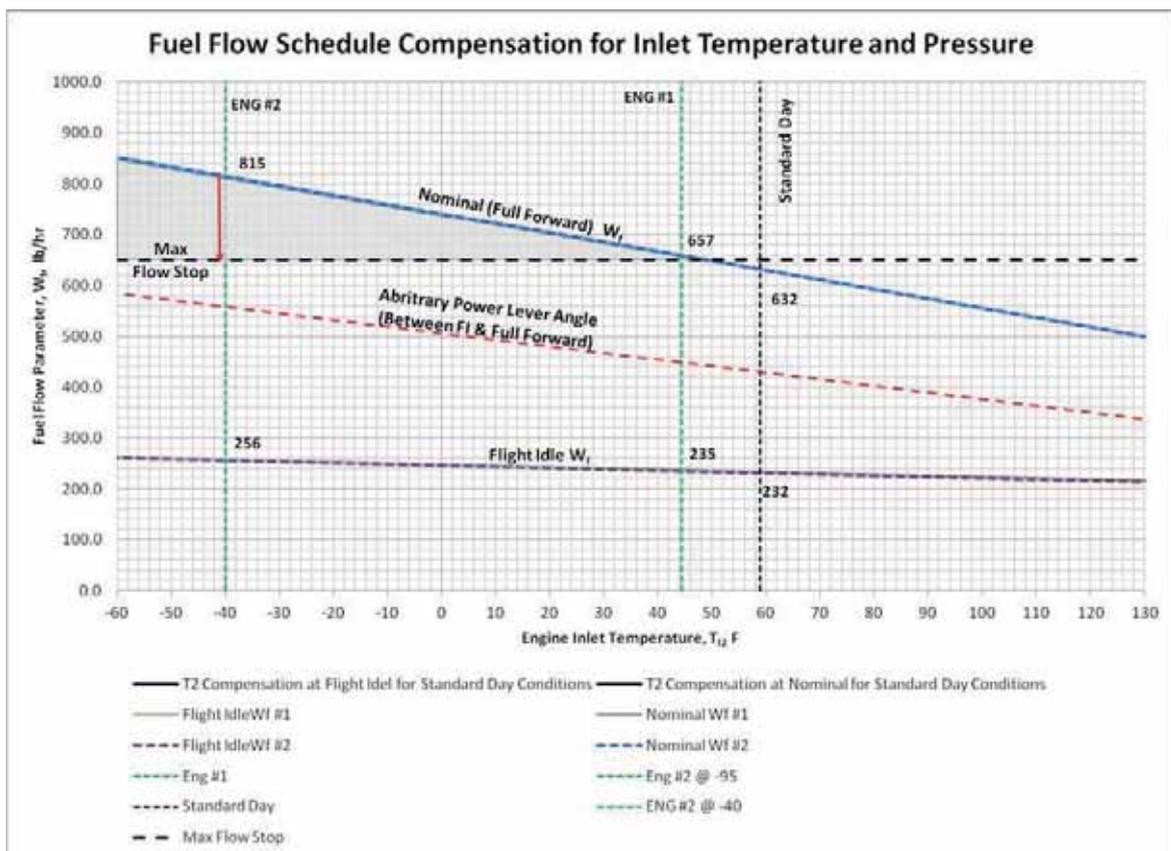
Figure No. 2: Fuel Flow Schedule Compensation (Source Honeywell)

When the engine speeds are stabilised at approximately 97% RPM, and the power levers are advanced from Ground Idle towards high power, the fuel control transitions from the underspeed governor fuel schedule to the power lever schedule. The power lever schedule is compensated for inlet temperature (T_{T2}) in accordance with the characteristics shown in **Figure No. 2**. In this case the lower nearly horizontal line represents the fuel flow with the power lever at Flight Idle while the upper blue line is the fuel flow with the power lever fully forward. Power lever settings between Flight Idle and maximum power would be represented by similar lines between the two. The x-axis is the engine inlet temperature in degrees Fahrenheit ($^{\circ}F$). There is a maximum flow stop at 650 lb/hr which is represented by the dashed black line.

As the power lever is moved from Flight Idle to full forward, which is illustrated at an arbitrary power lever position by the dashed red line, there is a proportionally higher fuel flow to the No. 2 engine than to the No. 1 engine.

Thus, as the power levers are advanced for take-off, the effect of a shortened bellows is to increase the fuel flow to the engine on the side with the shortened bellows, i.e. the No. 2 engine on EC-ITP.

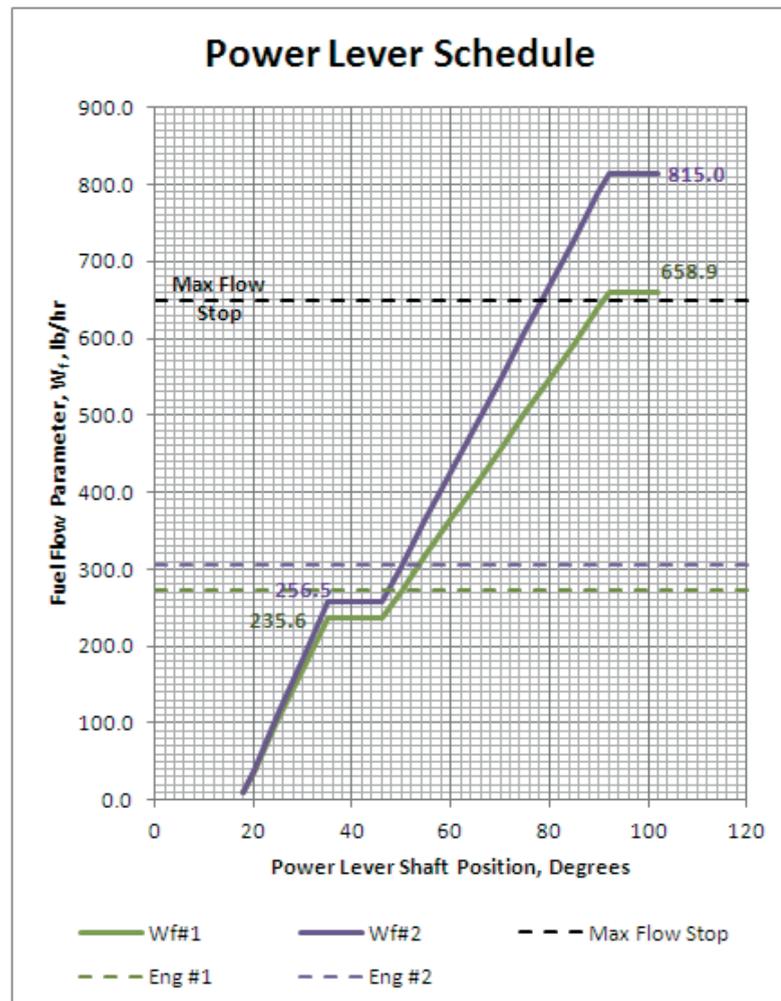
Figure No. 3: Power Lever Schedule for EC-ITP Engines (*Honeywell*)

Figure No. 3 shows the comparative power lever schedules for the two engines on EC-ITP. The power lever position fuel flow schedule for engine No. 1 is shown in green, representing compensation for the correct inlet temperature as sensed by the normal P_{T2}/T_{T2} sensor. The schedule for engine No. 2 (in purple), shows fuel flow against power lever position compensated for the negative temperature bias being transmitted from the P_{T2}/T_{T2} sensor with the shortened bellows. It can be seen that, for a given power lever angle, No. 2 engine fuel flow is higher than that for No. 1 engine.

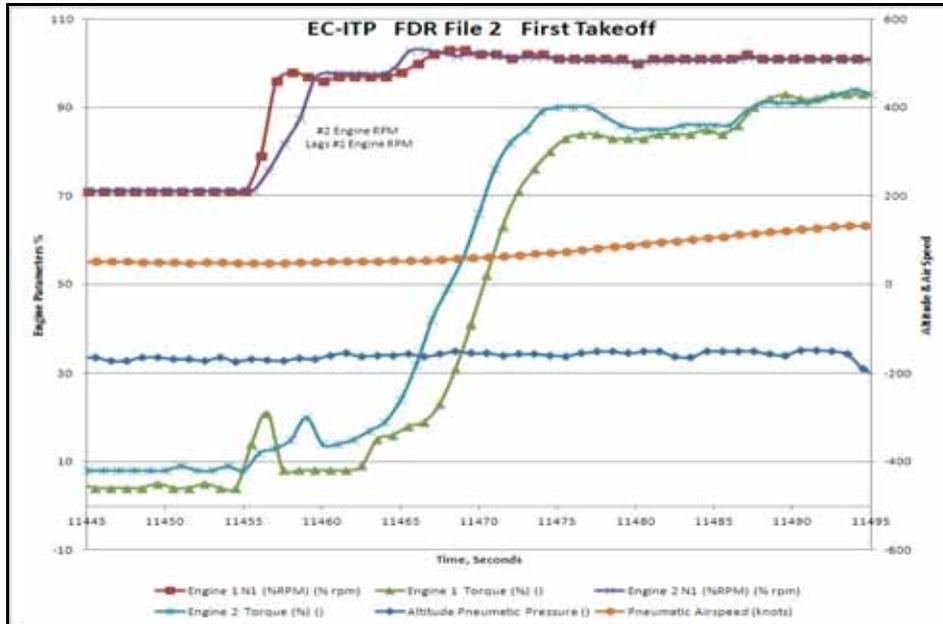
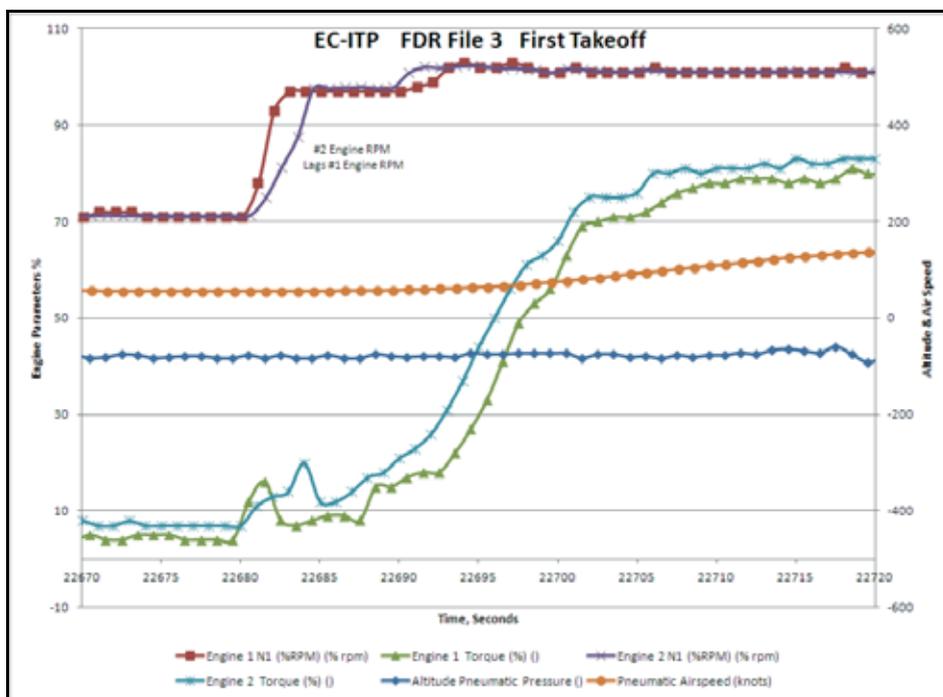
Figure No. 4 and **Figure No. 5** present FDR data for two further take-offs made by EC-ITP some weeks before the accident flight. Similar characteristics are seen, in that the engine No. 2 RPM lags that of engine No. 1 as the speed levers are advanced in each case. Also, the torque achieved by engine No. 2 advances ahead of that achieved by engine No. 1 and, particularly as seen in **Figure No. 5**, the No. 2 engine torque remains higher than that of No. 1 engine as the aircraft speed increases during its take-off run.

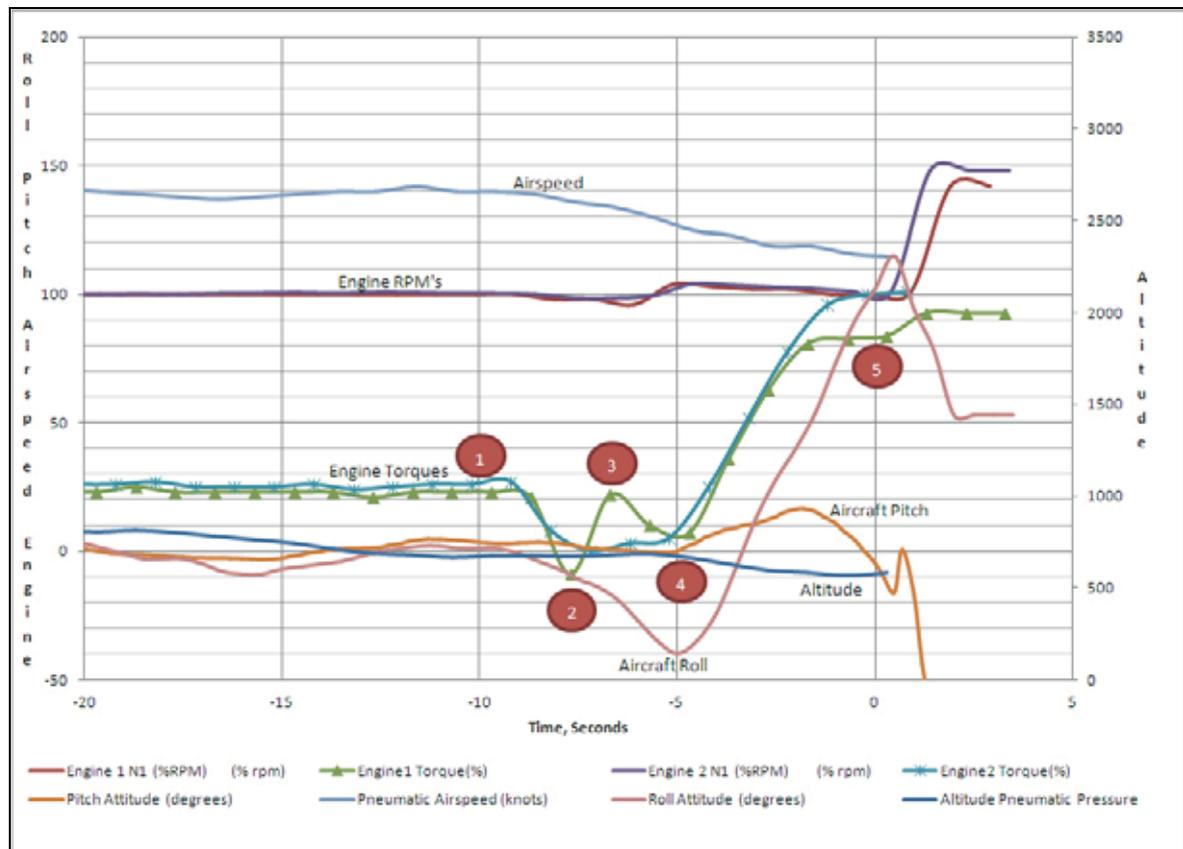
Figure No. 6: FDR Parameters during final approach (accident flight)

Figure No. 6 illustrates various FDR parameters recorded during the accident sequence. The x-axis represents time measured in seconds with the “0” point representing a time approximately one second before commencement of the impact sequence, when the values of recorded parameters became unreliable.

The data shows that, as the aircraft descended towards the runway during the time period from -20 secs to approximately -9 secs, the engine torque for the No. 1 engine was recorded at values generally in the range 21 to 23% while that for the No. 2 engine was in the range 25 to 27%. During this period, the engine speeds were recorded as 100% for No. 1 engine and at values in a range between 100.0% and 100.7% for No. 2 engine. These values are illustrated in **Figure No. 6** from the left hand axis until a time just after datapoint 1.

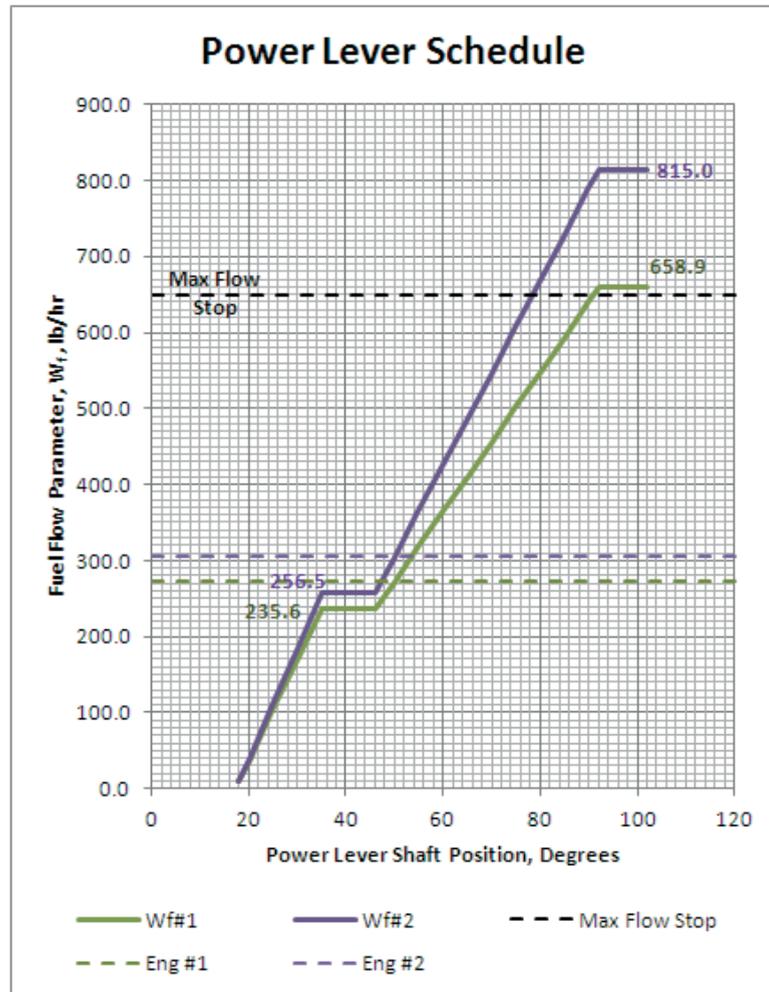
Figure No. 7: Fuel Flow/Power Lever Angle (PLA) Curves

All of the above calculations take no account of the effects of the shortened P_{T2}/T_{T2} sensor bellows height and the consequent negative temperature bias. In order to calculate the power lever angle at those data points where the fuel flow was on the respective power lever schedule, it is necessary to use the curves shown in **Figure No. 7** (which is a reproduction of **Figure No. 3**) and takes into account the effects of the shortened bellows.

In this figure, the curve of fuel flow (Wf#1) against PLA for the No. 1 engine, is shown in green while that for the No. 2 engine is shown in purple. If each of the fuel flow figures shown in **Table No. 3** is brought across to the applicable curve in **Figure No. 7**, then the equivalent power lever angles for each point can be derived. This data is shown for engines No. 1 and No. 2 in **Tables No. 4** and **No. 5** respectively.

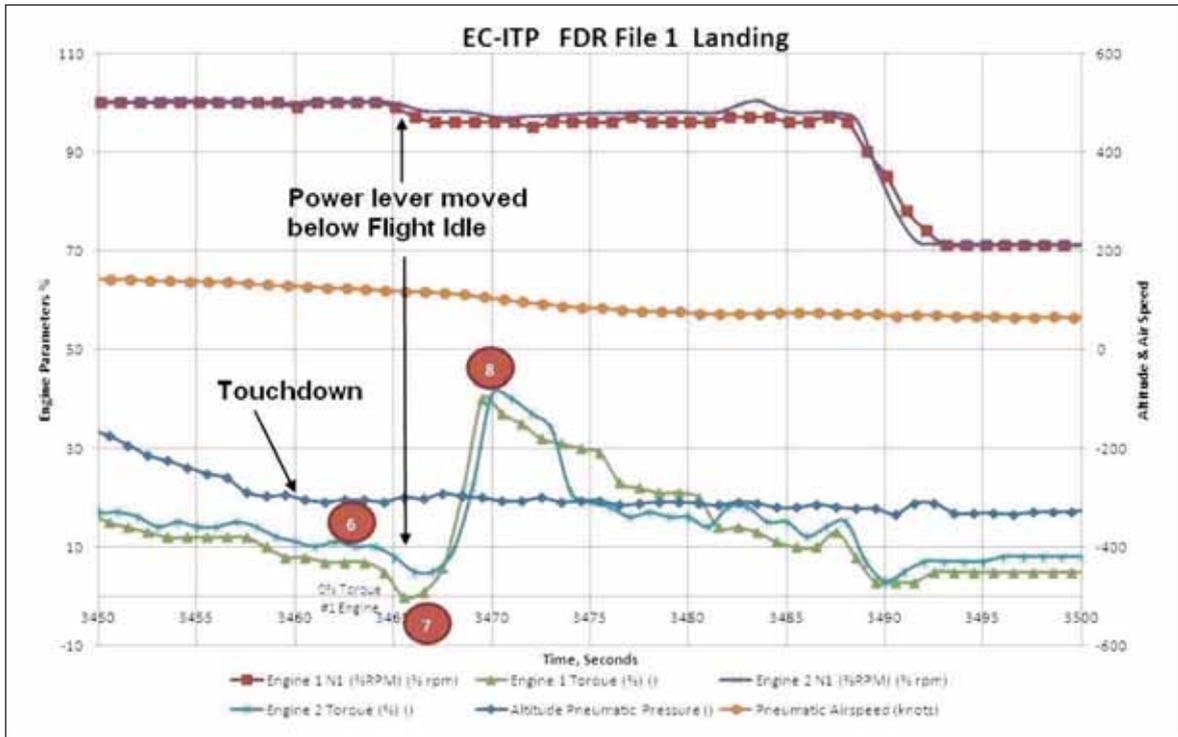
Figure No. 8: FDR Data from Previous Landing

The Investigation looked at a landing which had been made by EC-ITP at a Spanish airport several weeks before the accident, and for which FDR data was available. **Figure No. 8** illustrates the FDR data for this landing in similar format to that shown for the accident. Time in seconds is shown on the x-axis while the various engine parameters along with altitude and airspeed are shown on the y-axis. The touchdown occurred at FDR time reference 3460.

A similar analysis was carried out for this landing, and the manufacturer’s computer model was used to calculate the fuel flows at datapoints 6, 7 and 8 as shown in **Figure No. 8**. The data is shown for the No. 1 engine in **Table No. 6** and for No. 2 engine in **Table No. 7**.

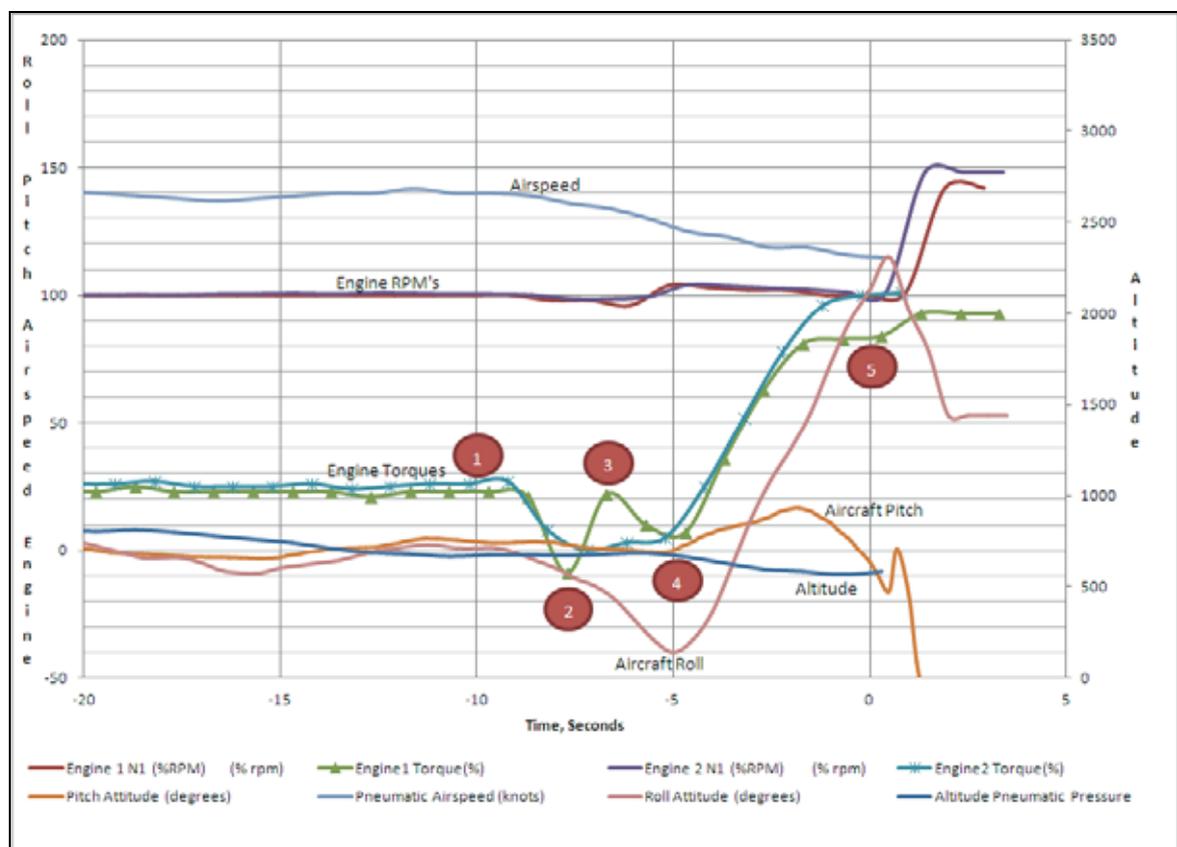
Figure No. 9: FDR Parameters during final approach (accident flight)

Regarding the final approach and the time period from -20 seconds to approximately -9 seconds, the engine torque for the No. 1 engine was recorded at values generally in the range 21 to 23% while that for the No. 2 engine was in the range 25 to 27%. During this period, the engine speeds were recorded as 100% for No. 1 engine and at values in a range between 100.0% and 100.7% for No. 2 engine, **Figure No. 9**.

The altitude can be seen to be slowly decreasing while the airspeed was being maintained around 140 kts. During this phase, the final approach appears to be stabilised with the speed levers set to High RPM and the power levers throttled back to low positive torque values consistent with values recorded during other approaches. The split between the torques of approximately 4% is consistent with the torque split identified throughout the FDR data where the torque output by No. 2 engine exceeded that of No. 1 engine due to the negative temperature bias caused by the shortened bellows of the P_{T2}/T_{T2} sensor on No. 2 engine.
