Air Accident Investigation Unit Ireland

SYNOPTIC REPORT

SERIOUS INCIDENT
Boeing 757-224, N41140
80 NM Southwest of Dublin, Ireland
20 October 2013

AAIU Report No: 2016-007

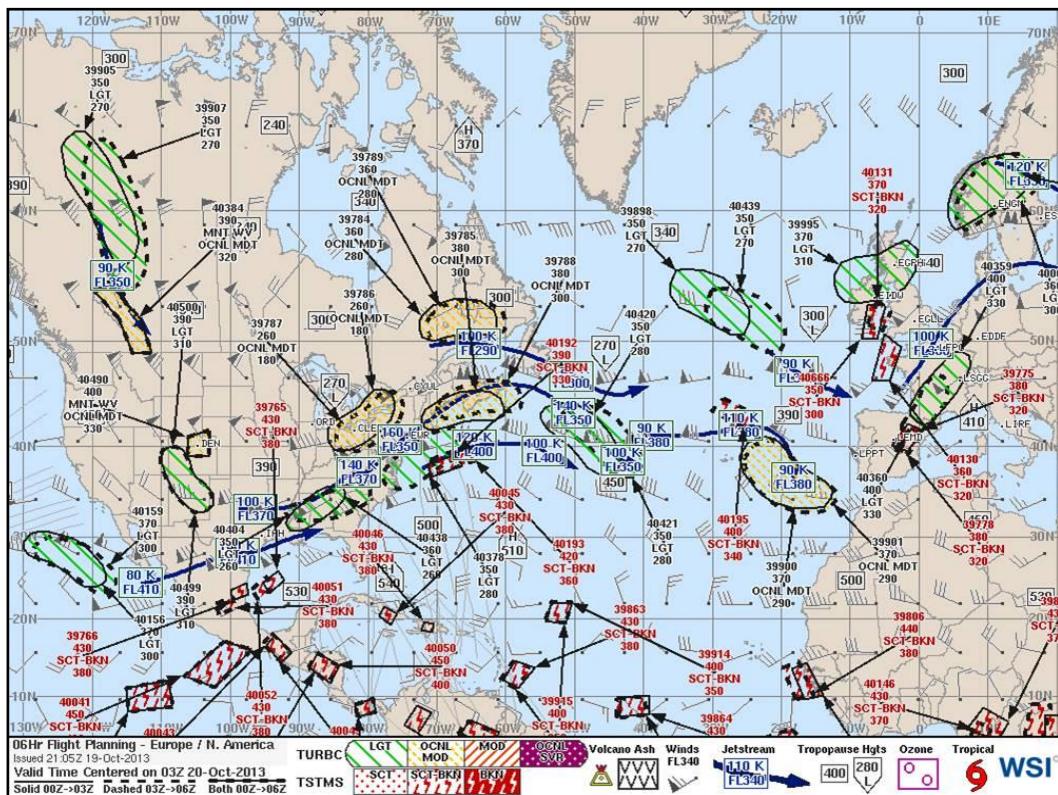
Figure No. 3. Significant Weather Chart, available to Flight Crew of this flight

The Operator provided the Investigation with a copy of a weather chart, which it describes as '*Significant Weather Briefing chart (available to the crew by 19/2105z)*'. This is shown in **Figure No. 3**. The chart indicates the possibility of scattered to broken thunderstorms over the south-eastern part of Ireland, and light turbulence forecast for the midlands and northern half of Ireland.
