Air Accident Investigation Unit Ireland

SYNOPTIC REPORT

**Serious Incident
Airbus A320-214, EI-DVJ
Dublin, Ireland**

3 October 2015

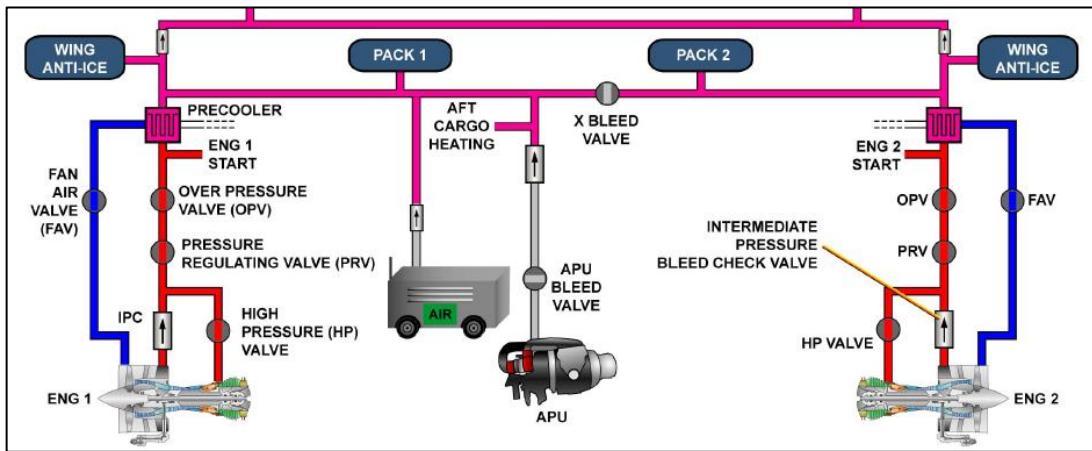
Figure No. 1: Pneumatic system schematic (Airbus A320 Technical Training Manual)

The aircraft's pneumatic system (**Figure No. 1**) utilises bleed air from the engines and/or the Auxiliary Power Unit (APU).

Engine bleed air is extracted from the fifth stage of each engine's high pressure compressor, through an Intermediate Pressure (IP) Bleed Check Valve, or from the ninth (final) stage, through a High Pressure (HP) Bleed Valve, depending on the engine speed/power settings.

When engine power is low, bleed pressure from the fifth stage is low. Therefore, bleed air is supplied from the ninth stage. According to the Engine Manufacturer, the temperature of this air is approximately 425° Celsius (C). When engine power is high, the HP Bleed Valve closes and bleed air is supplied from the fifth stage. The temperature of this air is 370-480° C. The temperature of the bleed air is then reduced to approximately 200° C by pre-coolers fitted to the engine pylons.

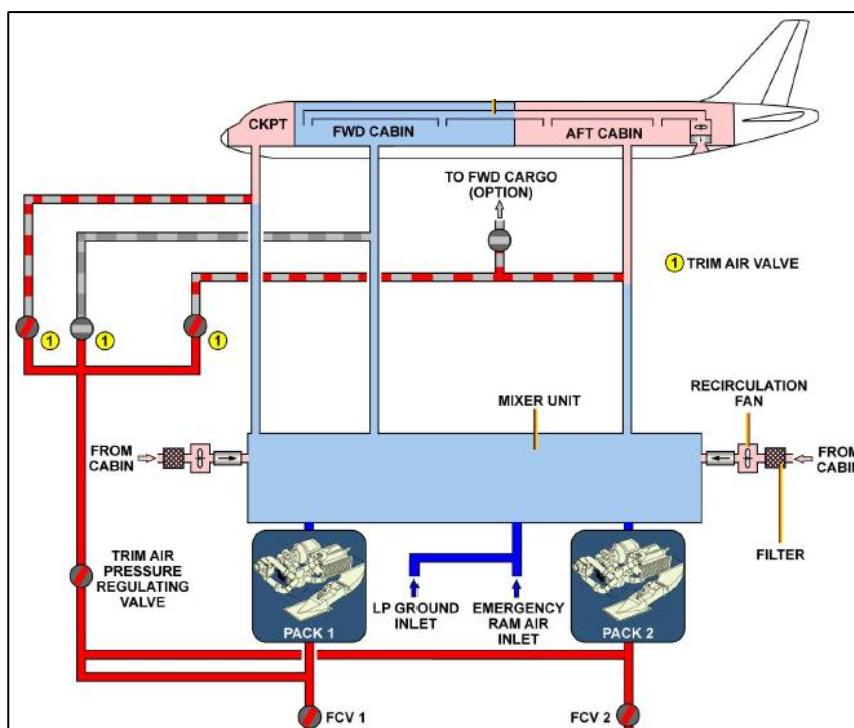
Figure No. 2: Air conditioning system schematic (Airbus A320 Technical Training Manual)

As shown in **Figure No. 2** below, two Flow Control Valves (FCVs) connect the pneumatic system to two air conditioning packs which cool and dehumidify the air. The cooled air is supplied to a mixer unit, where it is mixed with air returning from the aircraft cabin (recirculated air). Depending on the temperature selected by the Flight Crew, the trim air valves permit unconditioned hot air to be mixed with the air from the mixer unit. This air is then supplied to the aircraft cockpit and cabin.
