Air Accident Investigation Unit Ireland

SYNOPTIC REPORT

SERIOUS INCIDENT
Embraer SA, ERJ 190-200 LR, G-FBEM
Dublin Airport
16 October 2017

AAIU Report No: 2018-019

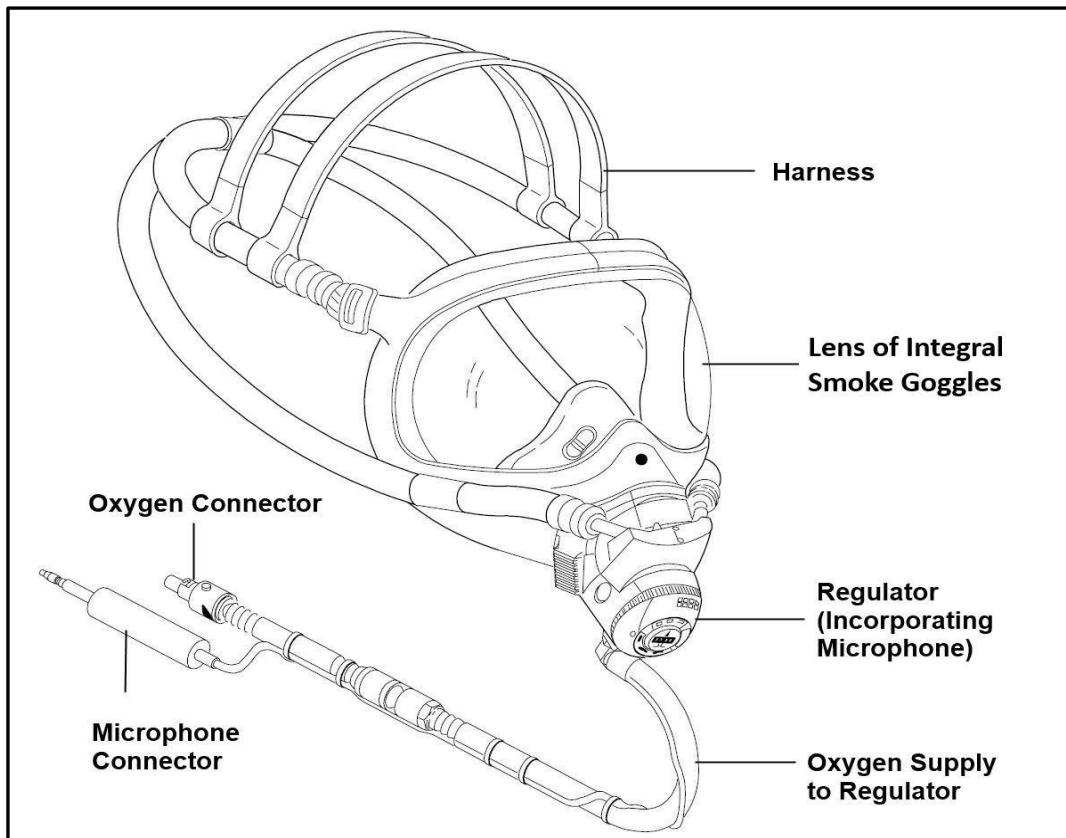
Figure No. 1: Diagram of the sweep-on oxygen mask

In some installations, including this case, oxygen masks may also incorporate a clear plastic visor or lens to protect the eyes in the event of smoke. **Figure No. 1** illustrates the main components of the masks in use on G-FBEM.
