Air Accident Investigation Unit Ireland

SYNOPTIC REPORT

ACCIDENT
Tecnam P2002-JF, EI-GIS
Waterford Airport

11 March 2019

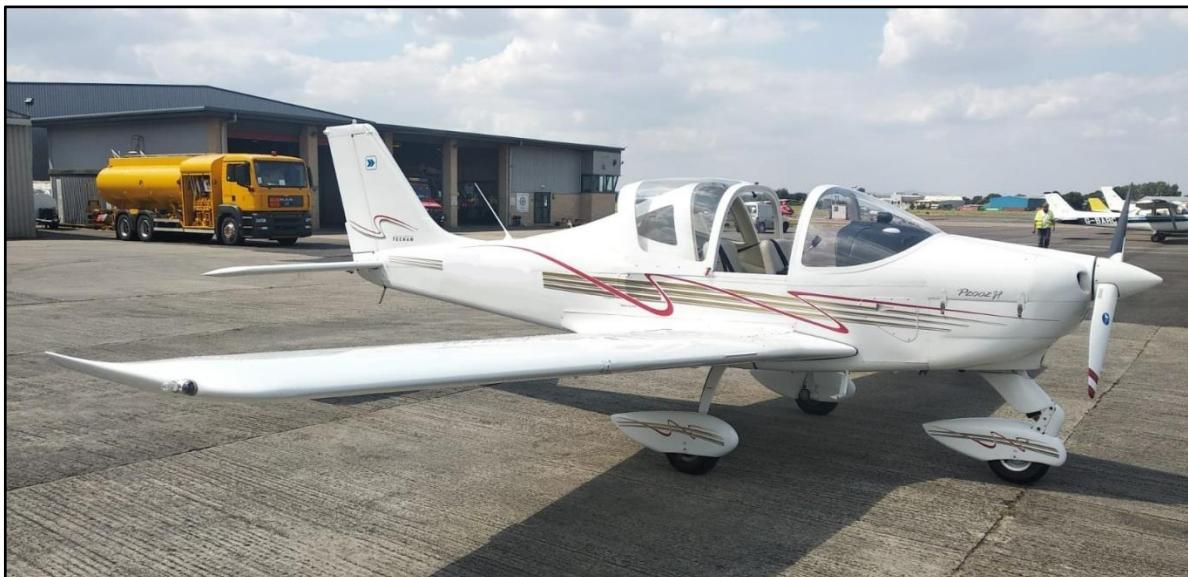
Photo No. 1: Accident Aircraft at time of purchase. (Courtesy of DTO). The previous registration identification has been removed from the image

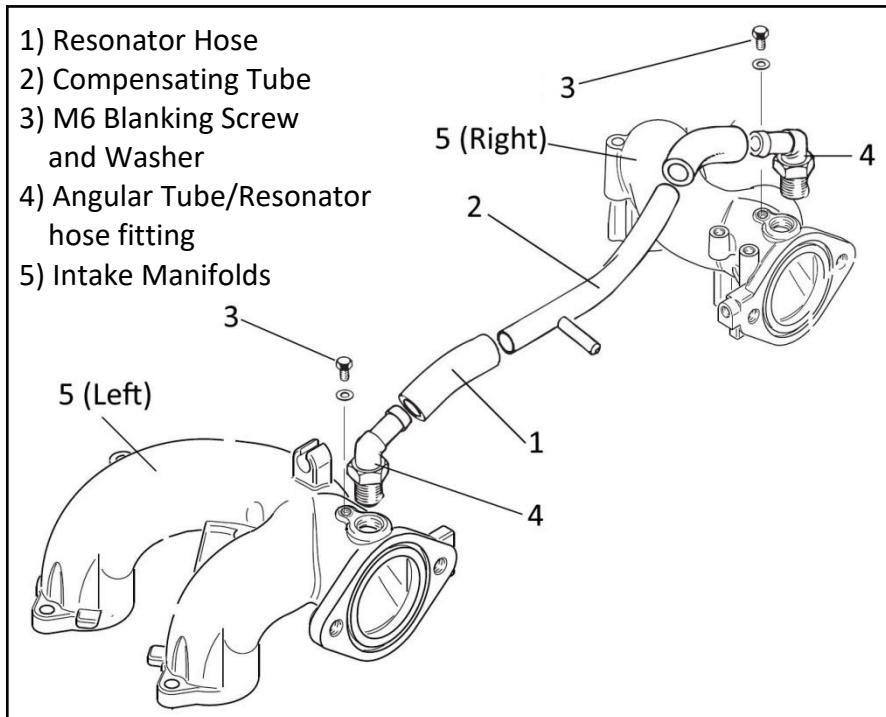
Figure No. 6: Schematic of Engine Intake Manifolds. (Adapted from Engine Manufacturer's Line Maintenance Manual)

Each manifold is also fitted with an M6 screw and washer combination as standard, (item 3 in **Figure No. 6**). These M6 screws are used to blank off an M6 tapping in each manifold, which may also be used during carburettor synchronisation.

When inspected, it was found that EI-GIS did not have the standard M6 blanking screw and washer arrangement fitted to the manifolds as required (**Figure No. 6**, item 3).

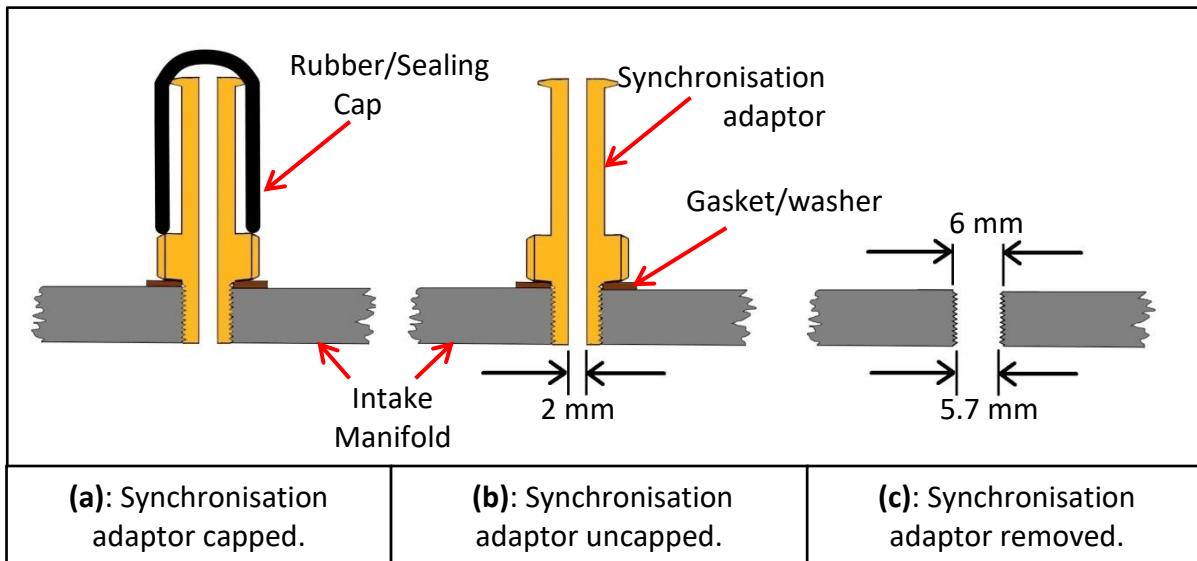
Figure No. 7: Cross section of a Carburettor Synchronisation Adaptor

When fitted with its washer/gasket and rubber sealing cap, the synchronisation adaptor tapping is sealed, **Figure No. 7 (a)**. If the rubber cap is not fitted, this presents a 2 mm opening in the top of the affected intake manifold, **Figure No. 7 (b)**. When the synchronisation adaptor is completely removed, a tapped hole of approximately 5.7 mm diameter is present in the top of the manifold, **Figure No. 7 (c)**. The Rotax 912 Series, Line Maintenance Manual indicates that this hole is normally closed (or blanked off) with a 6 mm hexagonal screw and gasket.
