Air Accident Investigation Unit Ireland

SYNOPTIC REPORT

ACCIDENT
Piper PA-28R-180, G-FBWH
Sligo Airport

5 August 2018

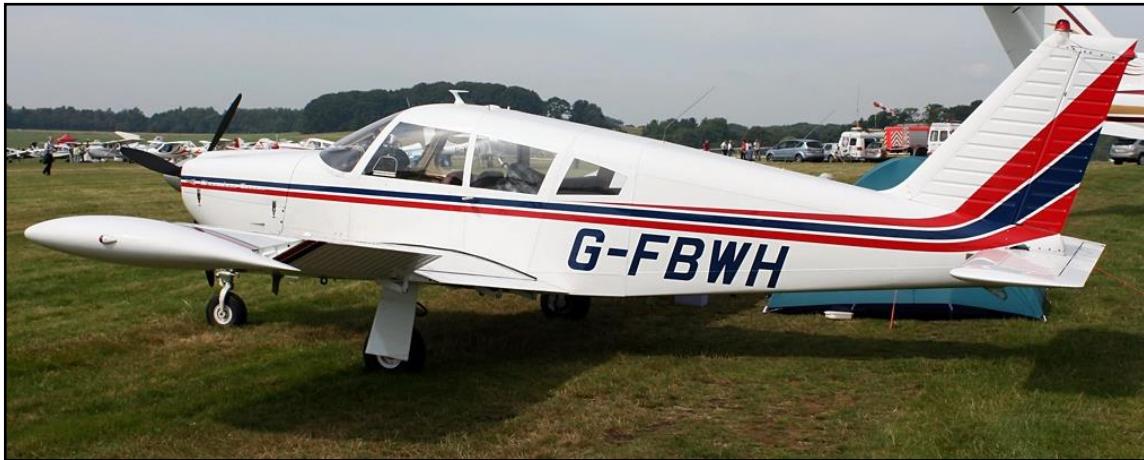
Photo No. 1: G-FBWH. A Piper PA-28R 180 Cherokee Arrow (Jeroen Stroes)

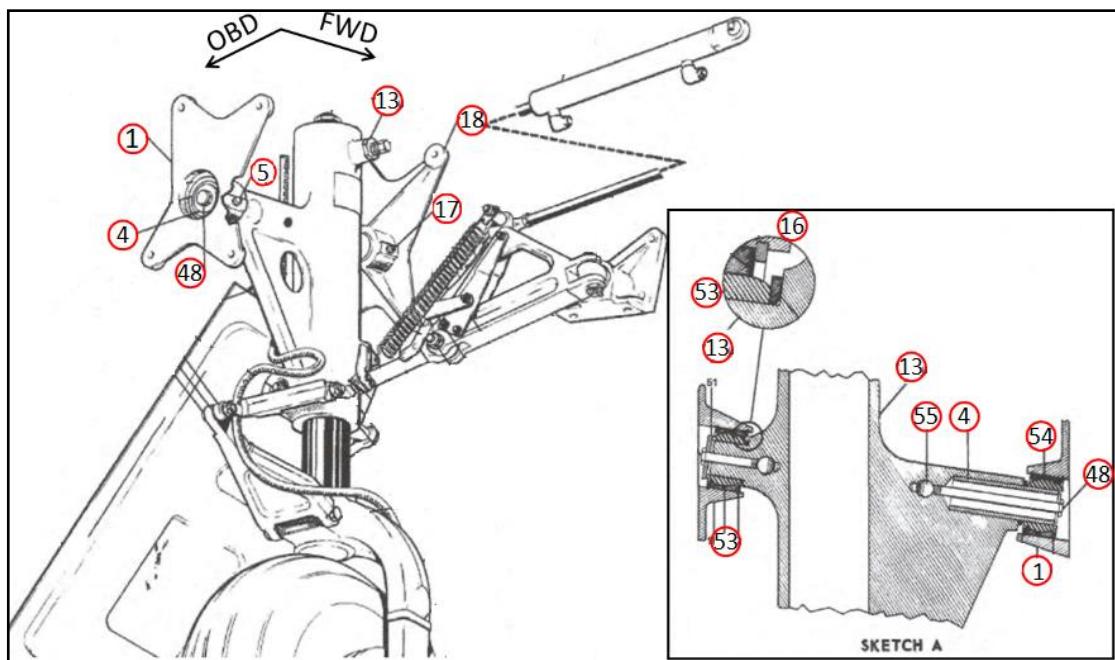
Figure No. 1: Main gear installation (Left-hand undercarriage shown, right-hand similar)
(Adapted from Piper Cherokee Service Manual, Jan 31, 2008)

As illustrated in **Figure No. 1**, the right-hand undercarriage strut housing (13) is located in the wheel well area within the wing of the aircraft via two support fittings, and rotates about two main gear pivot points. At the aft support fitting (1), the undercarriage strut housing is fixed using a bearing (54) and retainer tube (4) arrangement. The retainer tube passes through the bearing and is secured to the inside of the undercarriage strut housing using an attachment bolt (48).

This bolt is threaded into a barrel nut (55) which is positioned within the undercarriage strut housing. When secured within the forward and aft support fittings, the undercarriage will pivot about the forward and aft bearings (53 and 54) during retraction and extension.

The forward and aft bearings are serviced via grease nipples located at positions (17) and (5) respectively as shown in **Figure No. 1**.

The Aircraft Service Manual, Section III – Inspection, page 3I11 states that routine inspection for the '*Landing Gear Group*' is carried out at a 100 hours interval. The removal and installation of the main landing gear in the Aircraft Service Manual does not describe how to check for the correct location of the retainer tube, nor does it state what the minimum number of threads through the barrel nut (Item 55, **Figure No. 1**) should be following installation.
