# Air Accident Investigation Unit Ireland

**SERIOUS INCIDENT REPORT**  
**Boeing 737-8F2, TC-JGG**  
**Airbus 319, D-AGWJ**  
**Dublin Airport, Co. Dublin**  
**16 October 2010**

AAIU Report No: 2011-019

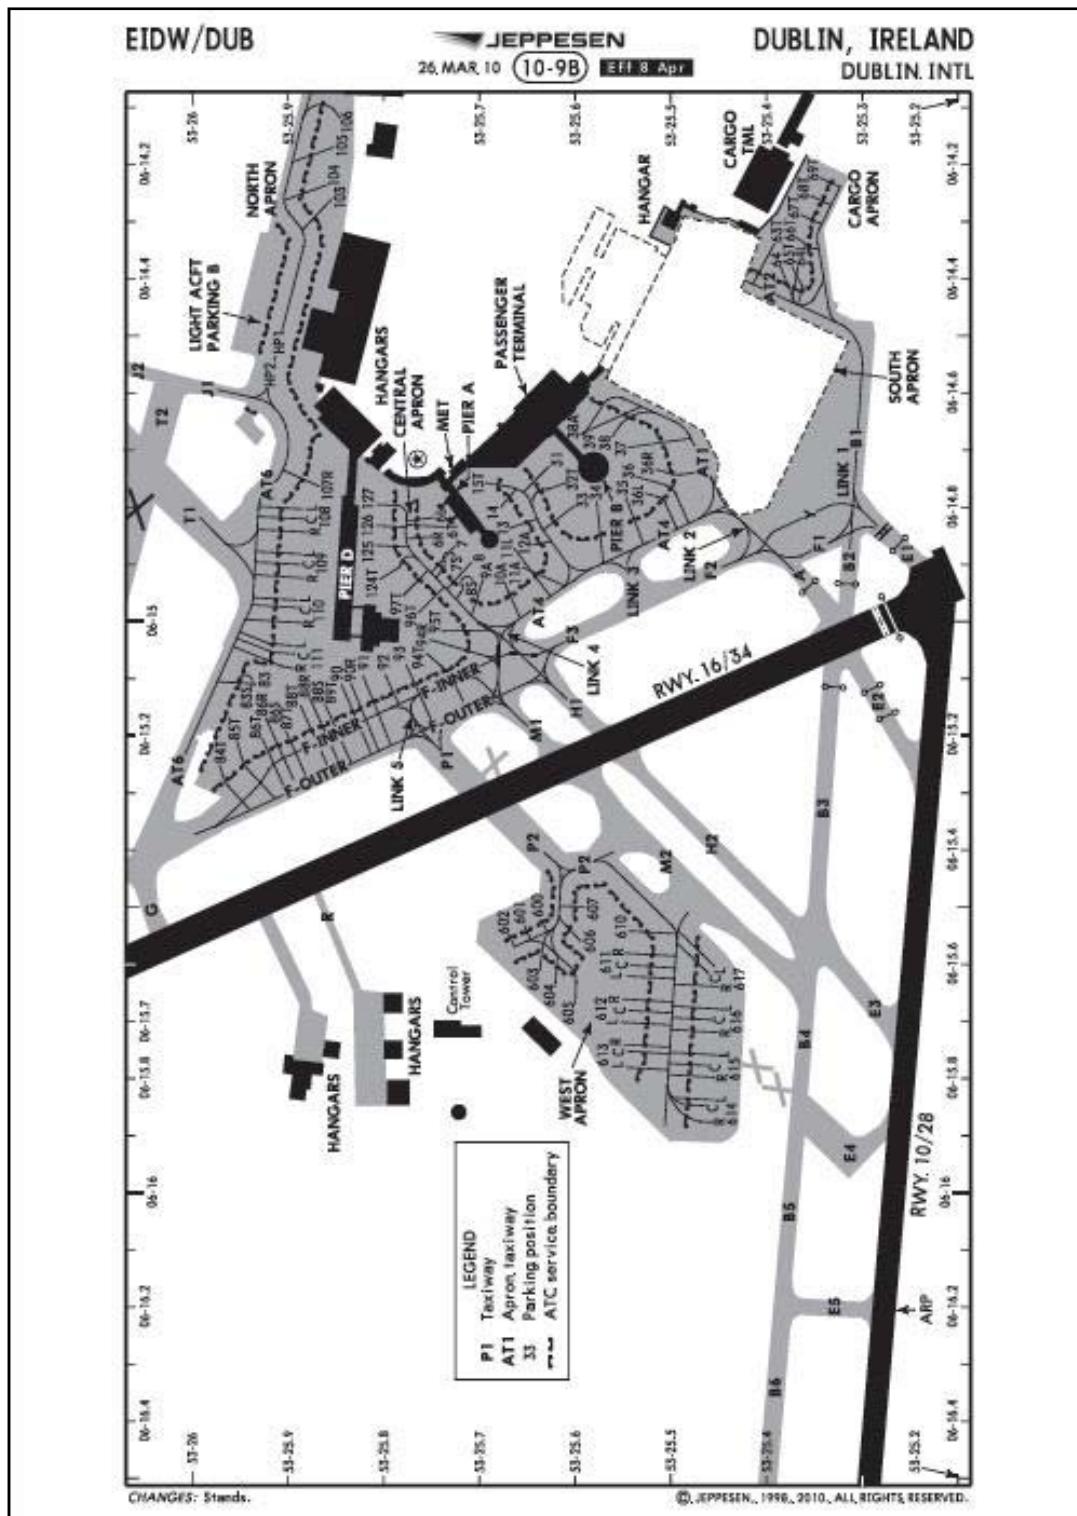
EIDW Airport Chart 10-9B

In the section of the AAIU Form entitled "Your assessment of the Cause of the Incident", the Commander wrote that the statement on Jeppesen page 10-1P2 that *"A further holding position is established on RWY 16/34"* was not understood correctly by the crew. He stated that the SMC cleared the aircraft to the holding position for RWY 28, but that the correct name for that holding position should be *"Holding Point RWY 28 and 34"*. He considered that when the SMC specified only RWY 28, this supported the crew's misunderstanding that there were two separate holding positions for RWYs 28 and 34. He also said that nowhere in the documentation was there a statement to the effect that RWY 28 and 34 have the same holding position. He stated that when the crew were doing mandatory head down tasks and calling cabin crew to be prepared for take-off, they only saw the signage of RWY 34 and they did not notice any other numbers. He considered that they had already decided that there were two holding positions and thus they *"did not notice enough"*. He considered that if the taxi instruction was given as *"Holding point RWY 28/34 for RWY 28"*, that would be helpful. He also considered that Ground Control should not change an aircraft to Tower frequency by means of an instruction to *"monitor"* the frequency. He felt that positive radio contact with the Tower might assist with an advance warning, when there was a runway incursion hot spot ahead.

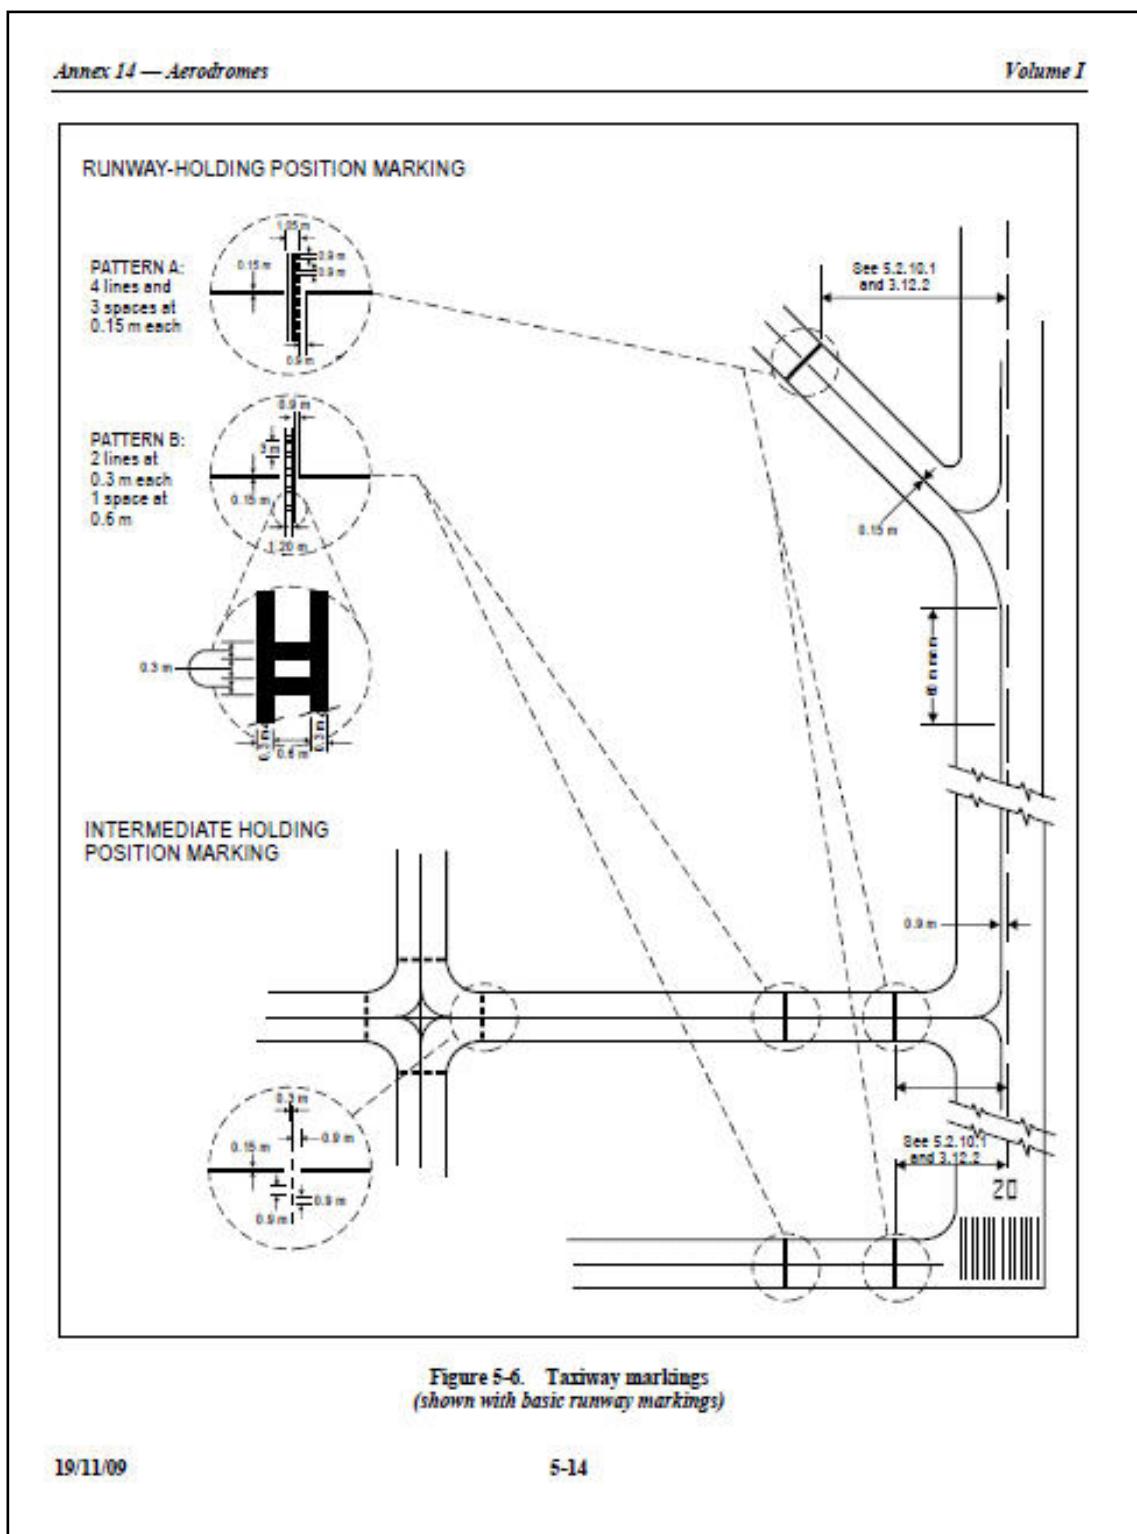
### ICAO Runway Holding positions Markings

Approximately 60 m further along TWY E1, a taxiing aircraft encountered the combined holding position signage for RWY 28 ILS Cat I and for RWY 34. These were red and white signs marked "34 28CAT I" accompanied by yellow flashing runway guard lights, mounted in the grass verges on both sides of the taxiway, **Photo No. 2**. At the same point, there were two large rectangular signs painted on the taxiway surface, one on either side of the centreline, with "34 28" in white against a red background. There were also double yellow solid lines and double yellow broken lines painted across the taxiway, as per runway holding position marking "Pattern A", as defined in ICAO Annex 14, see **Appendix C**.
