## FINAL REPORT

**AAIU Synoptic Report No: 2008-001**  
**AAIU File No: 2007/0078**  
**Published: 21/01/08**

<b>Aircraft Type and Registration:</b>	Urban-Air UFM10 Samba, EI-DRM	
<b>No. and Type of Engines:</b>	1x Jabiru 22A	
<b>Aircraft Serial Number:</b>	3/10	
<b>Year of Manufacture:</b>	2000	
<b>Date and Time (UTC):</b>	7 September 2007 @ 12.30 hrs	
<b>Location:</b>	Abbeysrule, Co. Longford (EIAB)	
<b>Type of Flight:</b>	Training	
<b>Persons on Board:</b>	Crew - 2	Passengers - Nil
<b>Injuries:</b>	Crew - Nil	Passengers - Nil
<b>Nature of Damage:</b>	Minor damage to nose gear and propeller	
<b>Commander's Licence:</b>	PPL/A (IRL)	
<b>Commander's Details:</b>	Male, aged 44 years	
<b>Commander's Flying Experience:</b>	1,496 hrs, of which 1,340 were on type.	
<b>Notification Source:</b>	AAIU Report Form submitted by Pilot.	
<b>Information Source:</b>	Aircraft's Irish Agent

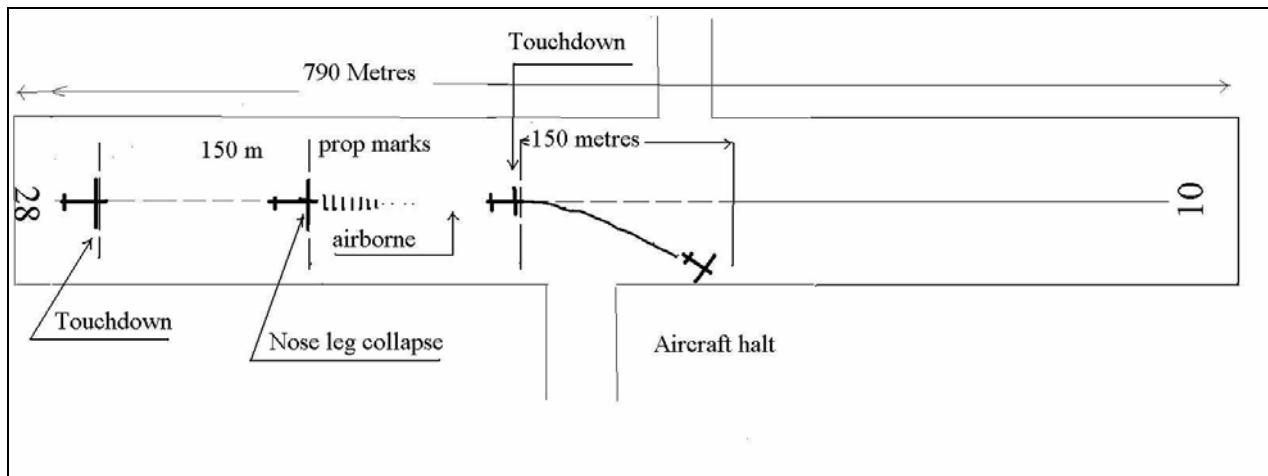
## Appendix A

**A schematic diagram of the runway at Abbeyshrule as submitted by the Instructor following this incident.**
