FINAL REPORT

AAIU Formal Report No: 2008-023

Operator:	Aer Lingus
Manufacturer:	Airbus
Model:	A330-301
Nationality:	Ireland
Registration:	EI-DUB
Location:	Approach to Runway (RWY) 22R, Chicago O'Hare Airport (KORD), USA
Date/Time (UTC):	16 September 2006 @ 21.45 hrs UTC

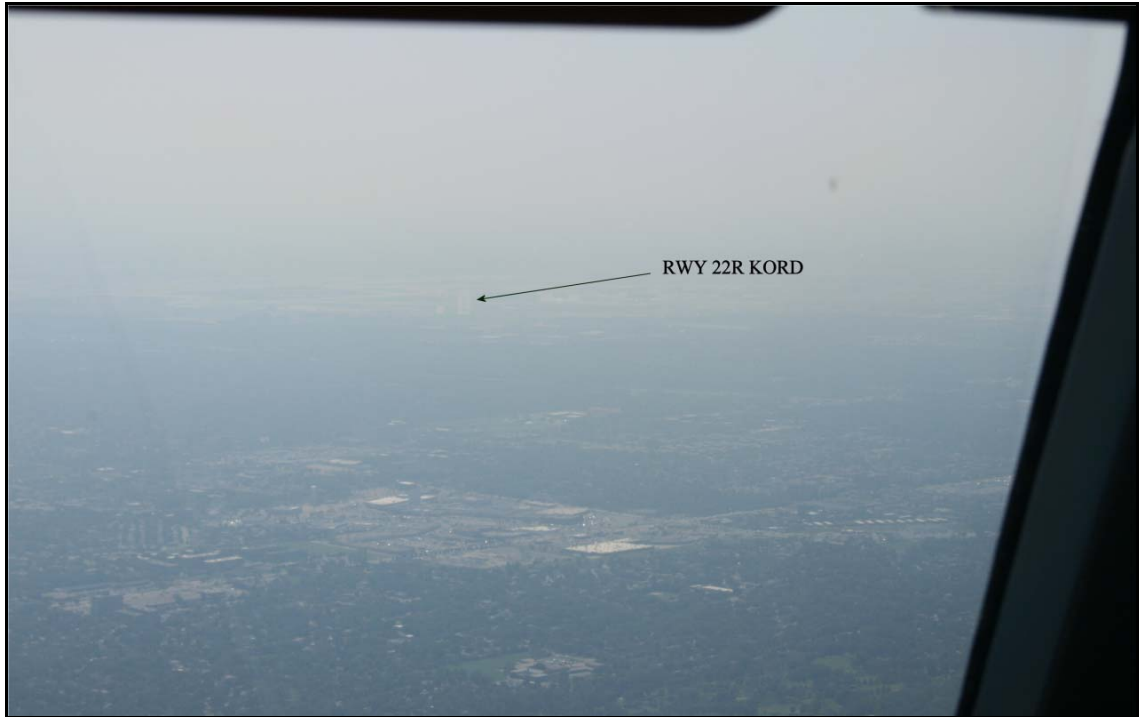
Photo No. 1

As the approach was conducted in the late afternoon in the autumn, it is probable that the runway approach lights and the airport itself would have been difficult to identify at a distance even though the visibility was probably in excess of 10 miles (**Appendix B Photos 1 & 2**). The former was due to the southwesterly approach into diffused sun light and the latter due to lack of terrain colour contrast at that time of year.

KORD RWY 22R Approach at 6 nm

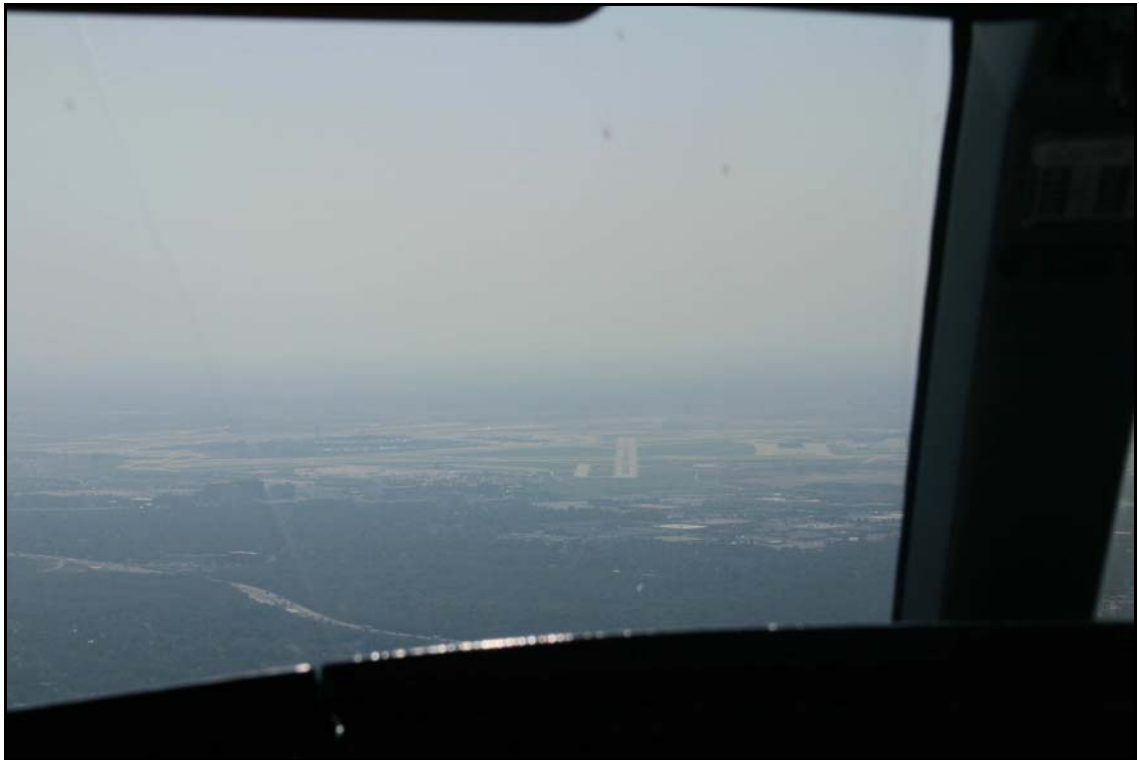
Photo No. 2

KORD RWY 22R at 3 nm in good visibility
