## FINAL REPORT

**AAIU Report No: 2010-005**  
**State File No: IRL00910015**  
**Published: 28/06/2010**

<b>Aircraft Type and Registration:</b>	Schleicher ASK 13 (Glider) EI-GLD	
<b>No. and Type of Engines:</b>	N/A	
<b>Aircraft Serial Number:</b>	13131	
<b>Year of Manufacture:</b>	1969	
<b>Date and Time (UTC):</b>	6 March 2010 @ 15.35 hrs	
<b>Location:</b>	Field adjacent to Gowran Grange Airfield, Punchestown, Co. Kildare	
<b>Type of Flight:</b>	Private	
<b>Persons on Board:</b>	Crew - 1	Passengers - Nil
<b>Injuries:</b>	Crew - 1 (Minor)	
<b>Nature of Damage:</b>	Significant	
<b>Commander's Licence:</b>	Bronze C Cert issued by the Irish Gliding & Soaring Association (IGSA)	
<b>Commander's Details:</b>	Male, aged 63 years	
<b>Commander's Flying Experience:</b>	123 hours, of which 45 hours were on type	
<b>Notification Source:</b>	Dublin Gliding Club	
<b>Information Source:</b>	AAIU Pilot Report Form submitted by Pilot

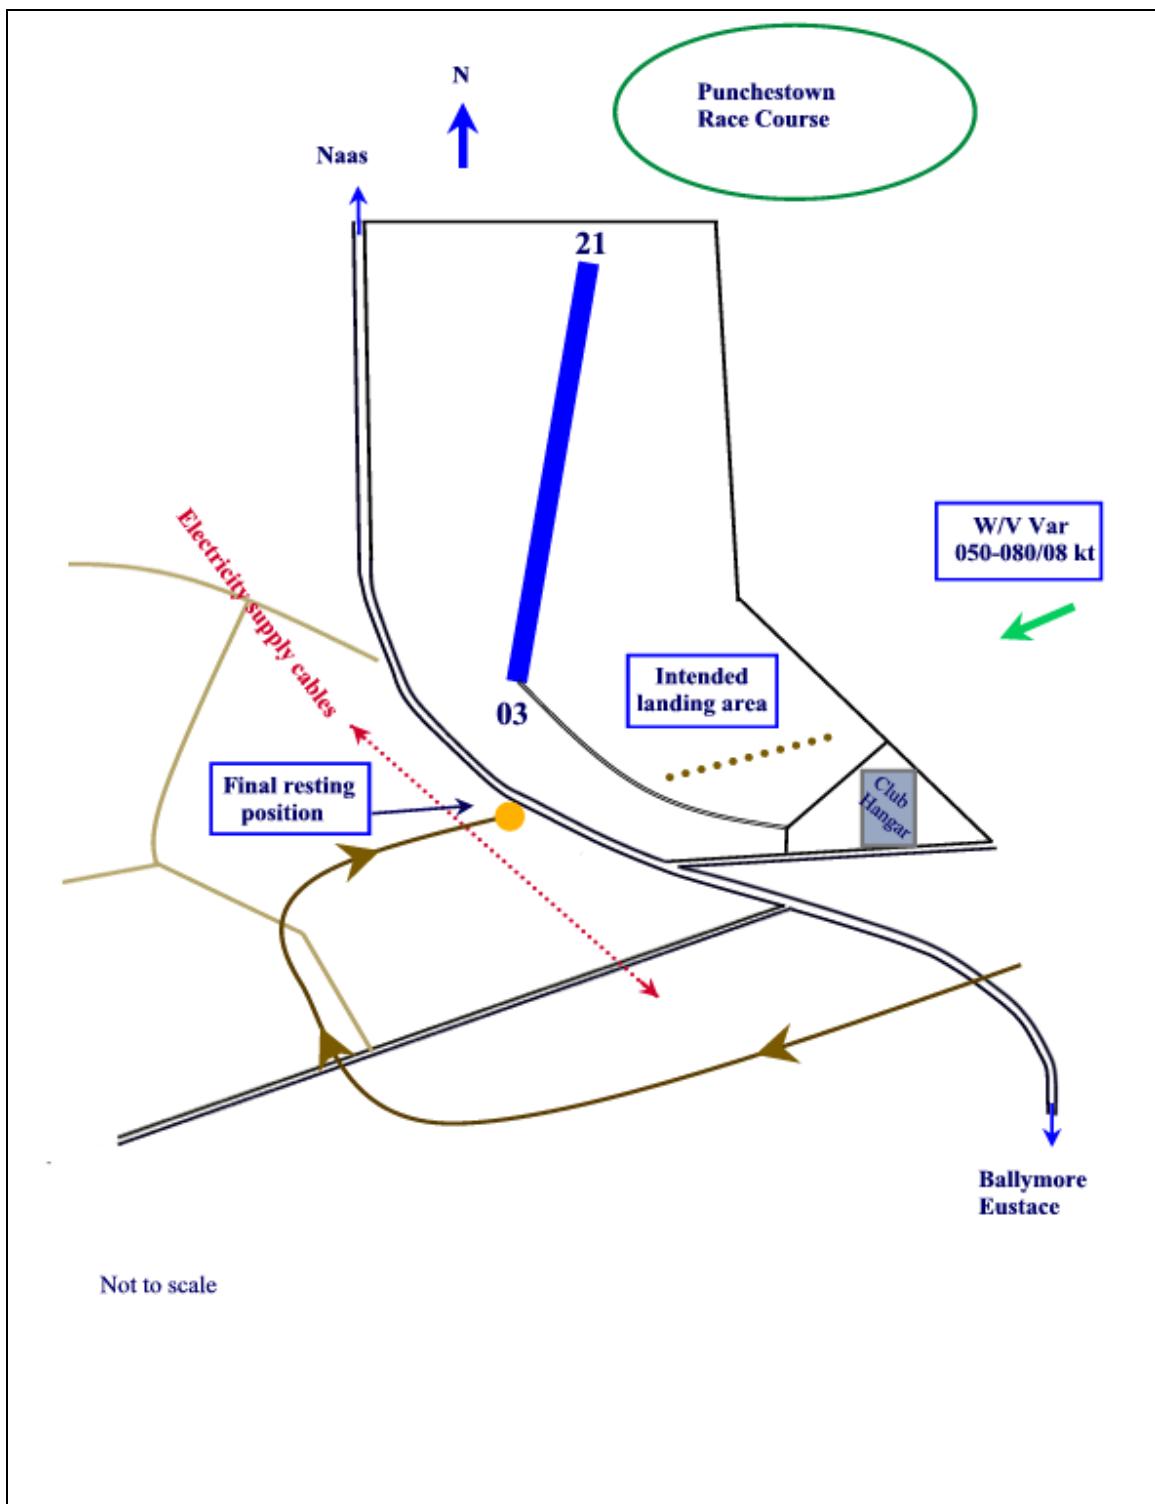
**Graphic No. 1: General depiction of Gowran Grange area, flight path, final resting position of EI-GLD and intended landing area.**
