FINAL REPORT

1 **AAIU Synoptic Report No: 2006-006**
2 **AAIU File No: 2004/0029**
3 **Published: 24/4/06**
4

Aircraft Type and Registration:	Airbus A330-301, EI-JFK
No. and Type of Engines:	2 x GE CF6-8OE1A2
Aircraft Serial Number:	086
Year of Manufacture:	1994
Date and Time (UTC):	4 June 2004 @ 10.07 hrs
Location:	On take off from RWY 28, Dublin Airport
Type of Flight:	Scheduled Public Transport
Persons on Board:	Crew - 12 Passengers - 303
Injuries:	Crew - Nil Passengers - Nil
Nature of Damage:	No damage to aircraft
Commander's Licence:	ATPL
Commander's Details:	Male, aged 44 years
Commander's Flying Experience:	15,000 hours of which 110 were on type
Information Source:	Operator informed AAIU

1. FACTUAL INFORMATION

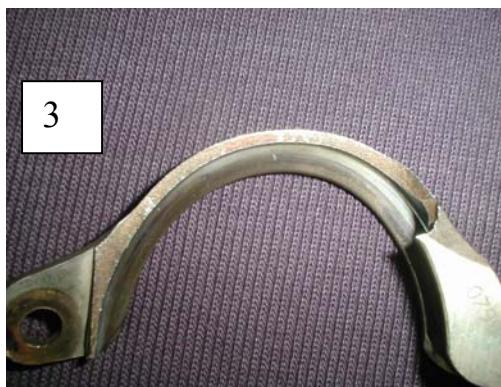
- 17 • Broken TTU adjustment sleeve lockwire.
- 18 • Disengagement of the adjustment sleeves.
- 19 • Distortion of the inner duct confirmed.
- 20 • Over-extension stops deformed and worn by 50% of new stop dimension.
- 21 • Witness marks on TTU adjustment sleeves resulting from contact with over
22 extension stops.
- 23 • Flange sealing surfaces damaged
- 24 • Races worn beyond limits

32
33 *The lockwire securing the TTU adjustment sleeves in the adjusted position failed, allowing in-*
34 *service rotation of the adjustment rings. The adjustment rings rotated in a direction that*
35 *extended the TTU to the point of maximum extension. The over-extension tab deformation and*
36 *wear identified during the examination of the TTU, permitted continued rotation of the*
37 *adjustments sleeves beyond the mechanical stops. The TTU adjustment sleeves continued to*
38 *extend to the point of thread disengagement.*

Photo 4: The detached TTU of EI-JFK
Photo 5: A serviceable TTU
