FINAL REPORT

AAIU Synoptic Report No: 2007-023

Aircraft Type and Registration:	Luscombe 8A, N2837K	
No. and Type of Engines:	1 x Continental A65	
Aircraft Serial Number:	5564	
Year of Manufacture:	1947	
Date and Time (UTC):	7 May 2006 @ 17.55 hrs	
Location:	Navan Airfield	
Type of Flight:	Private	
Persons on Board:	Crew - 1	Passengers - 1
Injuries:	Crew - Nil	Passengers - Nil
Nature of Damage:	Damaged beyond economic repair	
Commander's Licence:	PPL	
Commander's Details:	Male, aged 42 years	
Commander's Flying Experience:	432 hours of which 69 hours were on type	
Notification:	The owner of Navan Airfield reported this accident to the AAIU	
Information Source:	Accident Report Form submitted by Pilot. AAIU Field Investigation

SYNOPSIS

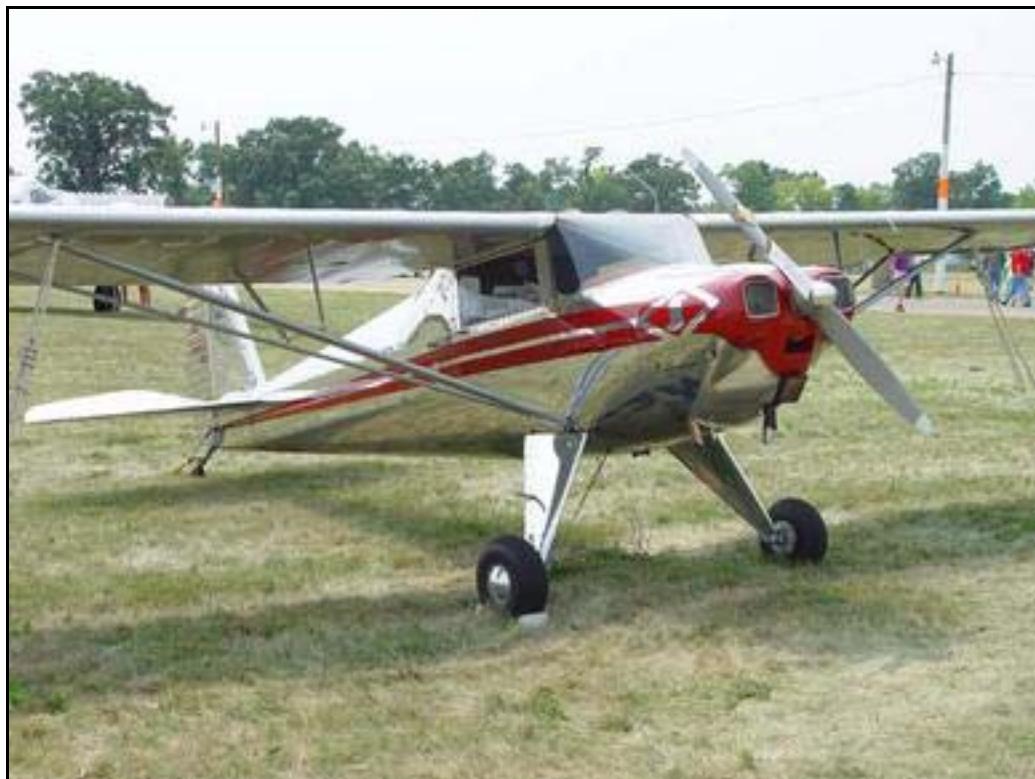
The fuselage failed at the aft bulkhead during the accident sequence. The empennage remained connected to the fuselage solely by the elevator and the rudder control cables. These cables cut into the lower rear fuselage skin forward of the failure point for about 0.6 metres as a result of the empennage hanging from the fuselage (**Photo No. 3**).

The damage suffered to the aircraft is consistent with the aircraft crossing the creosoted line of fence posts diagonally from the intended approach path. The aircraft impacted the first fence post causing damage to the left rear side of the fuselage and then the post struck the left support rod of the left side tailplane. This impact was sufficient to severely weaken the empennage attachment to the fuselage. The aircraft then impacted heavily into the adjacent ploughed field on its left hand main undercarriage leg, which then collapsed rearward. Just prior to bouncing into the deep ditch, the propeller made a vertical slice through the non-creosoted fence post along the line of the ditch. On coming to its final resting position the empennage peeled back from the fuselage and remained hanging from the structure through the elevator and rudder cable connections.

Photo No. 3: Resting position of N2837K
