# FINAL REPORT

**AAIU Synoptic Report No: 2004-016**

<b>Aircraft Type and Registration:</b>	Rans S-7 Courier, G-BWKJ	
<b>No. and Type of Engines:</b>	1 x Verner SVS 1400	
<b>Aircraft Serial Number:</b>	PFA-219-129218	
<b>Year of Manufacture:</b>	1997	
<b>Date and Time (UTC):</b>	05 July 2004 @ 2005 hrs	
<b>Location:</b>	Moyne Airfield, Thurles, Co. Tipperary	
<b>Type of Flight:</b>	Private	
<b>Persons on Board:</b>	Crew - 1	Passengers - 1
<b>Injuries:</b>	Crew - Nil	Passengers - Nil
<b>Nature of Damage:</b>	Substantial, U/C collapsed, prop (wooden) shattered, fuselage damage.	
<b>Commander's Licence:</b>	Irish Commercial Pilot's Licence	
<b>Commander's Details:</b>	Male, aged 36 years	
<b>Commander's Flying Experience:</b>	800 hours (of which 5.15 were on type)	
<b>Information Source:</b>	Notification by pilot and AAIU Report Form submitted by pilot

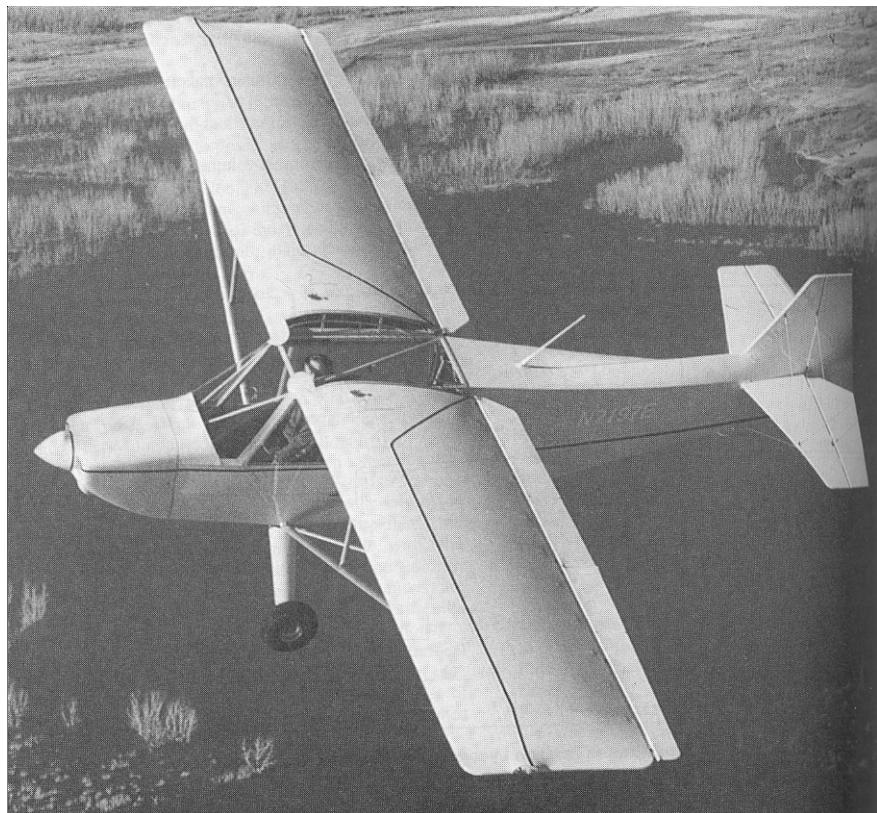
*(Photo Source: Janes All the Worlds Aircraft)*

The RANS S-7 Courier is a two seat STOL kit-built aircraft. The landing gear is non-retractable tailwheel type. The take-off run and landing run to safe turn speed is approximately 175 ft and 303 ft, respectively.
