**ACCIDENT
to
Bell 206B JetRanger II**

EI-ONE

Lispole, Dingle, Co Kerry

28 August 2002

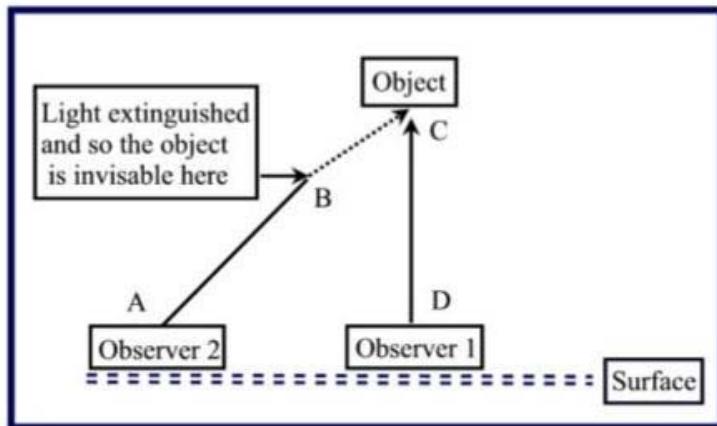
Fig 1.

Visibility reduction is a function of light scattering and absorption from fine particles and fine water droplets. From this, it is obvious that, for a relatively uniform airmass of high humidity, an object visible vertically upwards would not necessarily be visible if the observer were offset from the vertical. This is because the light to the “offset” observer has to travel through a greater distance and so through a greater amount of fine water droplets. (See Fig 1 below)

Note: The distance from A to B equals the distance from C to D
